## Engineer's Damaged Truss/Timber Evaluation

### 1.0 - Background and Purpose

On 11/12/2025 a Damaged Truss Evaluation (DTE) was performed at the property located at address 123 Main St, Your City, TN, 12345, which consists of a 2600 square-foot single family no garage structure built in 2007 with a truss roof framing.

# Exhibit A - Damaged Area 1 (Damaged King Post)

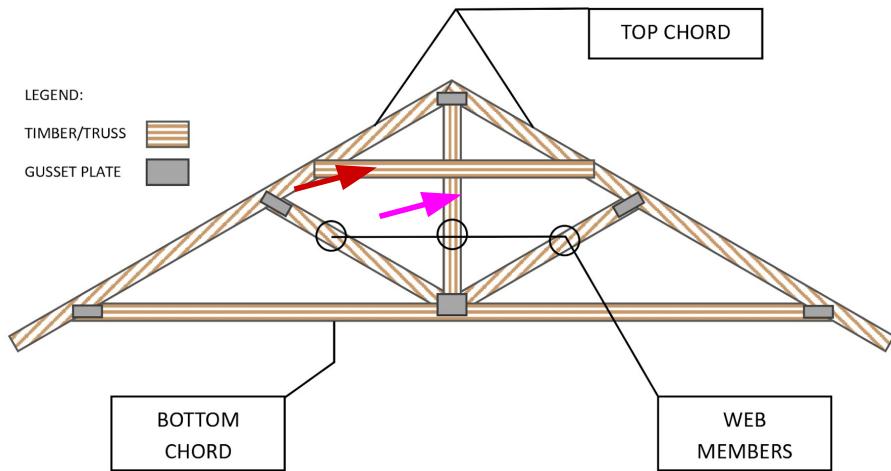
**Member Deflecting/Bowing:** We agree with the findings of the inspection report that the observed bowing of the king post of two truss members should be considered significant (See Exhibit A). The affected members exhibit noticeable bowing along their span, suggesting overstress, insufficient lateral restraint, or deformation due to sustained loading or moisture-related movement. The deflection indicates localized loss of stiffness and potential redistribution of loads within the truss system. While the overall roof structure remains generally intact, the bowed members may have a reduced capacity to maintain proper alignment and resist design loads.
