UPCHURCH INSPECTION
+19013508885
wes@upchurchinspection.com
<https://upchurchinspection.com>

RESIDENTIAL REPORT

1234 Main Street
Memphis, TN 38117

Buyer Name
01/10/2026 9:00AM

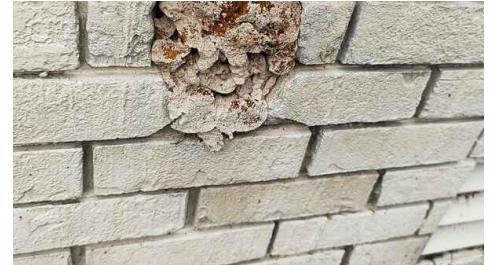
There is no dryer vent present at the property. The opening where a dryer vent would typically exit has been filled in with mortar and stone. A dryer vent helps ensure the dryer runs safely and efficiently. Without a vent, lint, heat, and moisture can build up in your home, which can lead to fire safety concerns, moisture issues, and mold within the laundry area, as proper ventilation is crucial for dryer operation.

Safety Hazard

It is recommended to consult with a qualified contractor to assess the situation and re-establish a functional dryer vent if necessary. Proper ventilation should be installed to ensure safe and effective dryer operation, preventing moisture buildup and potential damage to the property.

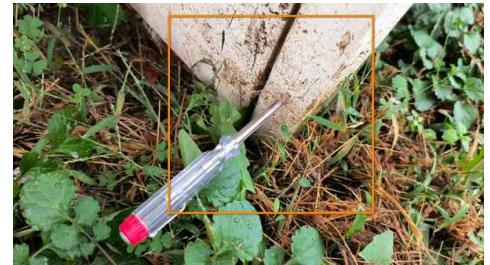
Bottom Support of Back Stairs

The wooden steps leading to the rear exit door make direct contact with the ground. This contact has resulted in visible signs of wood softening, and there are indications that the wood may be beginning to rot. Such deterioration can compromise the structural integrity of the steps, posing safety risks for users.

Immediate action is recommended to assess the extent of the deterioration. Consider replacing any compromised sections of the steps and elevating them to prevent further moisture exposure. Regular inspections should be conducted to monitor for ongoing deterioration and ensure the safety and longevity of the structure.

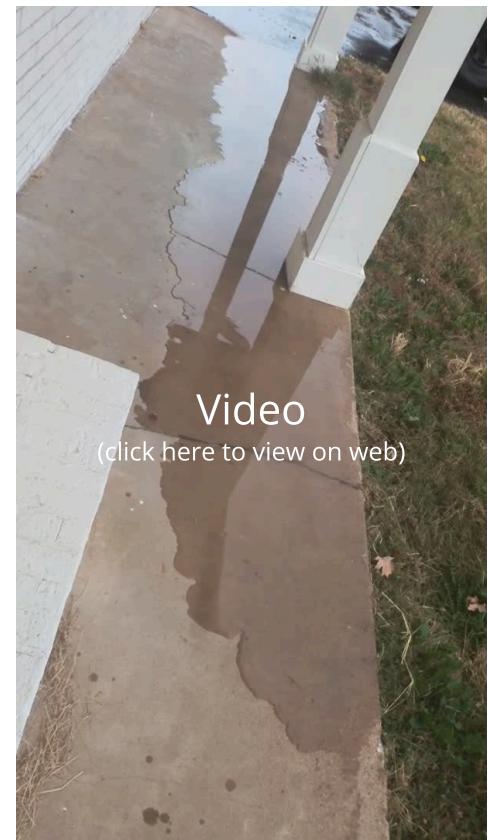
RAINWATER OBSERVED IN WALKWAY TO FRONT DOOR**Observation:**

Improper drainage from the gutter downspouts has been noted, resulting in water flowing onto the front porch walkway. This condition creates a potential slipping hazard for residents and visitors.

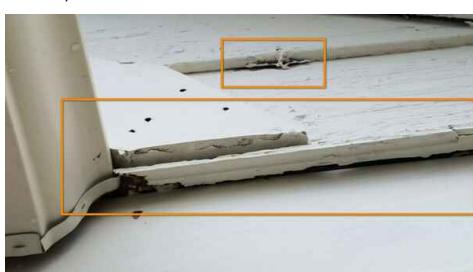
SOME INDICATIONS OF WOOD DETERIORATION AT THE EVES AND FASCIA.

Peeling Paint Indicates Moisture in underlying wood.

Separation of trim near attic in carport

Some indications of wood deterioration on facia.

Recommend monitoring.

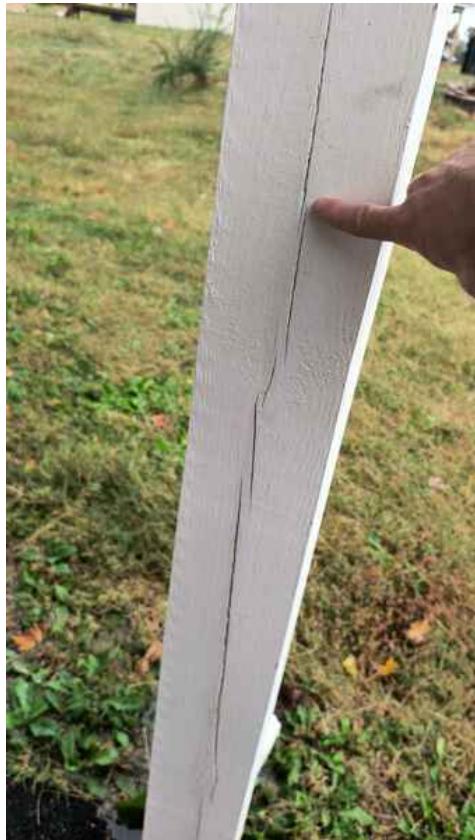
2.8.1 Pillar

The pillars in front of the house were inspected, and while those along the porch appeared adequate, the pillar on the right side of the carport exhibited vertical cracking and made direct contact with the ground, where water from the gutter downspouts was pooling. Upon examination, the pillars supporting the porch were found to be structurally sound, providing adequate support as intended. However, the pillar located to the right of the carport showed noticeable vertical cracking, which could indicate stress or movement in the structure. This cracking may compromise the pillar's integrity over time and should be monitored for further deterioration.

Additionally, this pillar is in direct contact with the ground, which raises concerns regarding moisture exposure. The pooling of water from the adjacent gutter downspout directly at the base of the pillar can contribute to deterioration and potential rot, further exacerbating the cracking issue. Prolonged moisture exposure can weaken the foundation and structural support of the pillar.

It is recommended to have a carpenter or structural engineer evaluate the extent of the cracking on the pillar and consider necessary repairs or reinforcement. Furthermore, addressing the drainage issue by redirecting the downspout or improving the grading around the area can help mitigate moisture exposure, protecting the integrity of the pillar and preventing future structural concerns.

Contact a qualified professional.

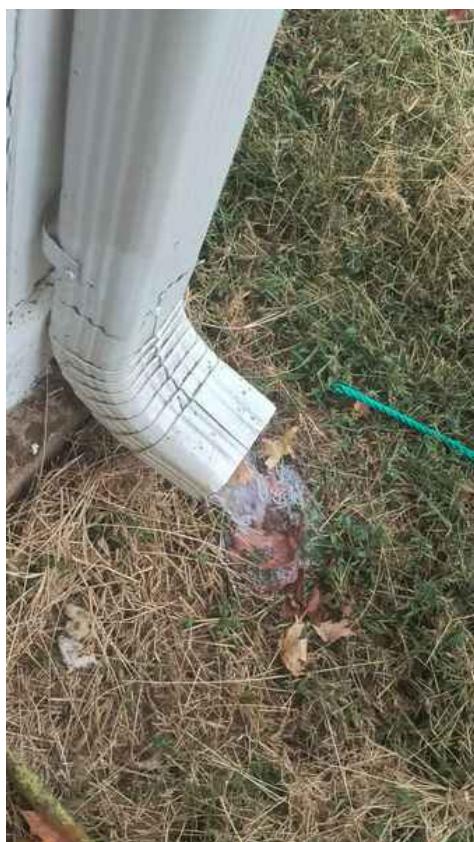
The gutter downspouts at various points (around the property discharge water too close to the foundation. Downspouts are currently terminating within approximately one foot of the home's perimeter, which can lead to water pooling near the foundation during heavy rains. This setup increases the risk of moisture intrusion, erosion, and possible foundation damage over time, particularly in areas with expansive soils or poor drainage.

To mitigate potential foundation issues, it's advised to extend downspouts to discharge at least 5–6 feet away from the home's foundation or connect them to a buried drain system that channels water safely away. Extensions or splash blocks can be used as cost-effective solutions to help direct water away from the home and protect the structural integrity of the foundation.

Contact a qualified gutter contractor

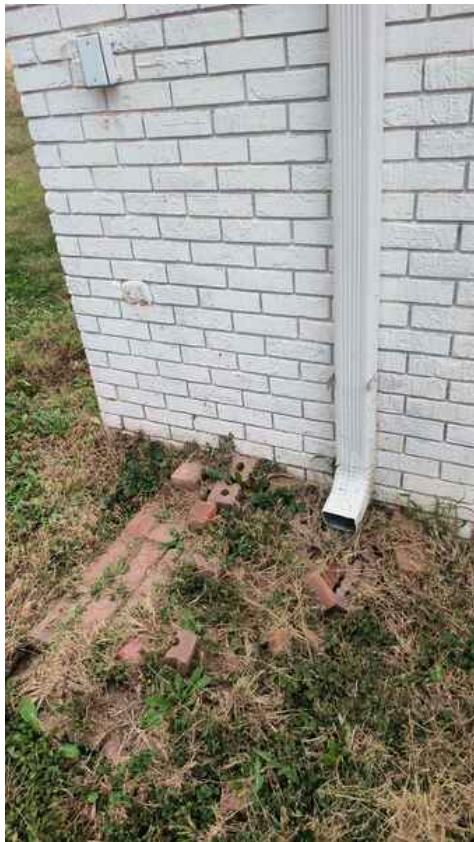
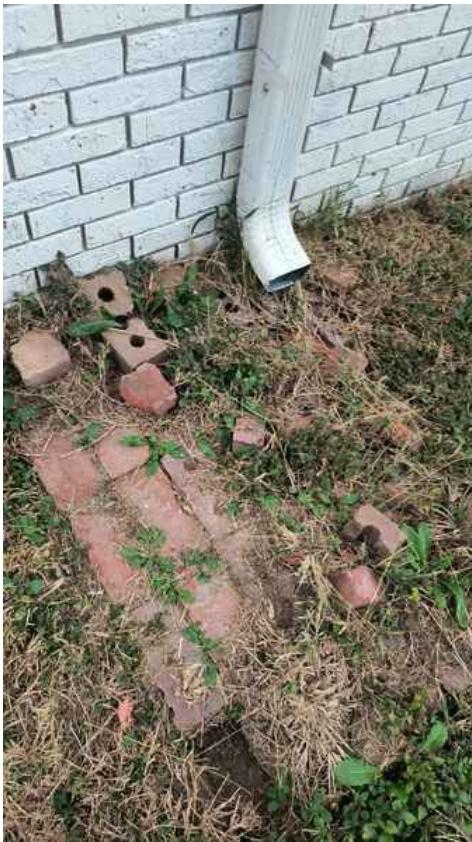
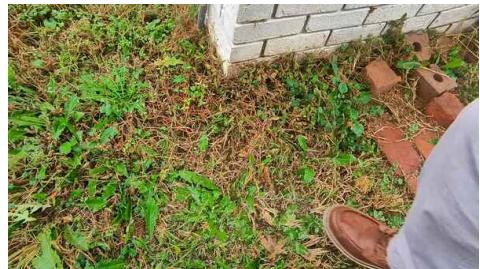
3.2.2 Roof Drainage Systems

DOWNSPOUT POOLING WATER IN BACKYARD

The downspout in the backyard is pooling water, and the brick splash block diversion system is not effectively directing water away from the home. Upon inspection, it was noted that the downspout discharges water onto the ground in the backyard, resulting in significant pooling around the base of the foundation. The existing splash block is insufficient in its current configuration, as it does not channel water away from the house effectively. This can lead to potential drainage issues, which may contribute to moisture problems in the foundation or crawl space.

It is recommended to re-evaluate the drainage system to ensure proper water diversion away from the home. Consider installing an extended downspout or a more effective drainage solution to mitigate water pooling and protect the integrity of the property.

Contact a qualified professional.

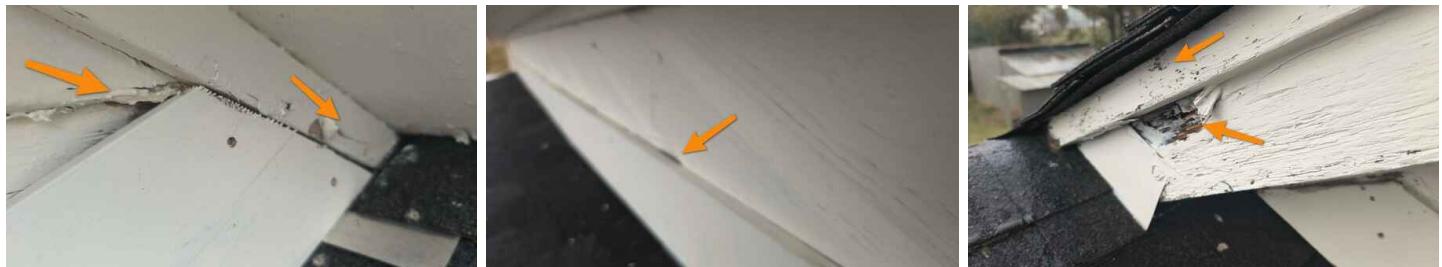
3.4.1 Sidewall

SIDEWALL SHOWS SIGNS OF ROT COVERED BY PAINT

Contact a qualified professional.

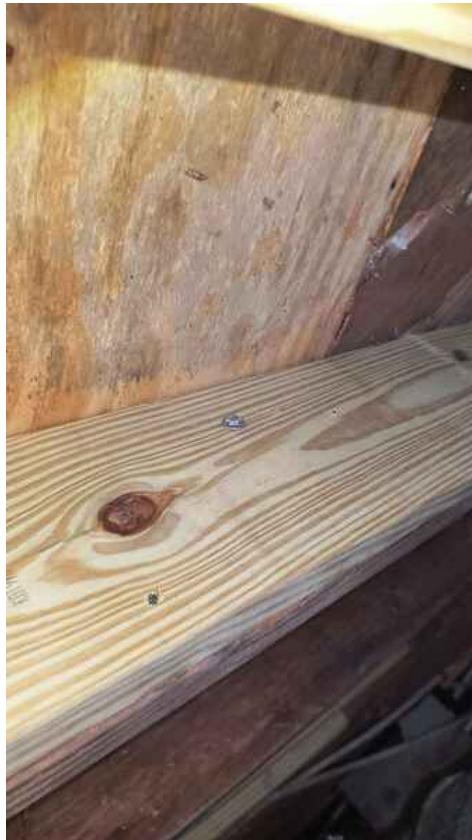
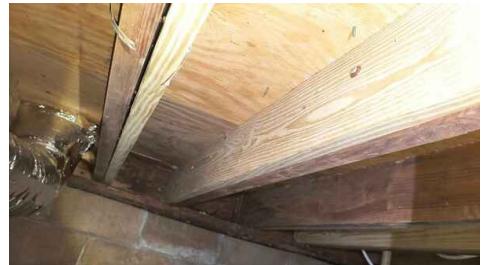
4.3.2 Floor Structure

SUPPORT BEAM SHOWS SIGNS OF SAGGING.

Contact a qualified professional.

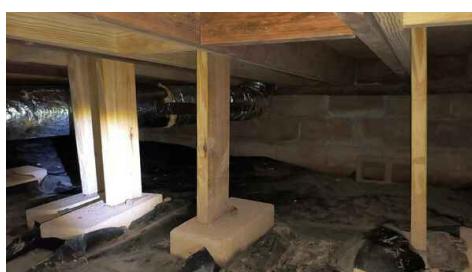
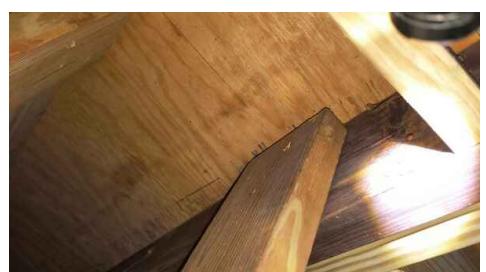
4.3.4 Floor Structure

FASTENING LOAD SUPPORT AT SIDES OF INDIVIDUAL FLOOR JOISTS

Contact a qualified structural engineer.

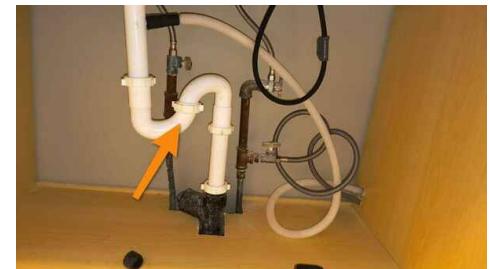
6.2.2 Drain, Waste, & Vent Systems

S-TRAP UNDER KITCHEN SINK

Observation: An S-trap was found installed under the kitchen sink. The S-trap configuration, while historically common, presents several issues that can lead to plumbing problems. S-traps can be prone to siphoning, where the water seal can be drawn out due to negative pressure in the drain system. This siphoning effect can allow harmful sewer gases to escape into the home, creating health risks and unpleasant odors. Additionally, S-traps can lead to frequent clogs, as the design allows for debris to accumulate in the trap itself, hindering proper drainage and requiring more frequent maintenance.

Current plumbing codes often discourage the use of S-traps in favor of P-traps, which are designed to maintain a more reliable water seal and provide better drainage flow. P-traps are less likely to siphon and are generally easier to clean and maintain.

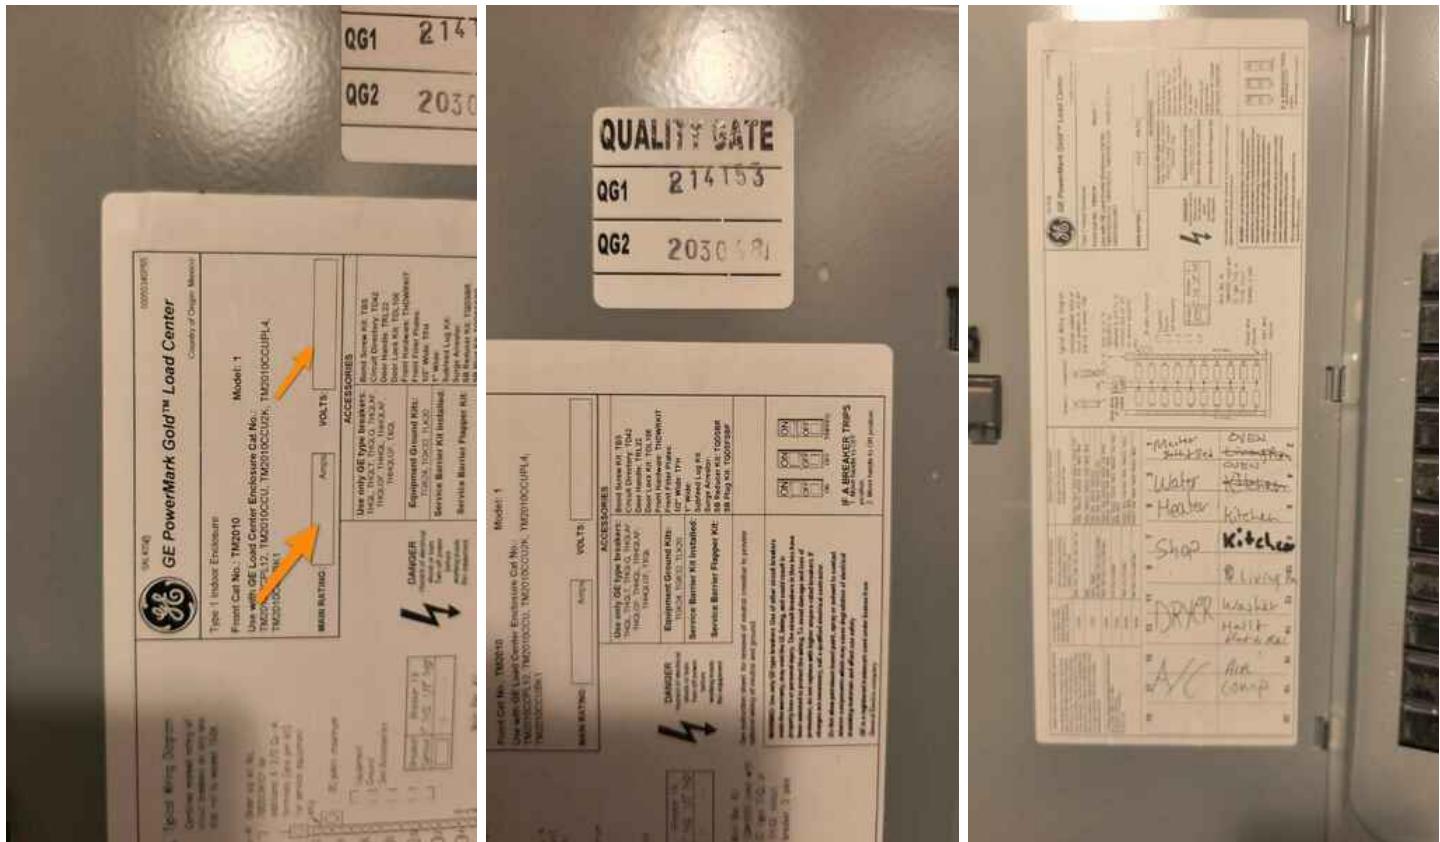
At the time of inspection, panel was labeled, however label was not filled out completely. Recommend a qualified electrician or person identify and map out locations.

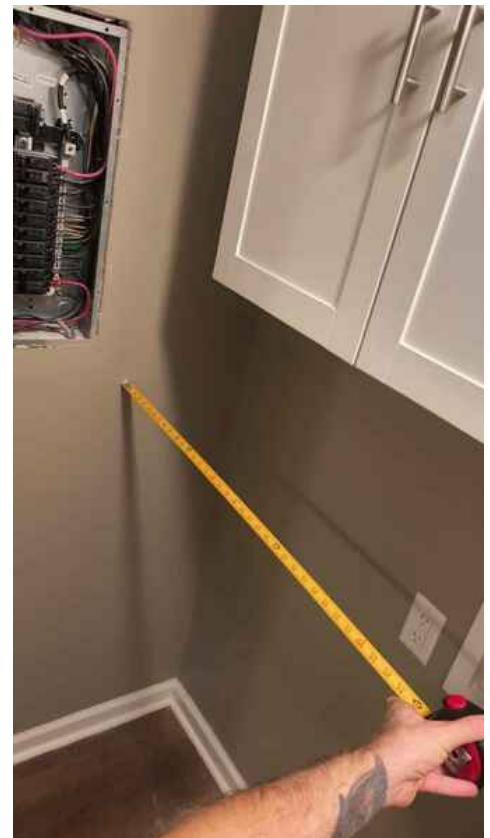
7.2.3 Main & Subpanels, Service & Grounding,
Main Overcurrent Device

7.2.3 Electrical - Main & Subpanels, Service & Grounding, Main Overcurrent Device: Inadequate Clearance Around Electrical Panel

Contact a qualified cabinet contractor.

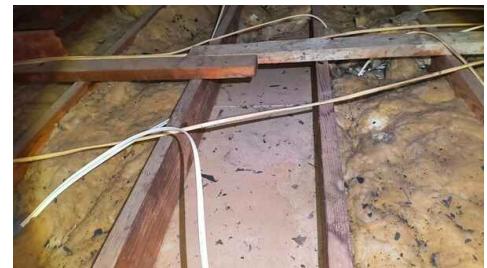
8.1.2 Attic Insulation

INSUFFICIENT INSULATION

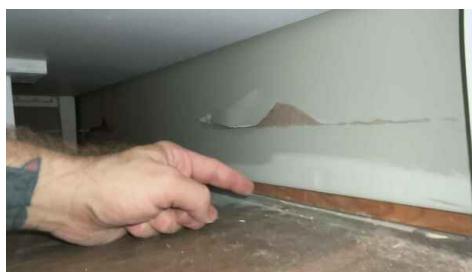
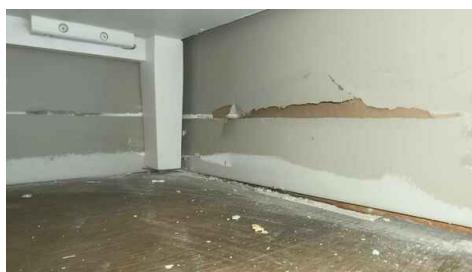
9.3.1 Floors

LIVING ROOM FLOOR AND HALLWAY SHOW SIGNS OF BOWING FLOOR

Contact a qualified professional.

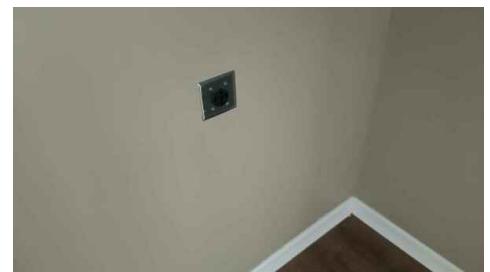
Upon examining the washer and dryer connections, no dryer vent connection was found. The area designated for the dryer vent was inspected, but it appears to be obstructed by drywall, preventing access to any existing connections. This absence of a proper dryer vent connection raises concerns regarding the safe and efficient operation of the dryer, as improper venting can lead to potential hazards such as moisture buildup and lint accumulation.

It is recommended that a qualified professional assess the area to properly install a dryer vent and remove the obstructing drywall to ensure compliance with safety standards and effective dryer performance.
