Executive Summary

Engineer's Foundation Evaluation

123 Main St, Your City, TN, 12345

0.0 - Background and Purpose

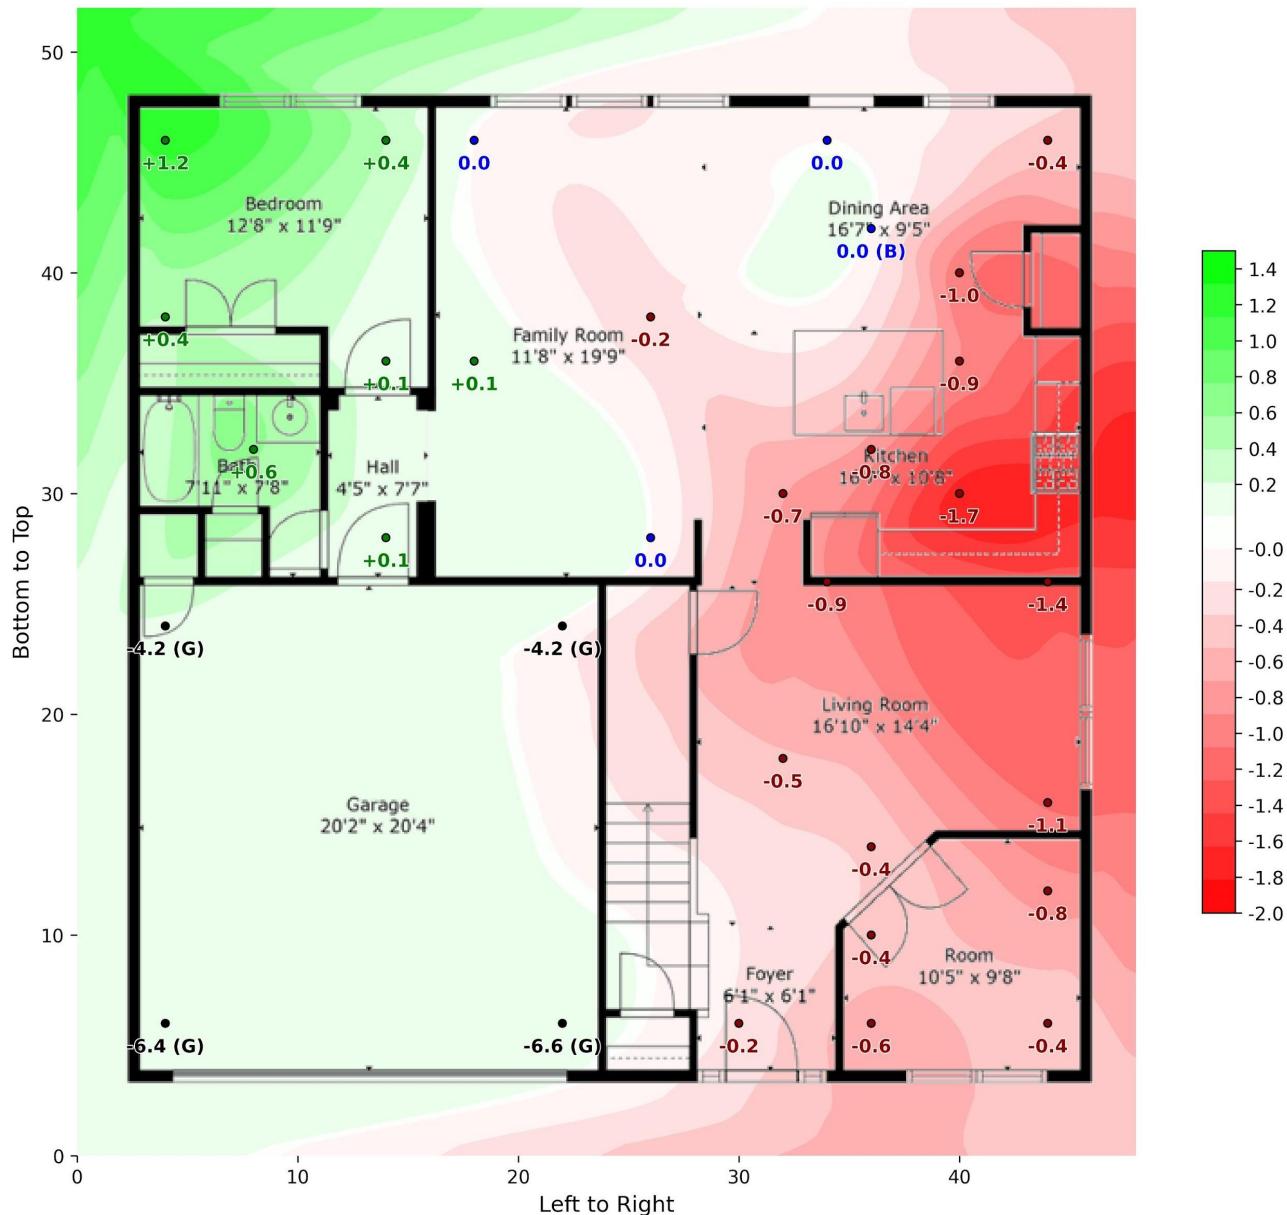
Elevation Plot Graphic (Figure A)

The elevation plot resulted in the graphic as depicted above in Figure A. The red-points and areas are elevation measurements that were lower than the base station elevation (0.0). The green-points and areas are elevation measurements that were higher than the base station elevation (0.0). The blue-points (and white areas) are equal to the base station elevation (0.0). The base station is depicted with a (B) symbol. The elevation plot takes into account differences in flooring thicknesses. The maximum elevation point was determined to be 1.2 inches and the minimum was -1.7 inches, resulting in an elevation difference of 2.9 inches of difference across the structure.

The elevation plot graphic above will show points labeled with a (G) symbol representing Garage. These elevation points were measured and plotted so they can be compared year-to-year, however, they are excluded from the foundation analysis. This is because garages can be non-monolithic and/or they are poured to purposefully slope toward the exterior garage door making any conclusions derived difficult to interpret.

Elevation differences across the structure are the first indicator that a foundation problem may or may-not exist. As documented above, the maximum elevation point of this structure was determined to be 1.2 inches and the minimum was -1.7 inches, resulting in an elevation difference of 2.9 inches of difference across the structure. The elevation plot takes into account differences in flooring thicknesses. The elevation deflection across an entire structure should, best-case-scenario, remain within 0.5 to 1-inch depending on the age of the structure. Measured differences approaching 2-inches are an initial sign of possible foundation fatigue. The maximum allowable elevation difference is subjective, depending on other factors such as the visual condition, size, and age of the structure (36 year(s) old) along with how the foundation performs when calculating deflection and tilt.

Based on observed elevations of the foundation from the elevation plot, the elevation differences do not fall within industry standards and tolerable limits. These findings indicate that the foundation does not have consistent and uniform elevation measurements. Note: elevation measurements alone is not the only indicator of foundation problems; see the deflection and tilt calculations (and the report's overall conclusion) for a complete understanding of foundation stabilization. If elevations fall outside of industry standard/tolerable limits, it is a first indicator that the foundation will fail in deflection and/or tilt.

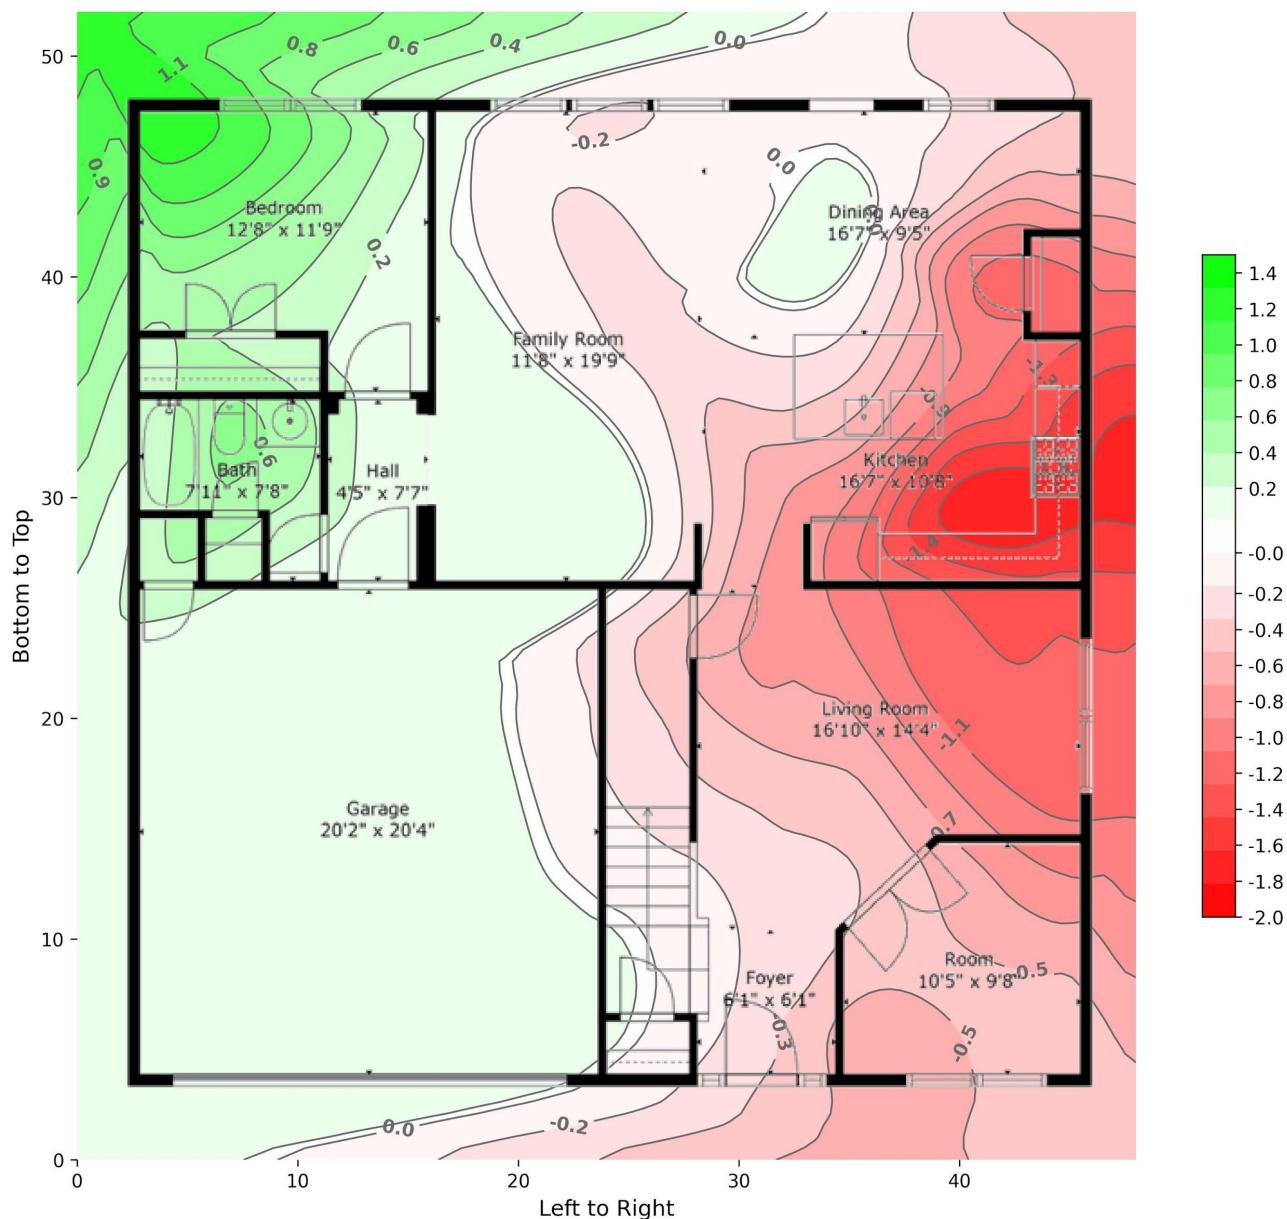
Mesh Contour Graphic (Figure B)

The mesh contours graphic depicted above in Figure B is similar to the elevation plot. The red, green, and white areas depict areas that are lower, higher, and equal to the base station elevation (0.0). The lines or contours (similar to map topography) are labeled at specific intervals.

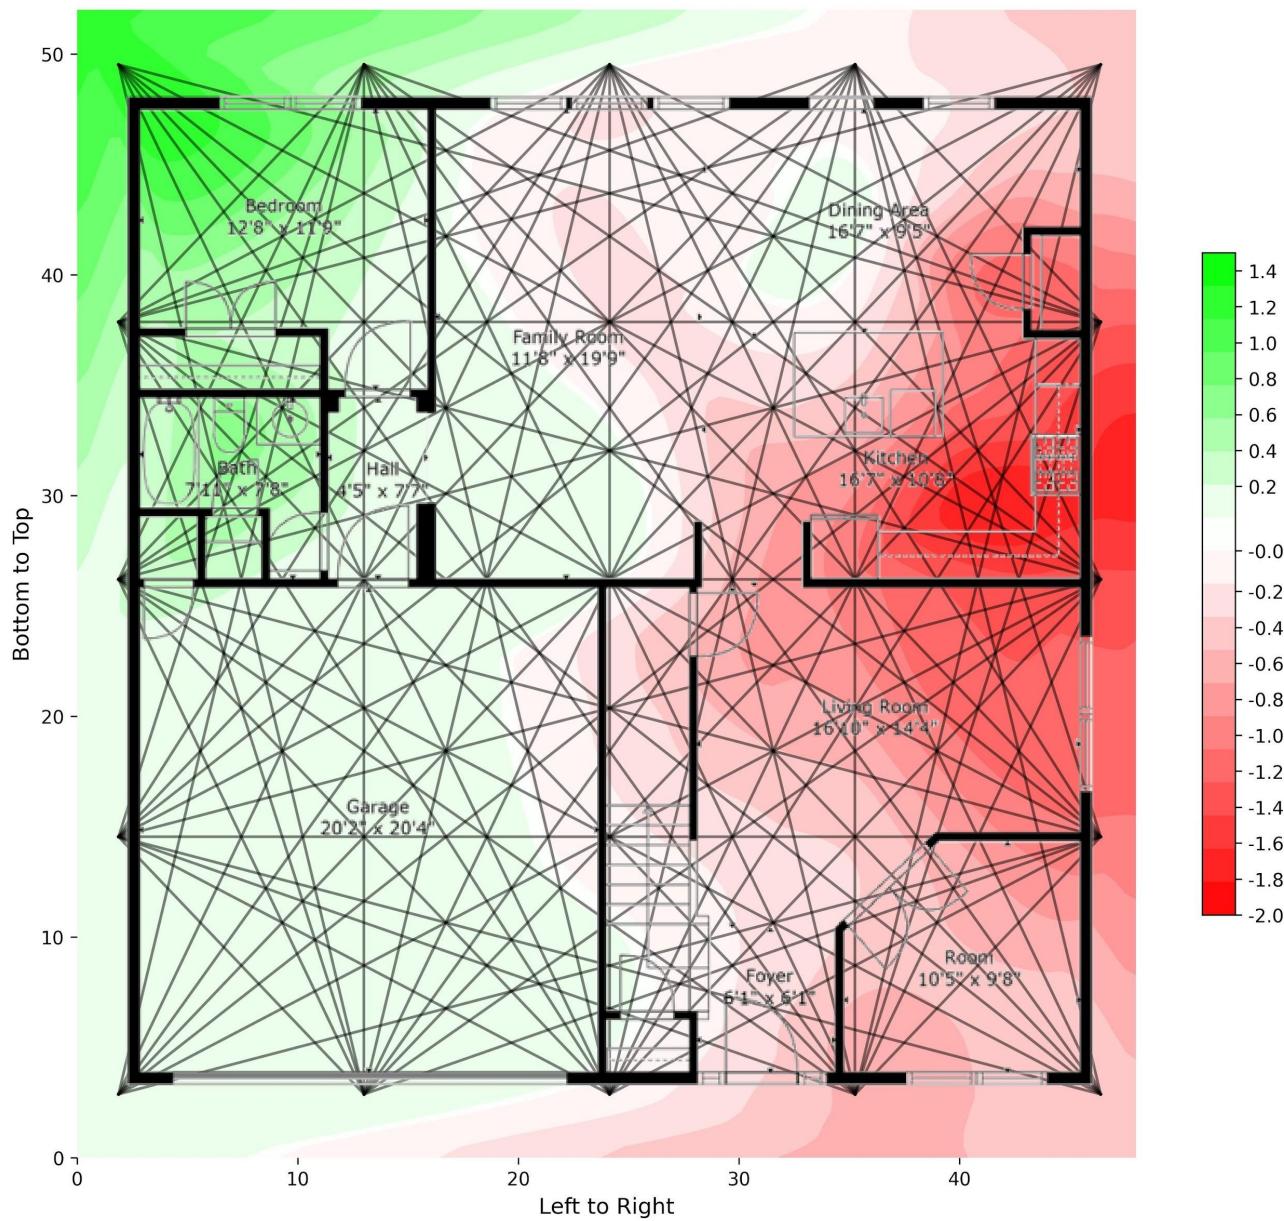
All Profiles Graphic (Figure C)

Below is a graphic that shows the locations of deflection and tilt profiles that were calculated. The total profiles calculated was 79 with a total usable profiles (above the effective length threshold) of 75.

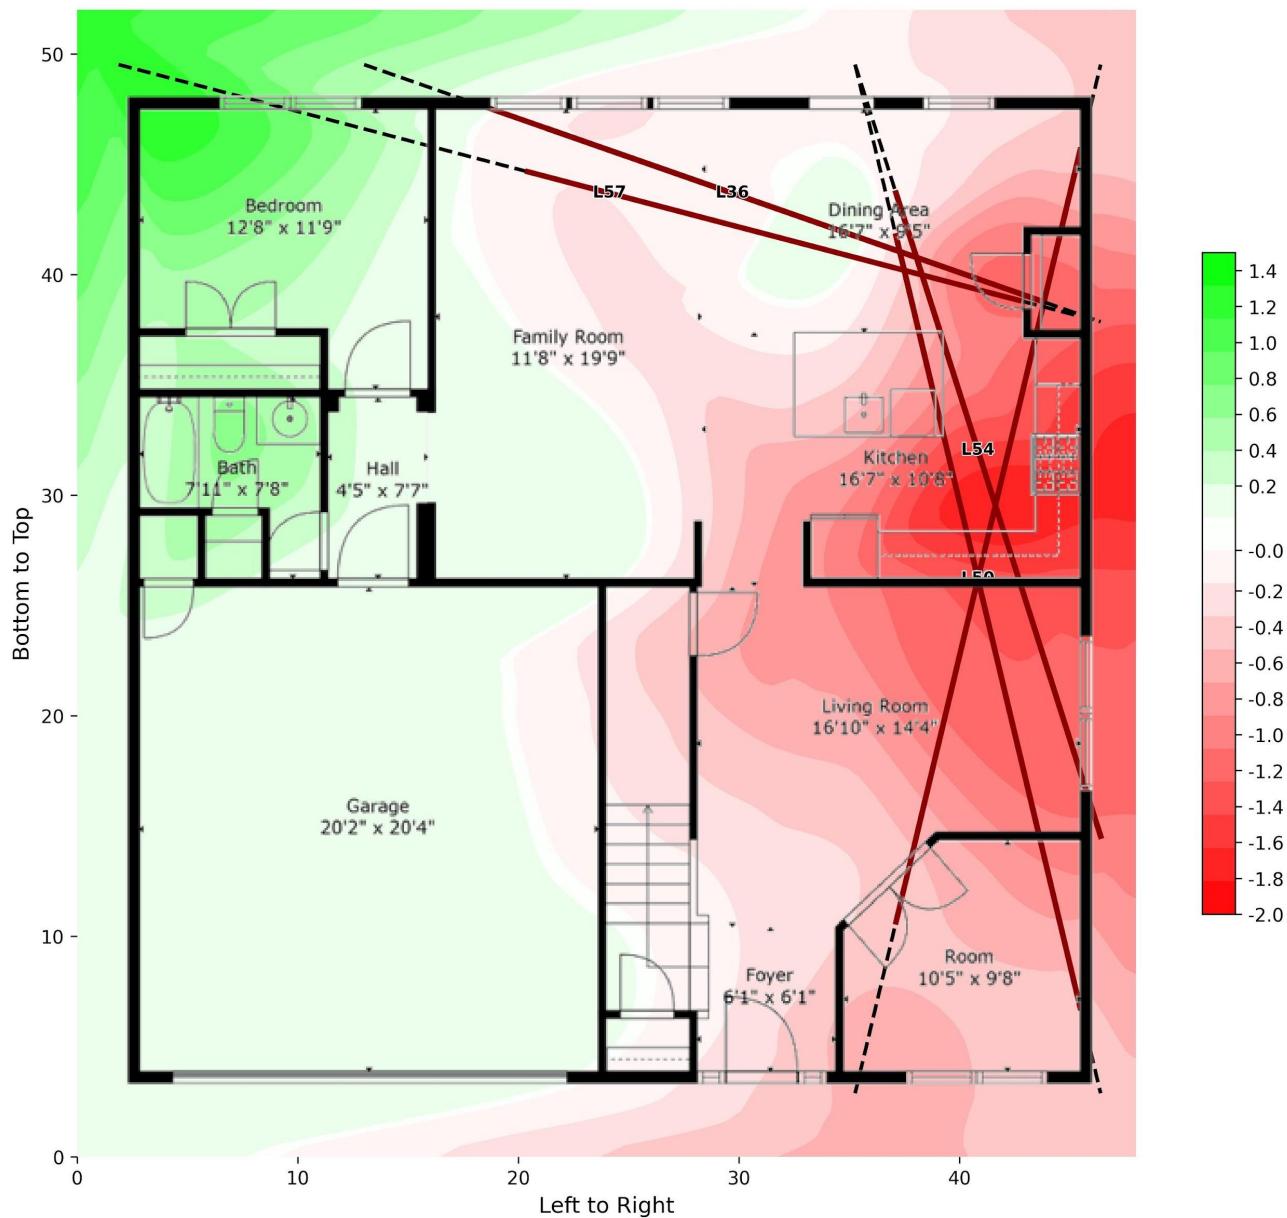
Deflection Failures Graphic (Figure D)

The above Figure D shows deflection failures along the foundation. Deflection failures can be considered localized failures in (sometimes) isolated portions of the foundation. The profile lines that were calculated are represented by a dashed black line and the areas that the deflection failures occur are represented by a dark red line segment. Of the 75 deflection profiles calculated, 5 profile failures were identified.

Deflection failures can be considered localized failures of the foundation in (sometimes) isolated portions of the foundation. Of the 75 deflection profiles calculated, 5 failures were identified.

Deflection failures are above standard acceptable limits; they exceed industry-standard thresholds and the structure should be considered actively moving/settling in areas where deflection failures are occurring. See the report's overall conclusion for a complete understanding of the overall foundation stabilization issue.

To stabilize and lift the foundation, install and/or adjust perimeter and interior piles/piers as shown in the attached Exhibit A - Proposed Repair Plan. The underpinning may be concrete cylinders, steel pipe, helical screws, or drilled concrete piers – refer to Exhibits D, E, F, and G. Underpinning will not improve the performance of the foundation in non-underpinned areas. Note, any foundation movement, even corrective, can cause additional cosmetic distress. The contractor shall determine the amount of elevation correction needed based on the reaction of the structure during the adjustment in order to minimize stress and additional cosmetic damages.

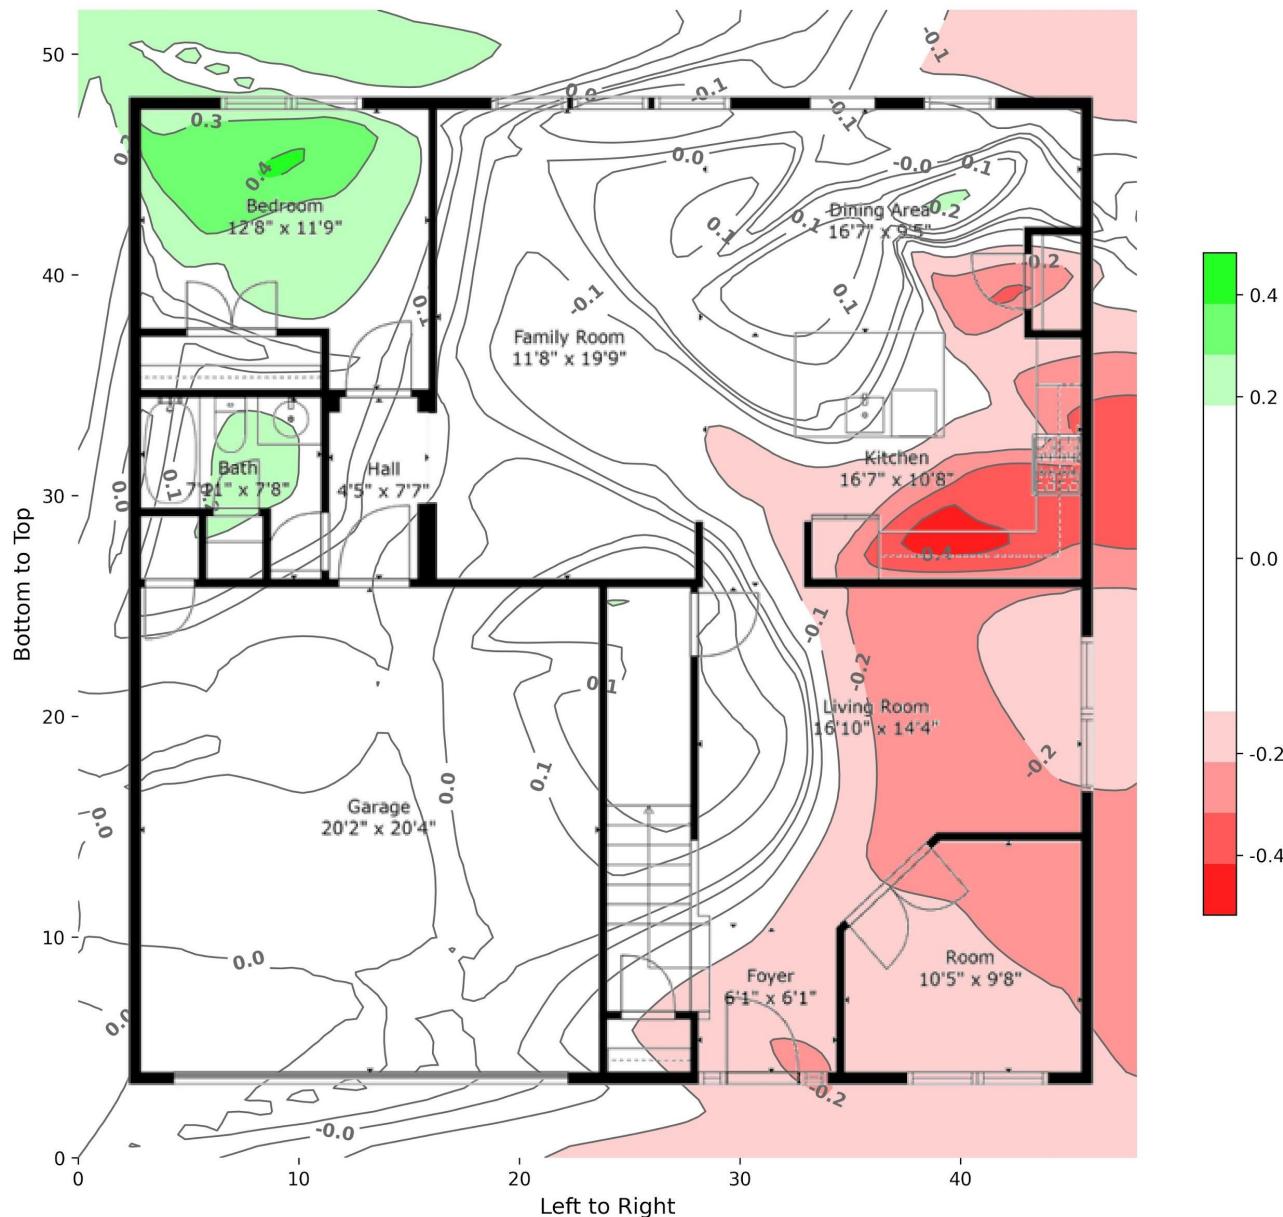
Elevation Plot Difference Graphic (Figure F)

A previous elevation plot completed in 2022 was available to use as a baseline of movement progression. Elevation differences are shown that show us the clear progression of movement from one date to another. As part of this evaluation, a contour mesh showing the elevation differences between the current contour mesh and the baseline was processed and is shown below.

The mesh contour graphic above in Figure F shows areas in red that are lower than the baseline elevation plot and areas of green that are higher than the baseline elevation plot (from the provided drawing completed in 2022). The darker the color (both red and green) the larger/smaller the elevation differences.
