UPCHURCH INSPECTION

RESIDENTIAL REPORT

1234 Main Street
Memphis, TN 38117

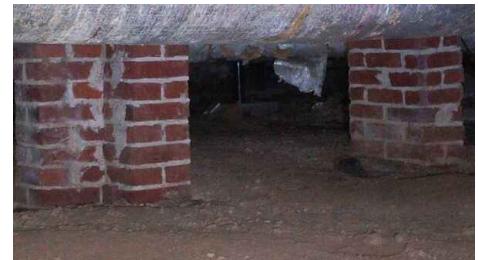
Basement/Crawlspace Floor

Dirt

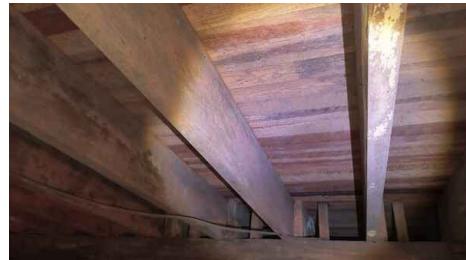
Floor Structure: Sub-floor

Plank

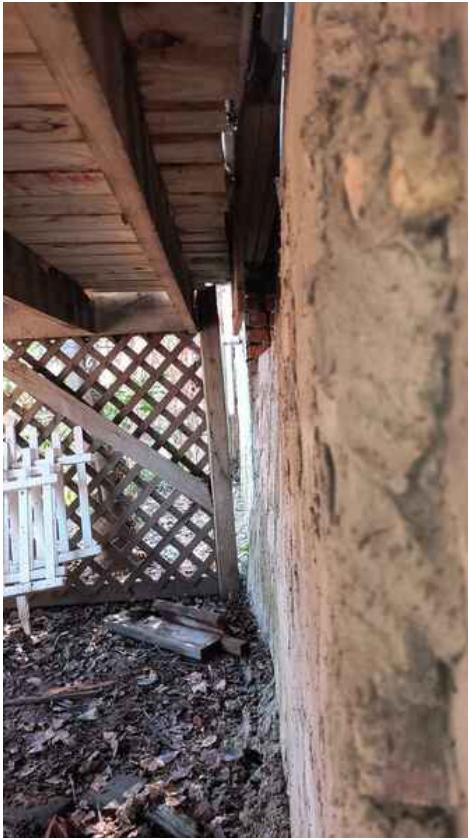
2.1.1 Foundation**WALL(S) BOWING/LEANING**

Foundation wall is bowing and/or leaning. Repair of wall may be required. Consult qualified foundation expert.

Contact a foundation contractor.

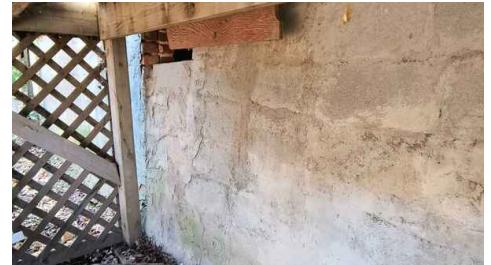
2.1.2 Foundation

NO CRAWLSPACE VENT COVER

There is no vent cover present at the crawlspace vent located under the back porch. This gap may allow for the entry of debris, moisture, or pests into the crawlspace. It is recommended to install a proper vent cover to ensure adequate ventilation and prevent potential issues with moisture or infestation.

Contact a foundation contractor.

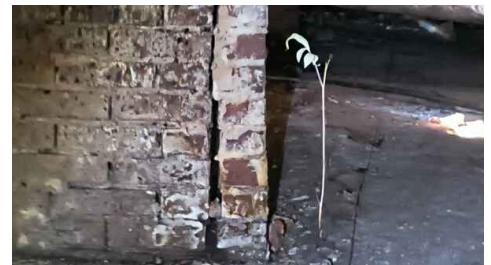
FOUNDATION PROBLEM (GENERAL)

Towards the front right side of the house, to the left of the crawlspace opening, the brick foundation wall is observed to be leaning. Additionally, a noticeable gap exists at the intersection of this wall with the adjacent wall. This may indicate shifting or settling of the foundation. Further evaluation by a qualified foundation specialist is recommended to assess the extent of the issue and determine appropriate corrective actions.

Contact a foundation contractor.

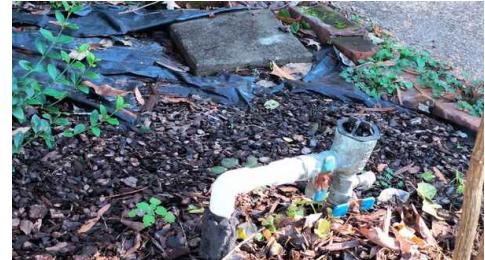
HOUSE HAS OUTDOOR SPRINKLER SYSTEM

The house is equipped with an outdoor sprinkler system. Please note that inspection and evaluation of irrigation systems fall outside the scope of this home inspection. It is recommended to have the system serviced or inspected by a qualified irrigation professional to ensure proper function and efficiency.

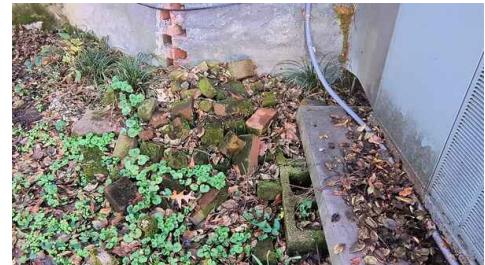
3.1.1 General**PILE OF BRICKS IN YARD**

A pile of bricks from a previous walkway was found in the yard, near the HVAC unit. It is recommended to remove the pile of bricks to avoid potential tripping hazards.

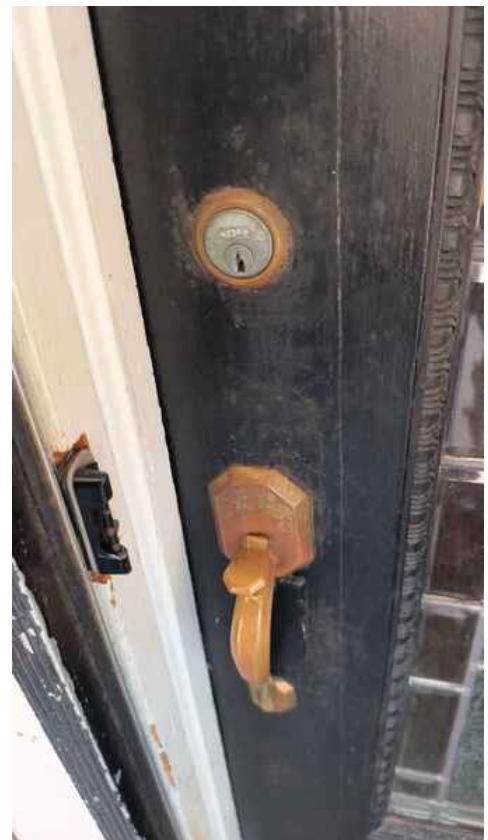
**3.3.1 Exterior Doors****FRONT DOOR DIFFICULT TO USE**

The front door was observed to be difficult to open and close properly. This may be due to misalignment, swelling of the door, or issues with the door hardware or frame. Difficulty in operation could lead to further wear or potential safety concerns. It is recommended that a qualified professional assess the door and make necessary adjustments or repairs to ensure smooth operation and proper sealing.

Contact a qualified professional.

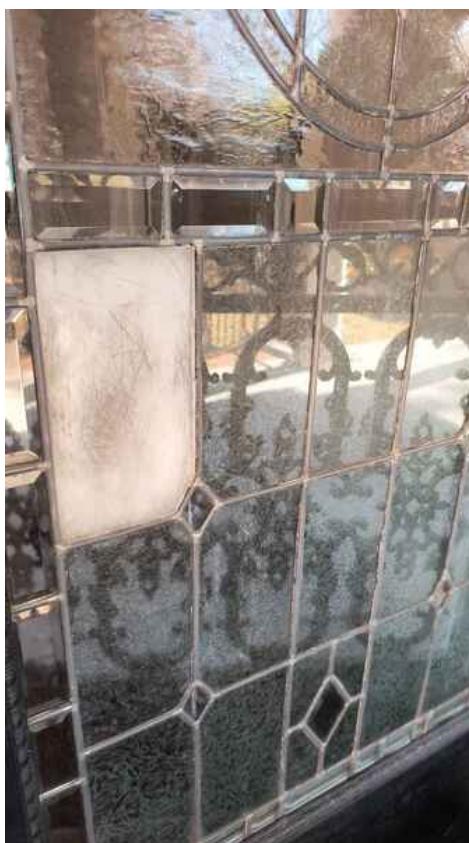
3.3.2 Exterior Doors

EVIDENCE OF REPAIR TO GLASS PANE

Glass pane on front door has been replaced, with glass that doesn't match.

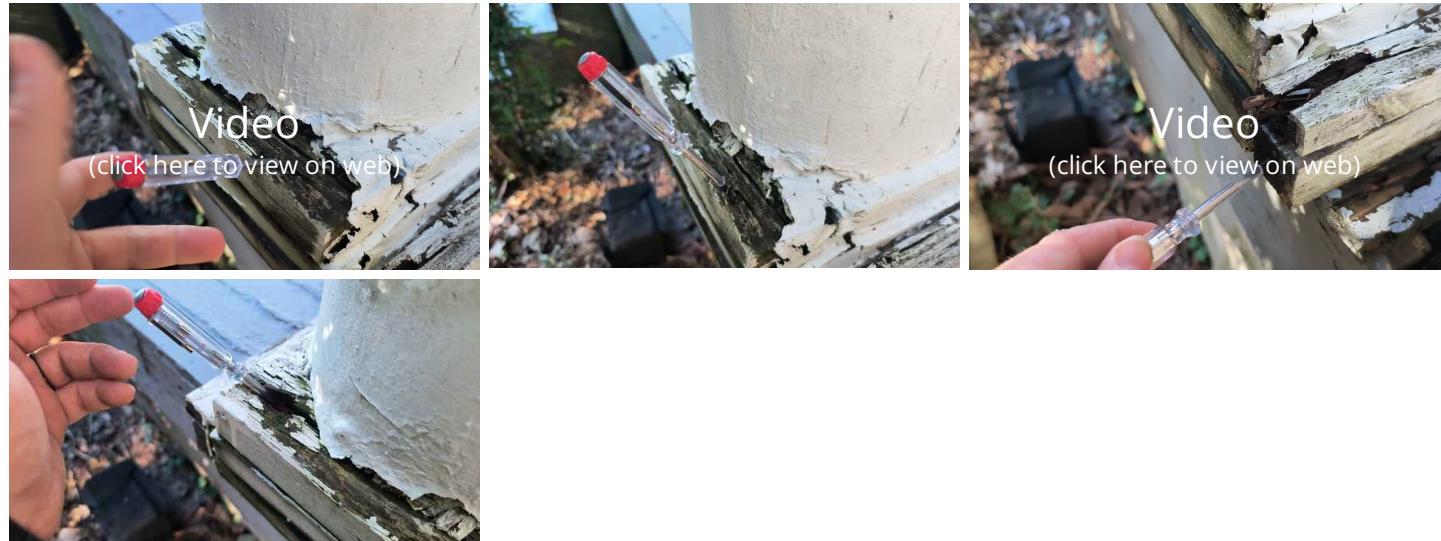
3.4.1 Decks, Balconies, Porches & Steps

WOOD ROT AT PILLAR BASE

The base of the pillar located to the right of the house on the front porch shows signs of deterioration, including evidence of wood rot. This damage is likely the result of water infiltration, possibly caused by a missing or improperly installed downspout above the pillar. It is recommended to address the downspout issue and repair or replace the affected pillar base to prevent further deterioration and potential structural concerns.

Contact a qualified professional.

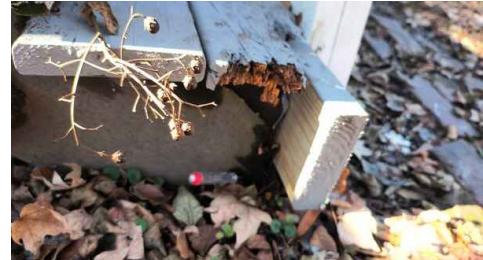
3.4.2 Decks, Balconies, Porches & Steps

WOOD IN DIRECT CONTACT WITH GROUND

The wood steps on the back porch are making direct contact with the ground, which is contributing to deterioration. As a result, the wood is beginning to soften and may be more prone to further damage. It is recommended to elevate the steps to prevent continued moisture exposure and replace any damaged wood to maintain structural integrity.

Contact a qualified deck contractor.

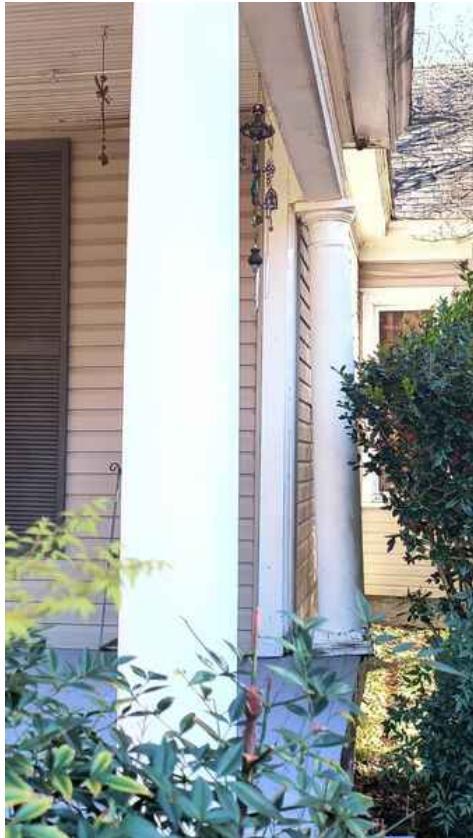
3.4.3 Decks, Balconies, Porches & Steps

PILLAR LEANING

One of the pillars on the porch is leaning, which may indicate a shifting or settling foundation or structural issue. It is recommended to have the pillar evaluated by a qualified contractor to assess the cause of the lean and determine the necessary repairs to ensure stability and safety.

Contact a qualified professional.

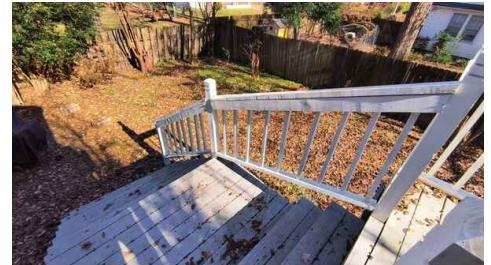
3.4.4 Decks, Balconies, Porches & Steps

MISSING GRASPABLE HANDRAIL

The outdoor steps are lacking a graspable handrail. According to safety standards, staircases with more than four risers should be equipped with a graspable handrail for safety. It is recommended to install a handrail to provide proper support and reduce the risk of accidents.

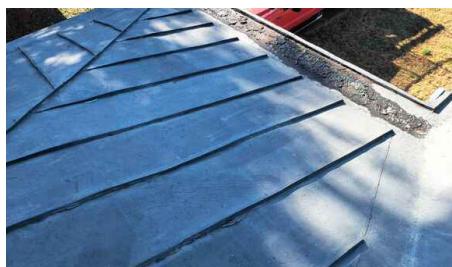
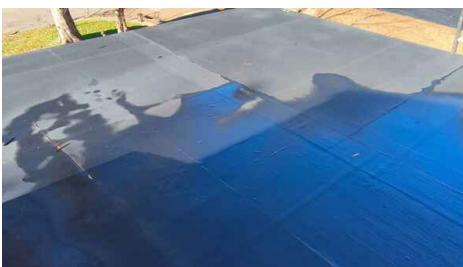
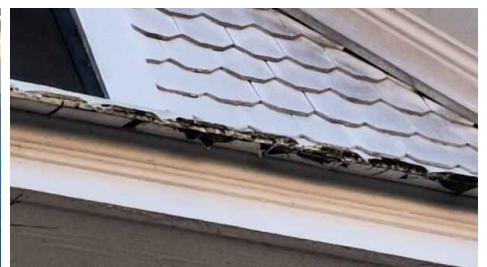
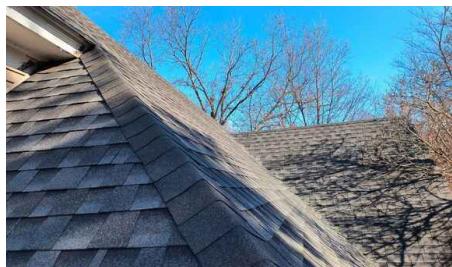
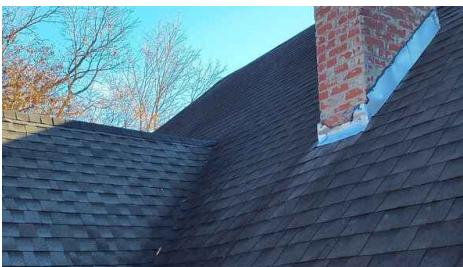
Coverings: Material

Metal, Fish Scale Wood Shingles, Asphalt Architectural Shingles, Rubber

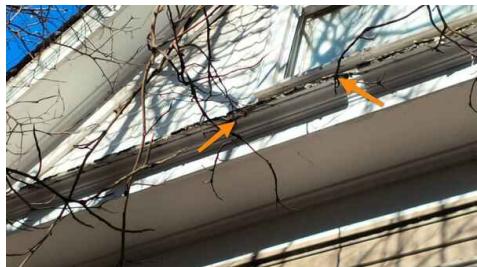
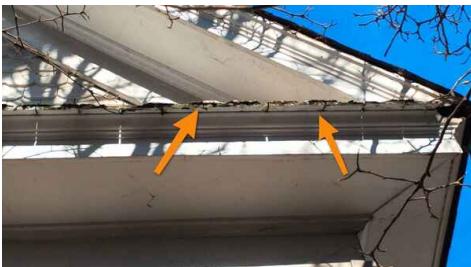
DAMAGED (GENERAL)

Roof coverings showed moderate damage. Recommend a qualified roofing professional evaluate and repair.

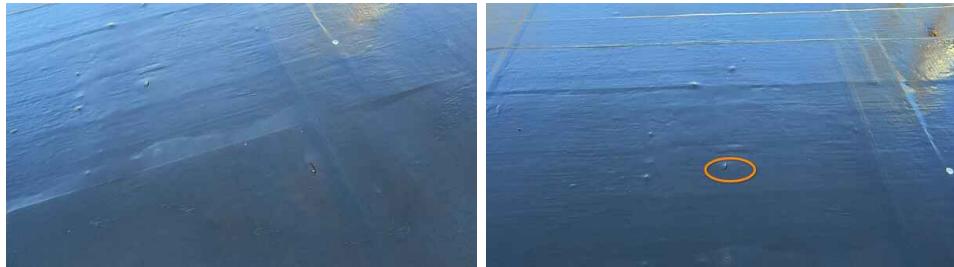
4.1.2 Coverings

HOLES IN RUBBER ROOF OVER SIDE PATIO

Holes were observed in the rubber roofing material over the side patio. These openings could potentially lead to water infiltration, which may cause damage to the underlying structure. It is recommended to have the roofing material repaired or replaced to prevent further damage and to ensure proper waterproofing.

Contact a qualified roofing professional.

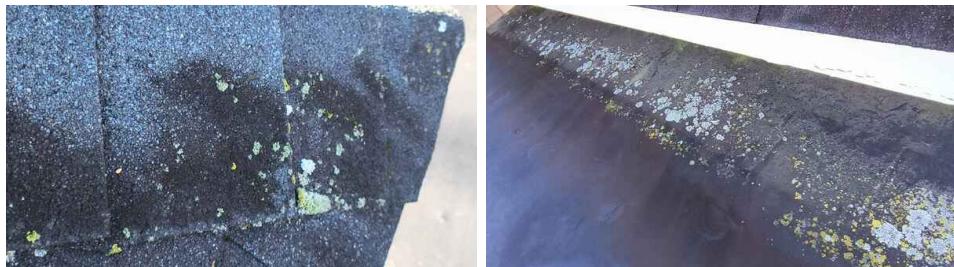
4.1.3 Coverings

MOSS ON SHINGLES & RUBBER ROOF

Moss growth was observed on the shingles and rubber roof. While moss may not cause immediate damage, it can retain moisture, potentially leading to roof deterioration over time. It is recommended to have the moss removed and to inspect the roof for any underlying damage. Regular maintenance, including roof cleaning, may help prevent future growth.

Contact a qualified roofing professional.

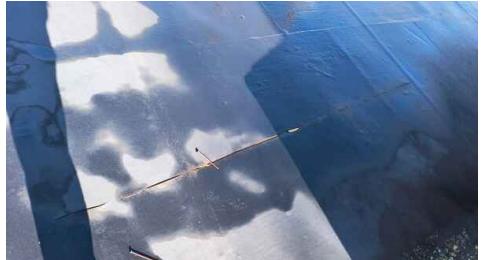
4.1.4 Coverings

TEAR IN RUBBER ROOF

A tear was observed in the rubber roofing material. This damage could potentially lead to water infiltration and further deterioration of the underlying structure. It is recommended to have the tear professionally repaired to prevent water damage and ensure the roof's integrity.

Contact a qualified roofing professional.

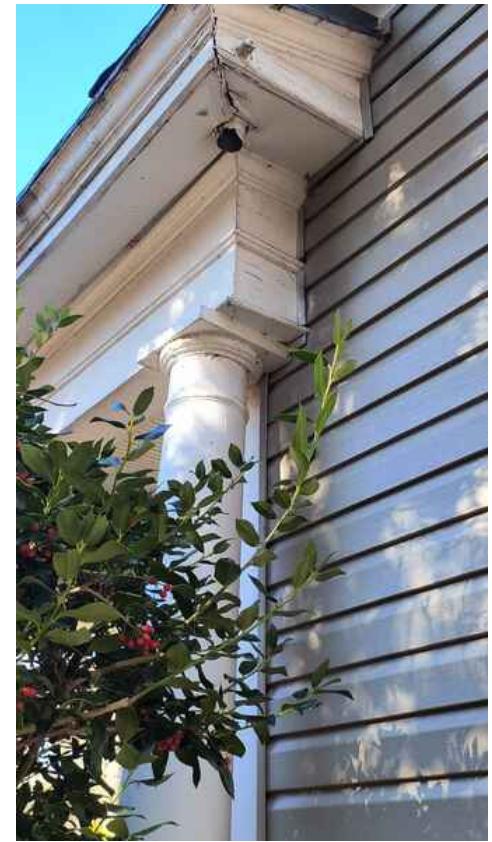
DOWNSPOUTS MISSING

Home was missing downspouts in one or more areas. Although this downspout may not be in use, it does appear to be draining water onto pillar base below. Have a qualified gutter professional evaluate and either repair or seal, based on his/her findings. Lack of downspouts can result in excessive moisture in the soil at the foundation (or in this case the pillar base below) which can lead to deterioration or structural movement. Unsealed openings can be entry points for animals.

Contact a qualified gutter contractor

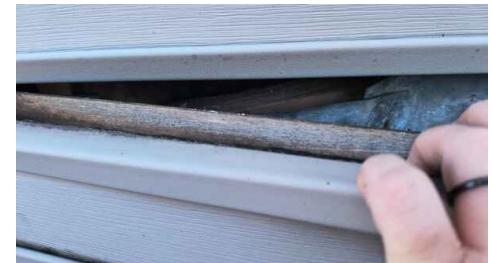
4.3.1 Flashings

SIDING LOOSE

Near the upstairs front bedroom, the siding and flashing on the exterior are separating from the house, creating an exposed gap. This gap presents a potential risk for water intrusion, which could lead to moisture damage and deterioration of the underlying structure. It is recommended to have the siding and flashing properly re-secured and sealed to prevent water penetration and further damage.

Contact a qualified professional.

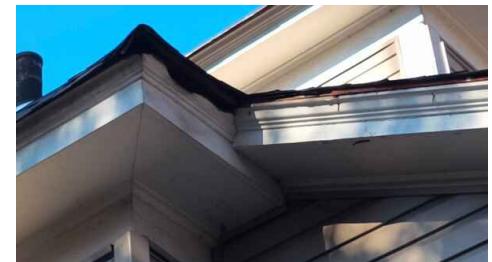
4.3.2 Flashings

DETERIORATION OF WOOD TRIM AT DRIP EDGE.

Deterioration was noted on the wood trim at the drip edge. This may be the result of prolonged exposure to moisture or inadequate drainage. It is recommended to have the trim inspected and repaired or replaced as needed to prevent further damage and ensure proper water management.

Contact a qualified carpenter.

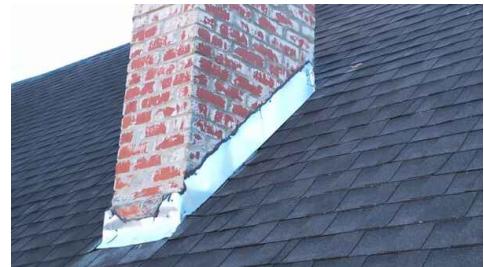
4.4.1 Skylights, Chimneys & Other Roof Penetrations

REPAIRS AT CHIMNEY FLASHING

Yes, the presence of roof cement (or sealant) around chimney flashing usually indicates an attempt to seal or repair the flashing and prevent water leaks. It's a common practice to use roofing cement to fill gaps or cracks in the flashing, creating a watertight seal between the chimney and the roof.

Contact a qualified roofing professional.

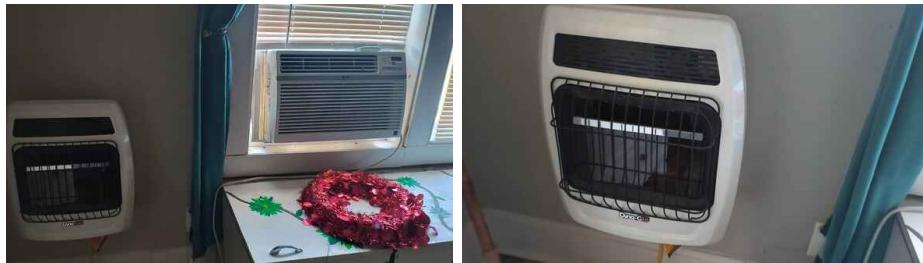
Equipment: Overview

The house is equipped with a Rheem RRNL-B048JK10E multiposition furnace/air conditioner packaged unit. This system combines both heating and cooling functions in one unit, designed for efficient climate control. It is recommended to have the system regularly serviced by a licensed HVAC technician to ensure proper operation and longevity. The house also has a Dynaglo vent free wall heater (upstairs).

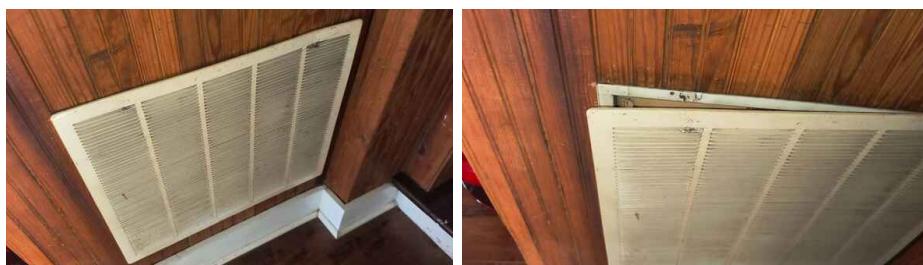
Equipment: Filter

The system has a return downstairs, with a filter. Filters should be changed monthly.

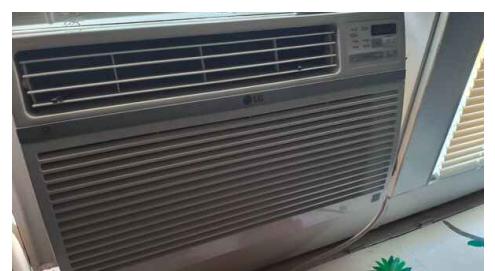
LOW TEMPERATURE

The A/C unit was not tested due to low outdoor temperature. This may cause damage the unit. (The same is true for the window unit.)

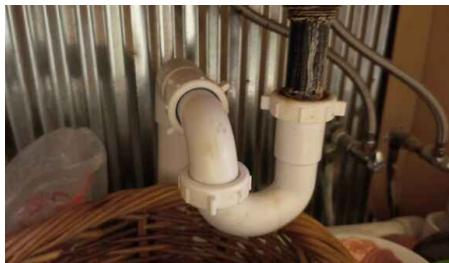
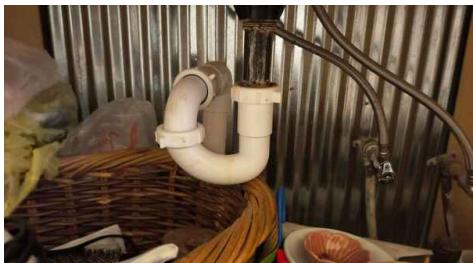
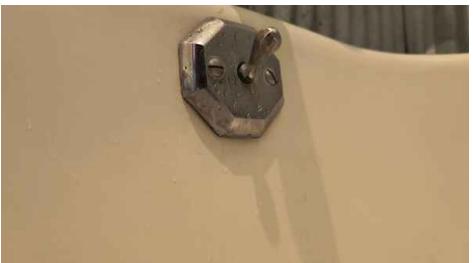
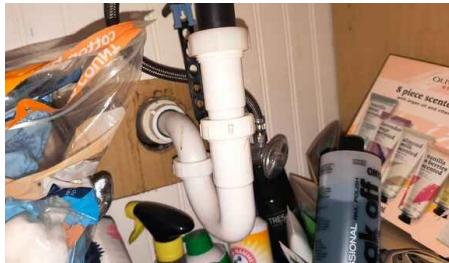
Drain, Waste, & Vent Systems: Overview

All fixtures were checked to ensure they drain properly and have appropriate traps installed.

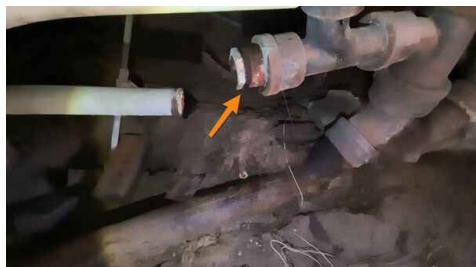
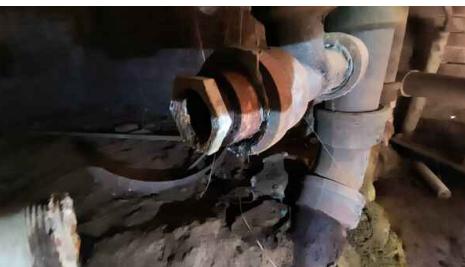
LEAKING PIPE

A drain, waste and/or vent pipe showed signs of a leak. Specifically, a drain pipe is leaking at the cleanout to the right of the crawlspace opening. Recommend a qualified plumber evaluate and repair.

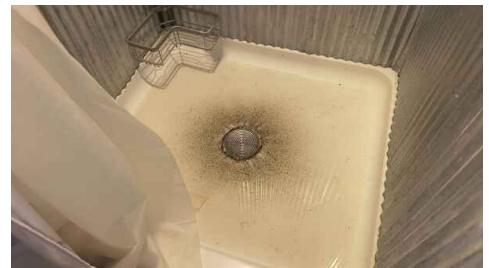
7.2.2 Drain, Waste, & Vent Systems

PLUMBING PROBLEM (GENERAL)

Flushing the upstairs toilet caused bubbling and backup of sewage in the shower. This may indicate a blockage or an issue with the plumbing or drainage system, such as a clog in the drain line or venting problems. It is recommended to have the plumbing system inspected by a licensed plumber to identify the cause of the backup and perform necessary repairs to prevent further issues.

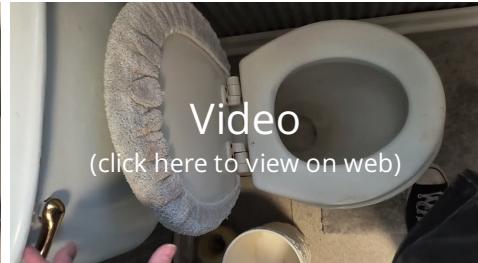
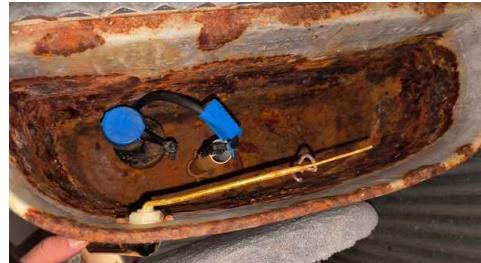
7.3.1 Water Supply, Distribution Systems & Fixtures

TOILET DIDN'T FLUSH

During the inspection, it was noted that the toilet in the rear downstairs bathroom did not flush properly. Upon testing, the toilet failed to fully evacuate waste and water, indicating a potential issue with the flushing mechanism, such as a malfunctioning flush valve, low water pressure, or a clogged drain line. Further evaluation and possible repairs are recommended to ensure the toilet is functioning properly.

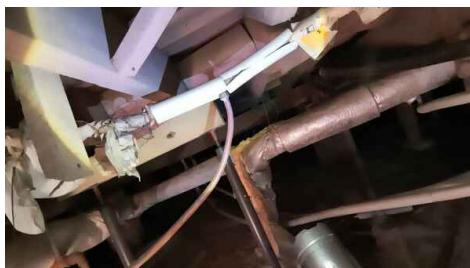
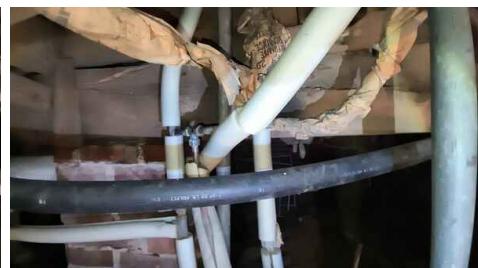
While newspaper can offer some insulation, it's not the ideal or recommended material for insulating pipes in a crawl space. Recommend installing proper insulation.

Contact a qualified plumbing contractor.

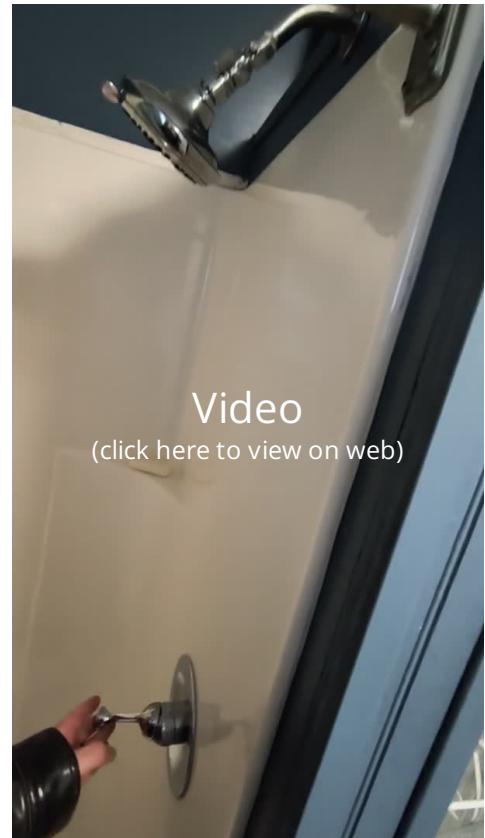
7.3.3 Water Supply, Distribution Systems & Fixtures

SHOWER INOPERABLE

The shower in downstairs rear bathroom is inoperable. It was not functioning properly at the time of inspection, and the cause may be related to issues with the plumbing, water supply, or fixtures. It is recommended to have the shower evaluated and repaired by a licensed plumber to restore proper function.

Contact a qualified plumbing contractor.

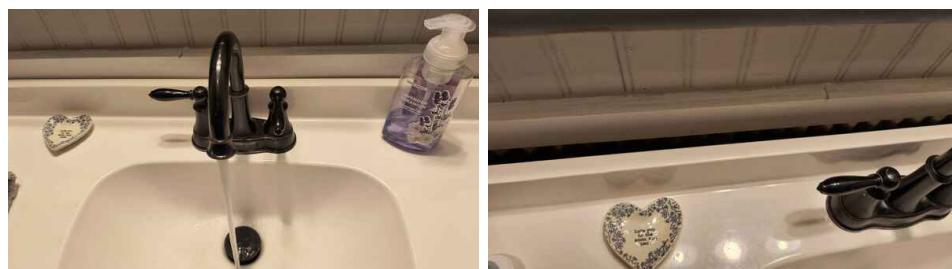
The vanity in the master bathroom is poorly attached to the wall, which may cause instability or risk of damage over time. It is recommended to have the vanity securely re-attached to ensure proper support and prevent further issues.

Contact a qualified professional.

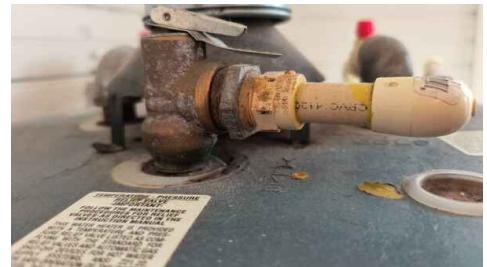
7.4.2 Hot Water Systems, Controls, Flues & Vents

The temperature and pressure relief (TPR) drain pipe is smaller than the size of the TPR valve, which is a defect. According to plumbing standards, the drain pipe should be the same size as the valve to ensure proper discharge of excess pressure or temperature. It is recommended to have the drain pipe replaced with the correct size to ensure safety and compliance with plumbing codes.

Contact a qualified professional.

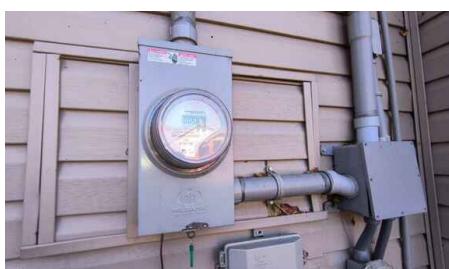
Service Entrance Conductors: Electrical Meter

Overall, the electric meter is in satisfactory condition, functioning properly, and compliant with local regulations. Regular monitoring of the meter readings is recommended to ensure efficient energy use and identify any potential issues with electrical consumption.

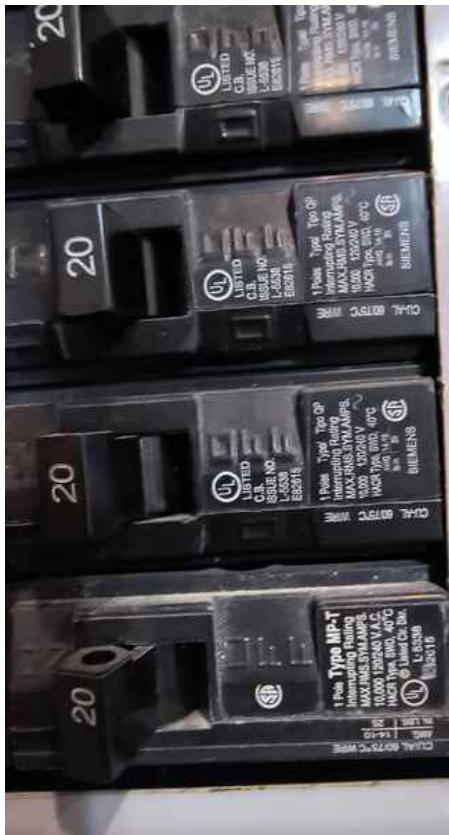
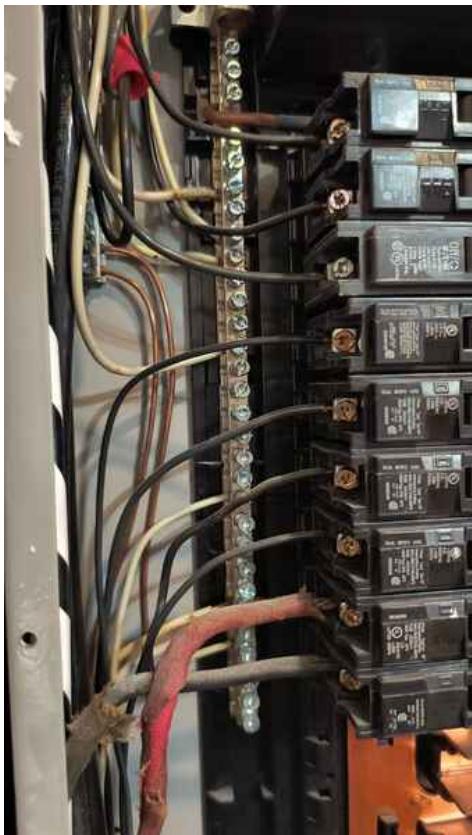
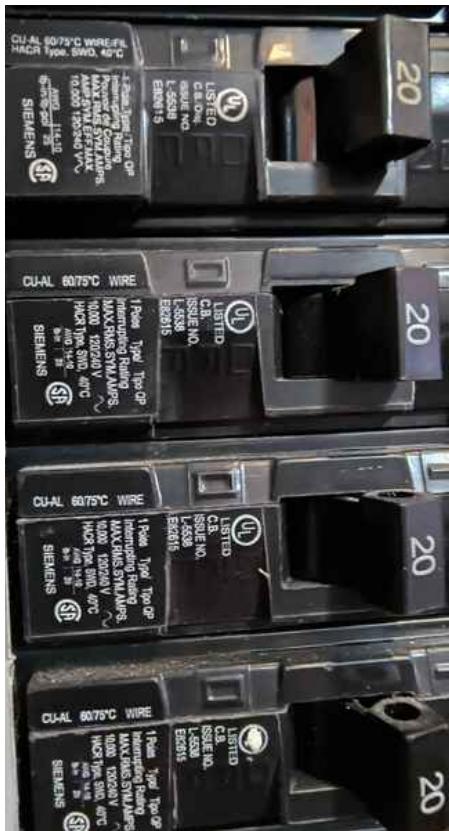
Main & Subpanels, Service & Grounding, Main Overcurrent Device: Panel Type

Circuit Breaker

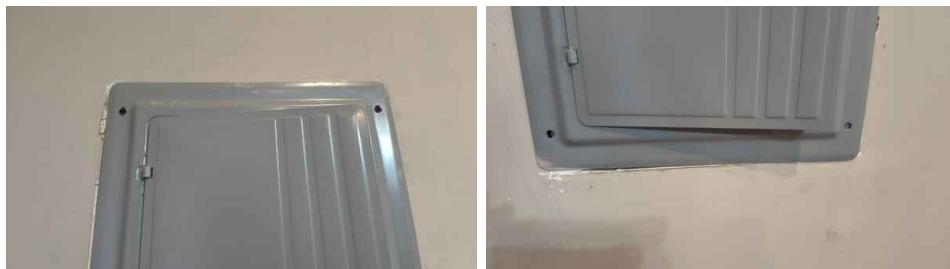
MISSING SCREWS (DEAD FRONT COVER)

The dead front cover is missing screws, which could result in the cover not being securely fastened. This may pose a safety hazard by potentially exposing electrical components. It is recommended to have the cover properly secured with the appropriate screws to ensure safety and compliance with electrical codes.

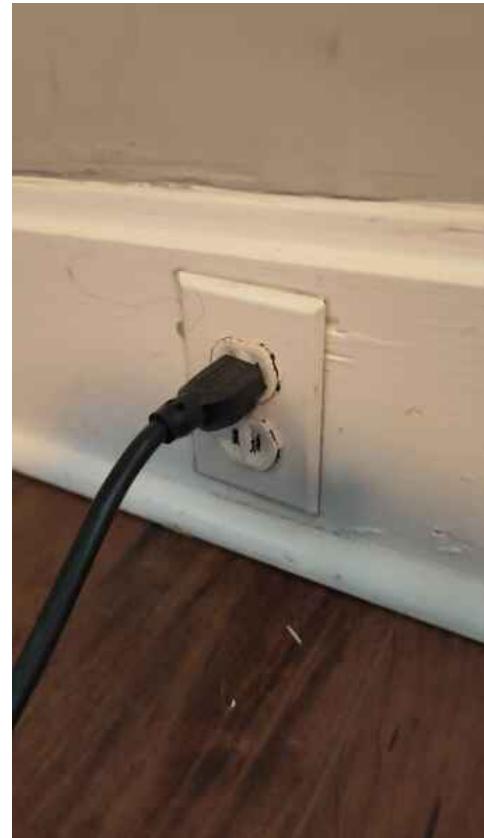
8.4.1 Lighting Fixtures, Switches & Receptacles

TWO PRONG OUTLETS

The house primarily has two-prong outlets, which do not provide the same level of grounding as modern three-prong outlets. While two-prong outlets may still be functional for certain appliances, it is recommended to have a licensed electrician evaluate the system for safety and consider upgrading the outlets to three-prong grounded outlets where necessary to meet current electrical standards.

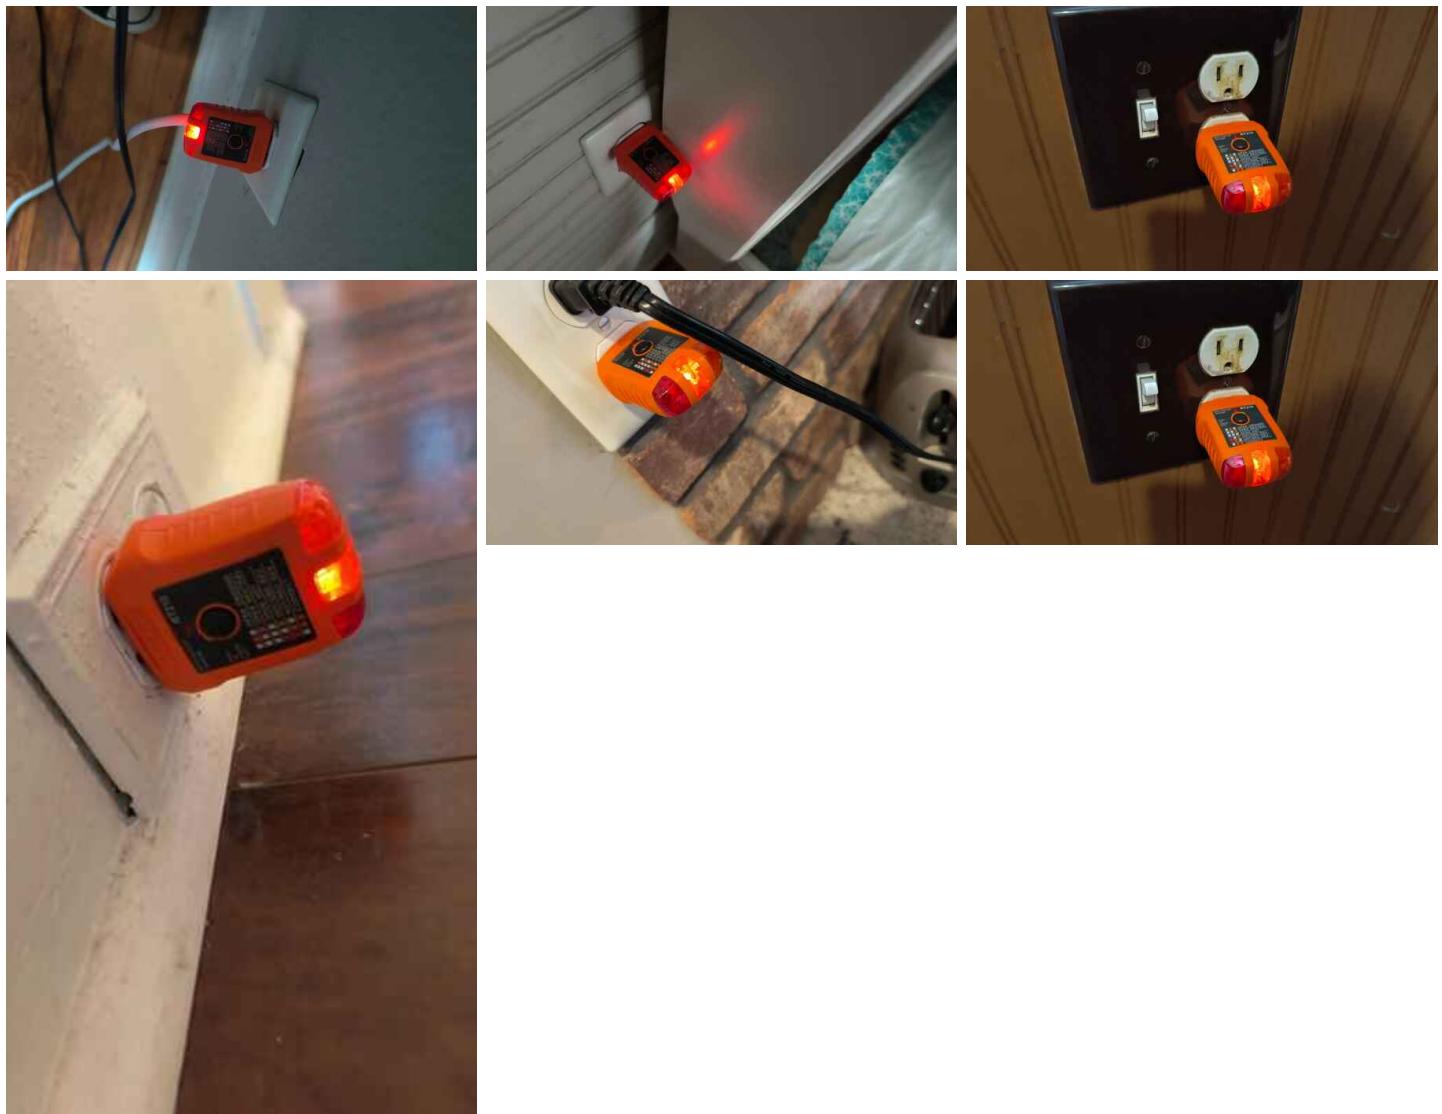
8.4.2 Lighting Fixtures, Switches & Receptacles

OPEN GROUNDS

Although there are three-prong outlets throughout the house, many of these outlets are not properly grounded. (The only exception is the upstairs bathroom.) This can pose a safety risk, as ungrounded outlets may not protect against electrical faults. It is recommended to have a licensed electrician inspect and address the grounding of these outlets to ensure they meet safety standards.

Contact a qualified professional.

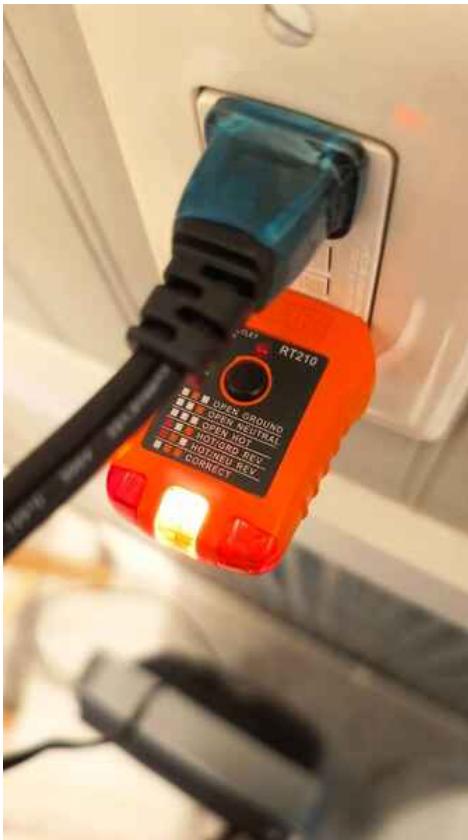
8.5.1 GFCI & AFCI

IMPROPER INSTALLATION

GFCI outlets installed in kitchen, however they are not grounded and failed to trip when testing. Recommend repair by electrician.

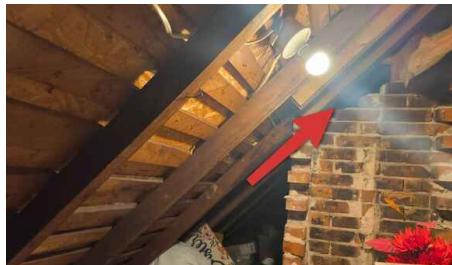
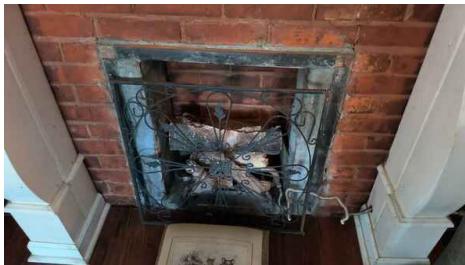
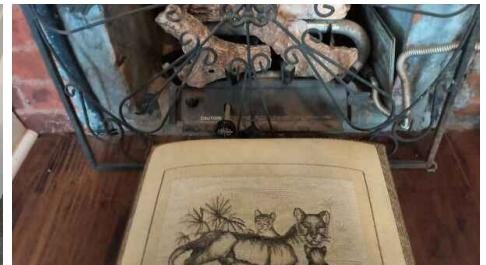
This house has dual chimneys, accessible from more than one side of a divided wall. The chimney on the right (when entering the house) has collapsed and is inoperable. It is recommended to have the chimney professionally inspected and repaired or decommissioned to prevent potential hazards and ensure the safety of the home.

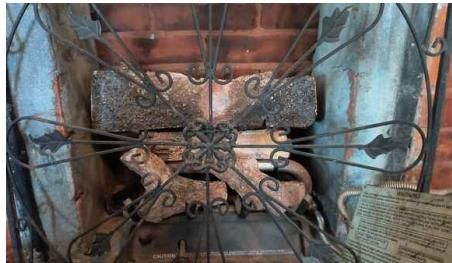
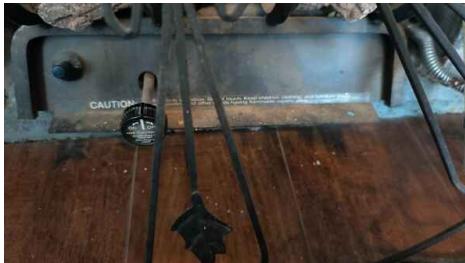
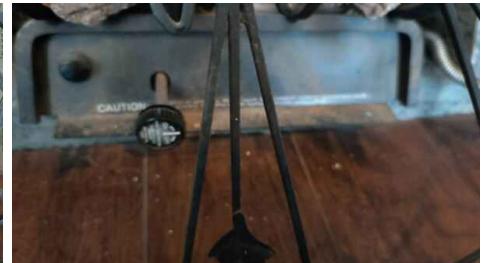
9.1.1 Vents, Flues & Chimneys

Chimney appears to have suffered structural damage. Recommend a structural engineer evaluate & repair.

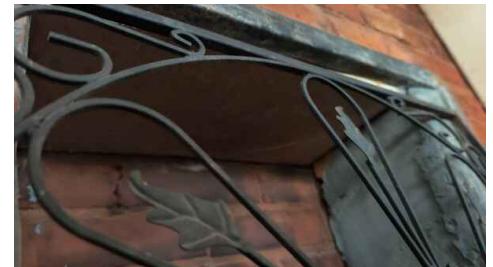
9.4.1 Cleanout Doors & Frames

NO FIREPLACE SCREEN

Fireplace screen was missing in front of fireplace. Fire logs can split, so this is recommended as a safety precaution.

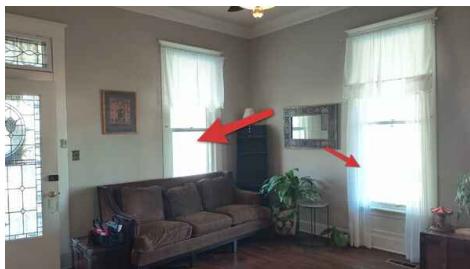
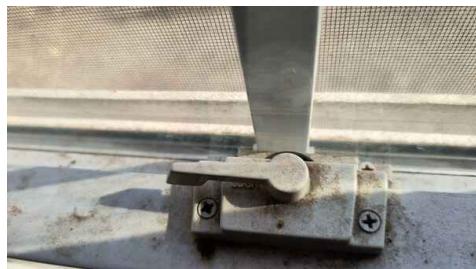
Most of the downstairs windows do not open, and the rear upstairs bedroom window doesn't open. Many of the downstairs windows have two sets of windows set in each pane. This may be due to a mechanical issue, paint or debris obstructing the tracks, a problem with the window frame or it could indicate settling with age. It is recommended that the window be assessed and repaired by a qualified professional to restore its functionality.

Contact a qualified window repair/installation contractor.

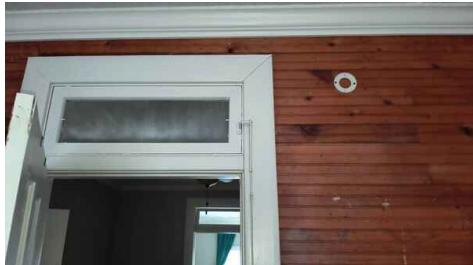
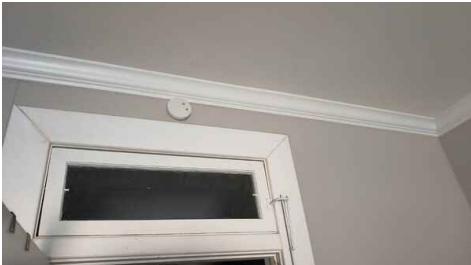
11.2.2 Windows

TRANSOM WINDOW TO REAR UPSTAIRS BEDROOM DOESN'T OPEN.

Transom window to rear upstairs bedroom doesn't open. May repair if desired.

Contact a qualified professional.

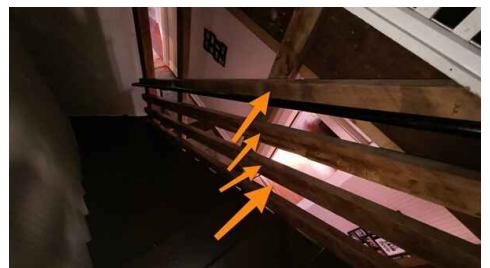
STAIR HAZARDS (GENERAL)

Contact a qualified professional.
