UPCHURCH INSPECTION

RESIDENTIAL REPORT

1234 Main Street
Memphis, TN 38117

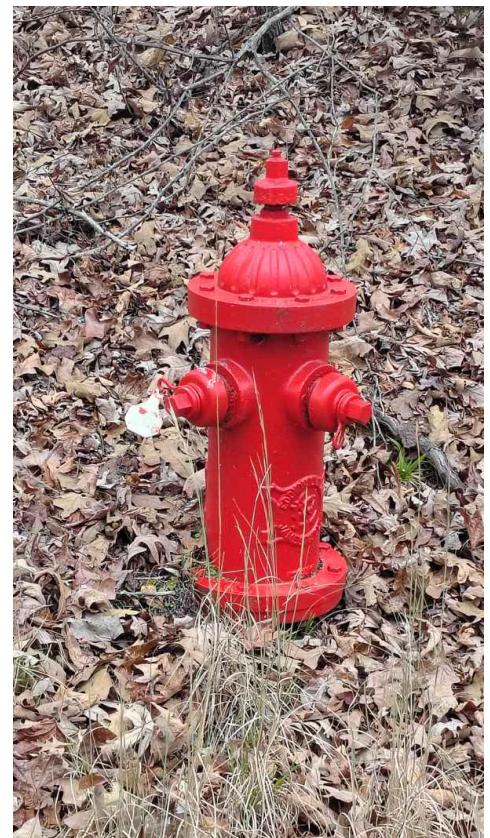
FIRE HYDRANTS

Fire hydrant present on site, but not inspected. Inspection of Fire Hydrants falls outside scope of standard home inspection.

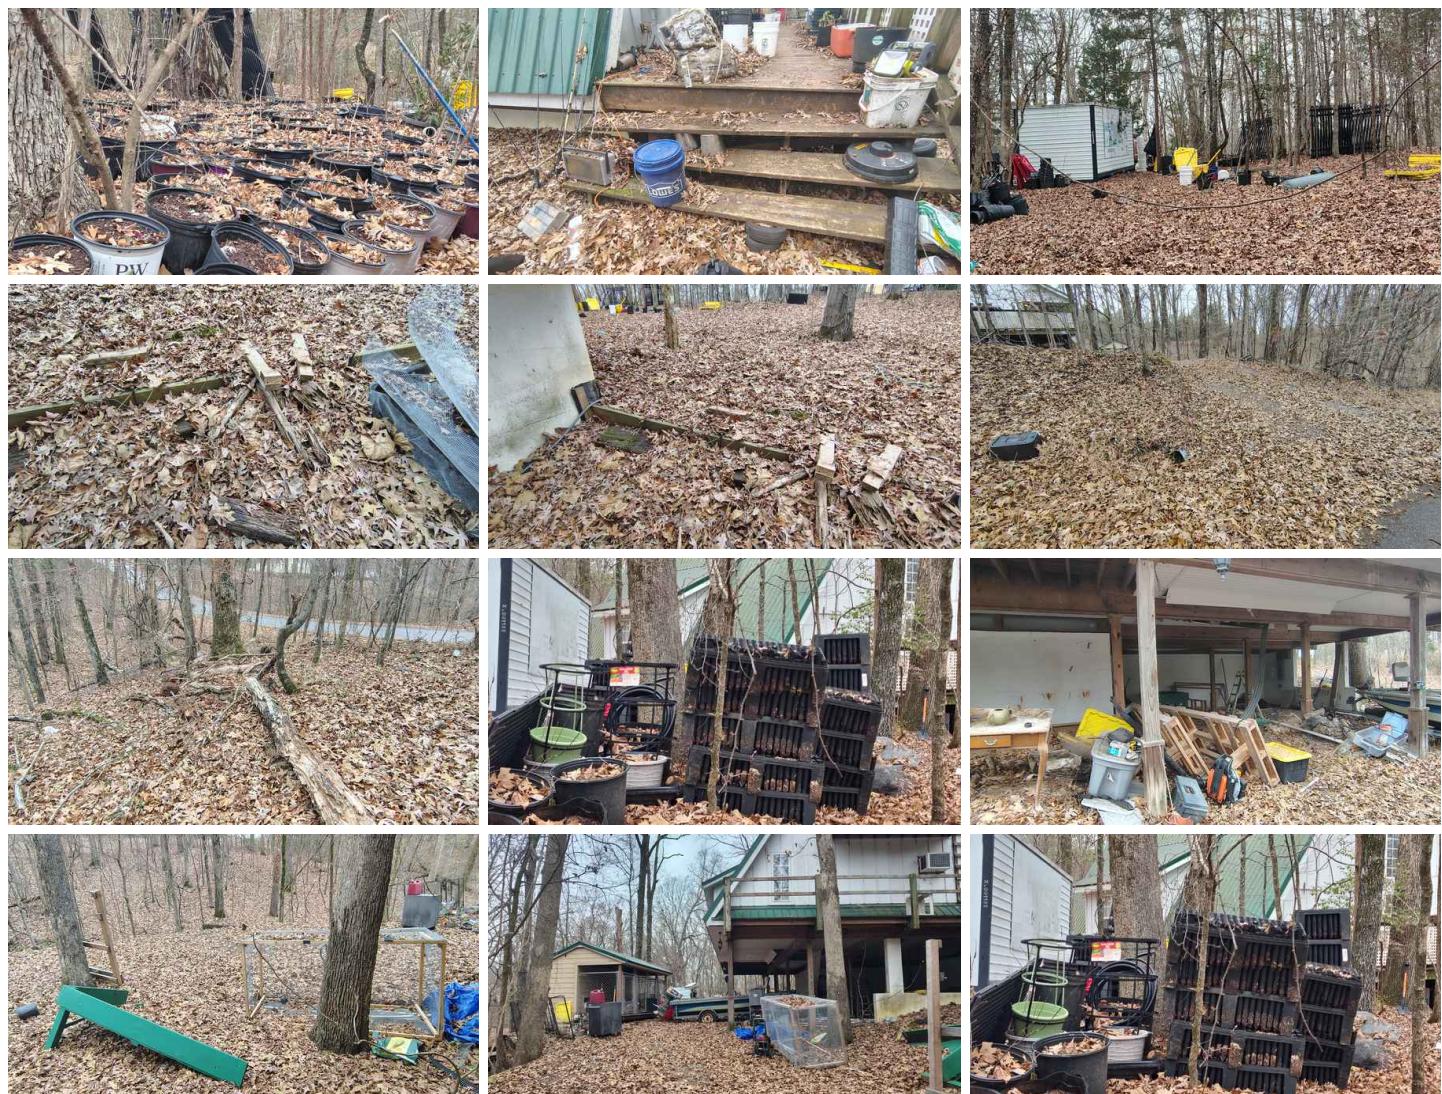
YARD - TRIP, FALL, AND GENERAL SAFETY HAZARDS

The yard contains a significant accumulation of debris, including empty planting pots, discarded tables, loose materials, fallen and rotting wood members with exposed nails, and other miscellaneous trash. Portions of rotting lumber appear to have fallen from the balcony/deck area and remain on the ground. The terrain includes uneven surfaces, changes in elevation, sloped areas, and deteriorated retaining wall sections, particularly near the hillside and creek areas.

The condition of the yard represents an extreme trip and fall hazard. Exposed nails, rotting wood, unstable debris, and uneven terrain significantly increase the risk of injury, particularly during routine access or maintenance. The combination of debris, slope, and retaining wall deterioration further elevates safety concerns.

All debris, trash, and loose materials should be removed from the yard. Exposed nails and rotting wood should be properly disposed of. A qualified professional should evaluate retaining wall conditions and grading, especially in areas near elevation changes and the creek. Extraordinary caution should be exercised when navigating the yard until corrective actions are completed.

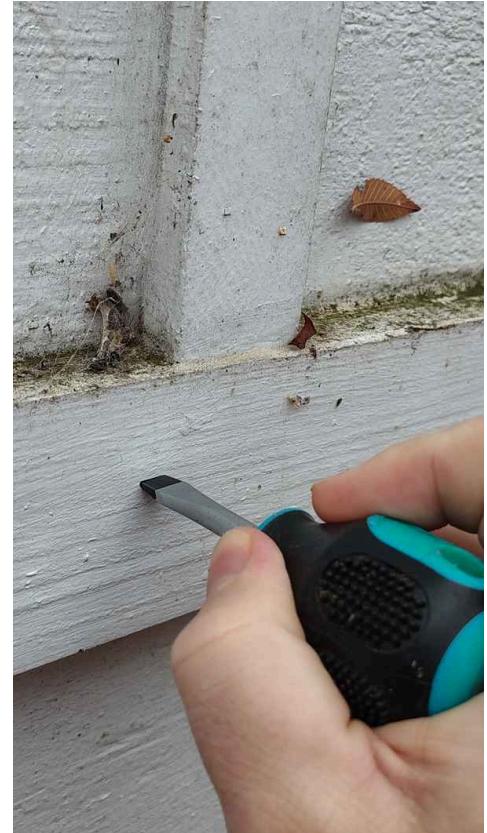
The exterior wood siding exhibited visible deterioration and material loss consistent with wood rot. Probing of the siding indicated softened wood, confirming moisture-related decay. This condition is commonly associated with prolonged moisture exposure and inadequate clearance, drainage, or sealing at wall components.

Deteriorated siding can allow moisture intrusion into the wall assembly and may contribute to concealed damage to underlying sheathing or framing.

Recommend repair or replacement of the affected siding by a qualified contractor. Repairs should include correcting the underlying moisture source and properly sealing or protecting repaired areas to help prevent recurrence.

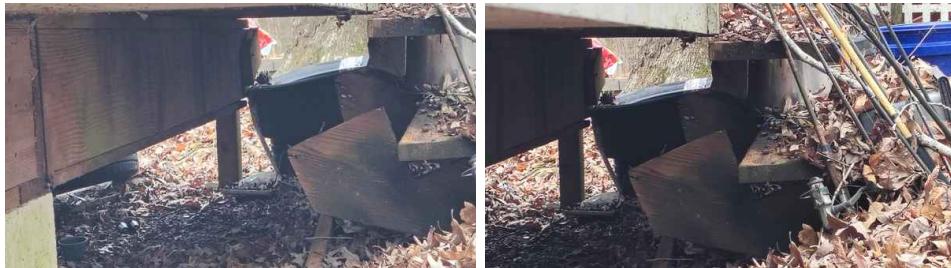
One or more sections of the exterior deck stairs are deteriorated. The stairs are being propped up by other objects and are not supported by the proper stringers for the steps. Exercise extreme caution if navigating these steps. In their current state, they are not safe. Recommend qualified concrete contractor evaluate & repair.

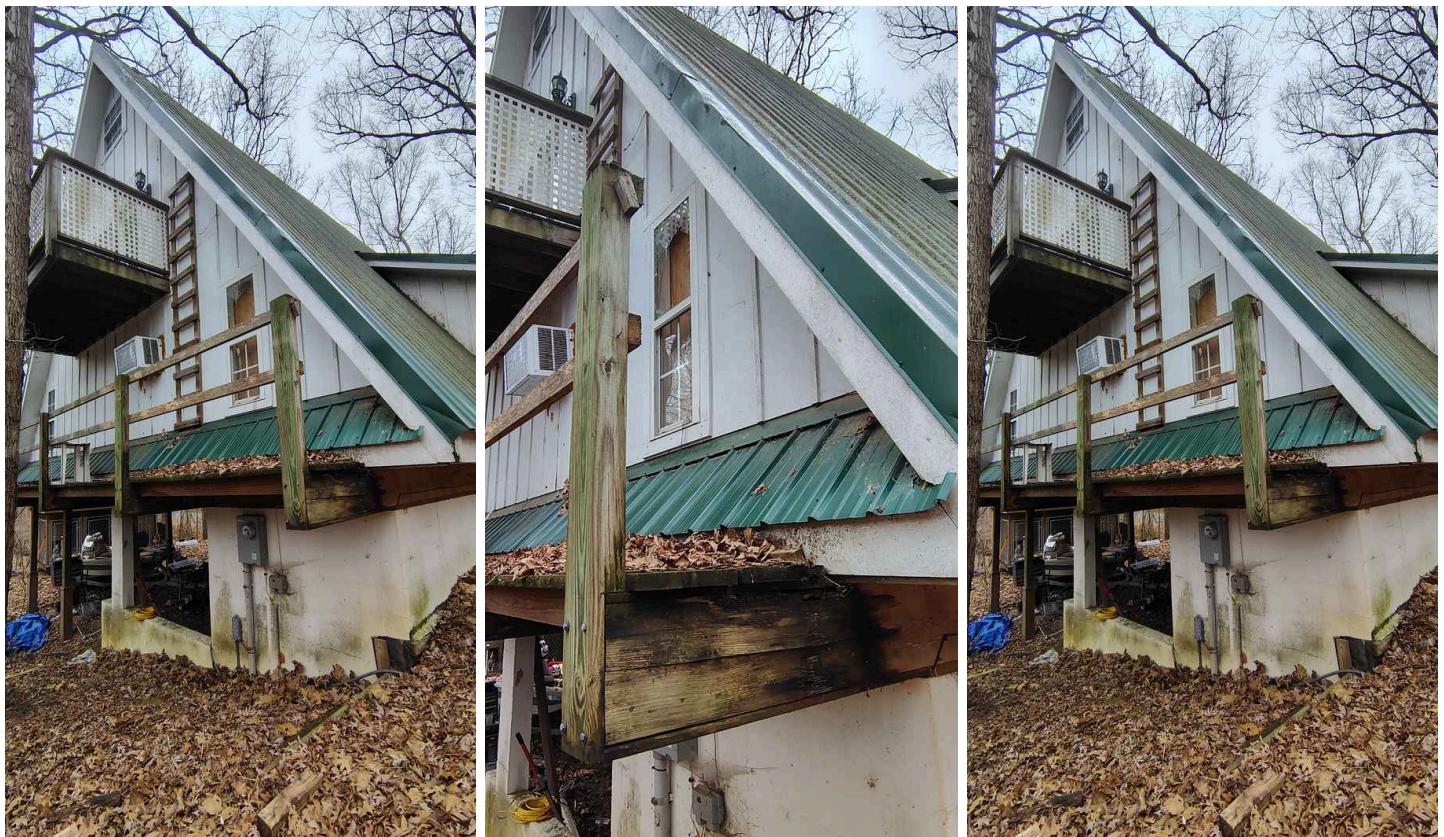
Improper egress provisions may delay evacuation during an emergency and increase the risk of injury.

Recommend evaluation and correction by a qualified contractor. A properly designed and code-compliant emergency egress solution should be provided where required.

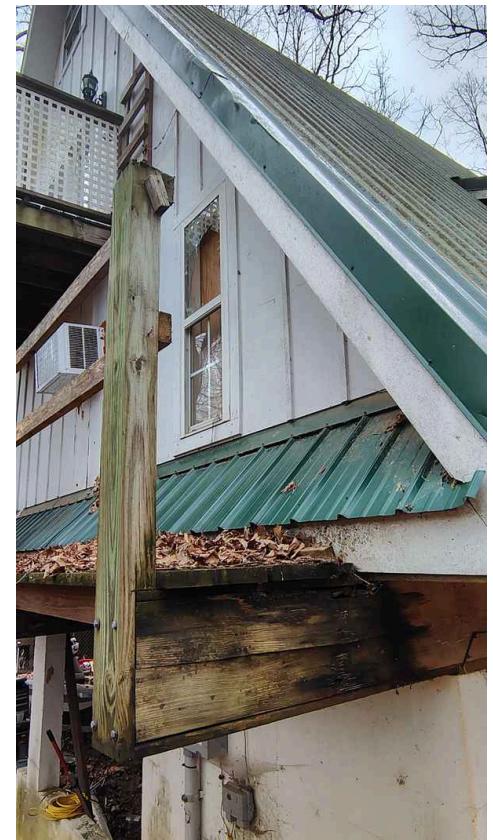
EXTERIOR – DECKS / BALCONIES

The absence of proper guarding presents a safety hazard, particularly for occupants and guests.

Recommend installation of a properly designed and secured guard system by a qualified contractor to improve safety.

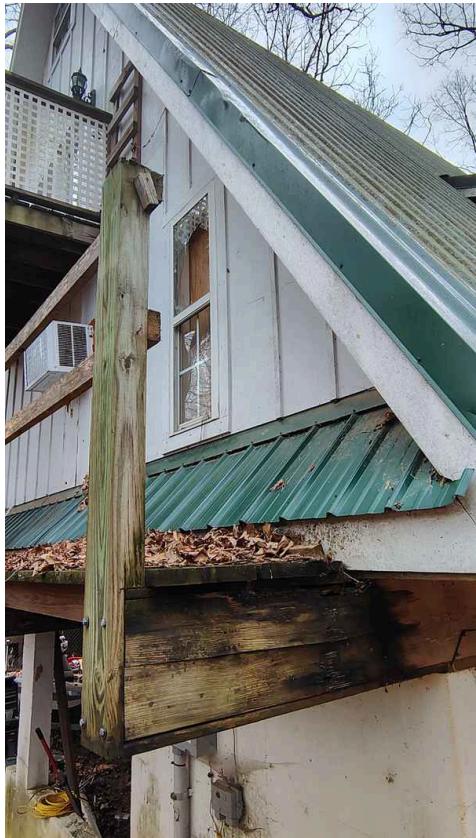
EXTERIOR - DECK STRUCTURE / DRAINAGE INTERACTION

Prolonged moisture exposure can accelerate wood deterioration and may contribute to concealed damage.

Recommend repairs as needed by a qualified contractor, including correction of drainage conditions to help prevent recurrence.

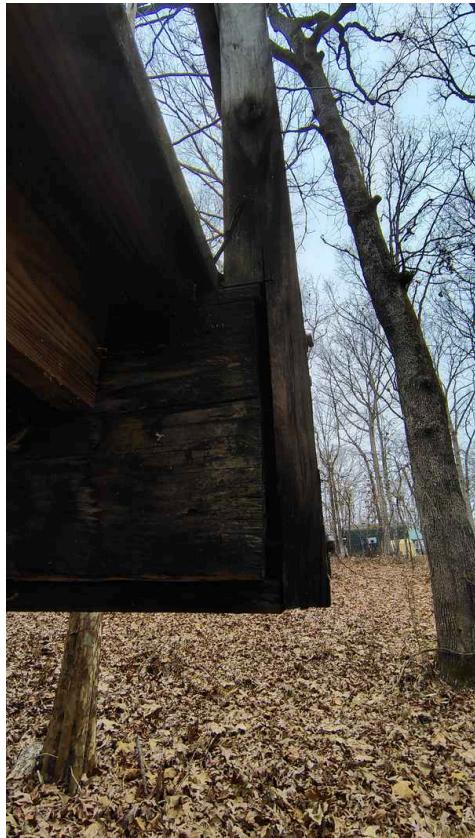
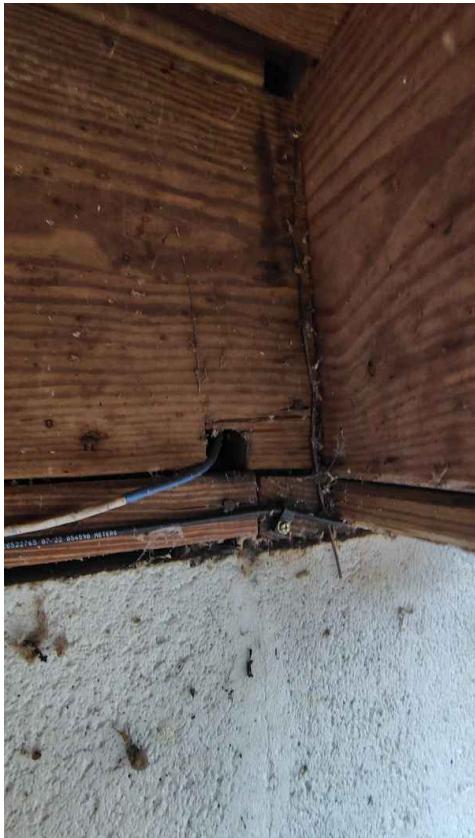
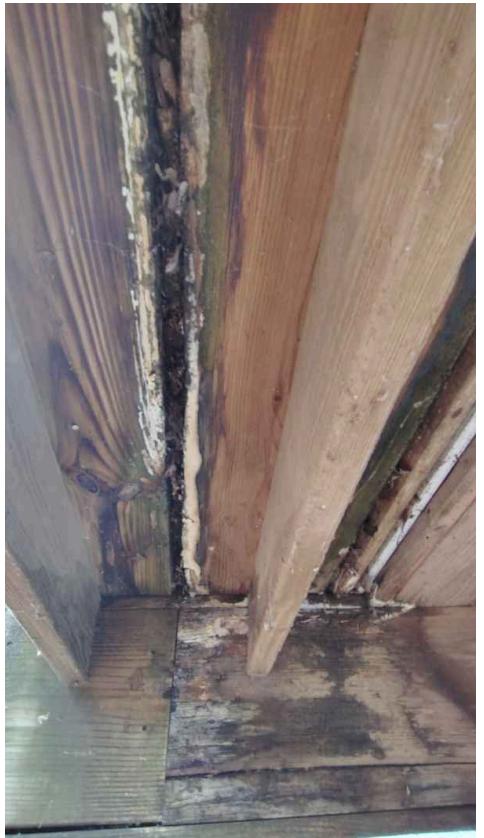
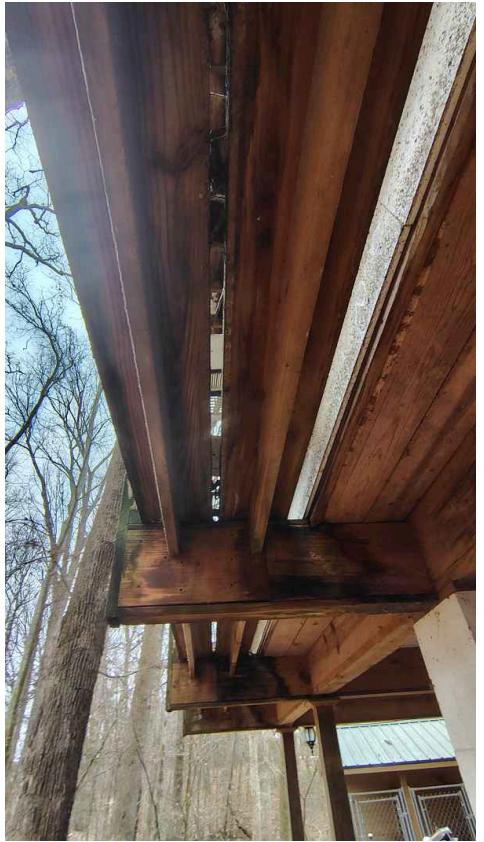
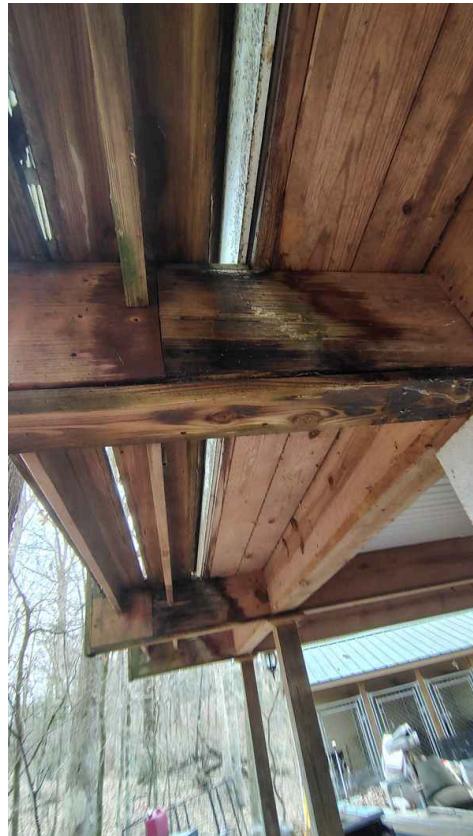
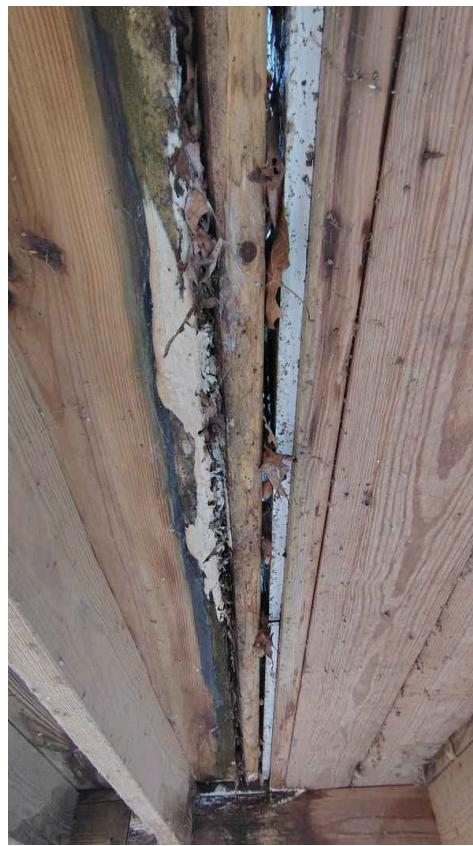
EXTERIOR – DECKS / ELEVATED STRUCTURES (SECOND-STORY DECK)

The second-story and upper-level balconies exhibited widespread moisture-related deterioration and improper construction details. Observed conditions included:

Recommend prompt evaluation and repair by a qualified contractor experienced with elevated deck construction. Due to the extent of deterioration observed, partial or full deck reconstruction may be necessary.

If structural integrity is in question, evaluation by a licensed structural professional is advised to determine appropriate corrective measures. All repairs should include correction of moisture intrusion sources and proper detailing to prevent recurrence.

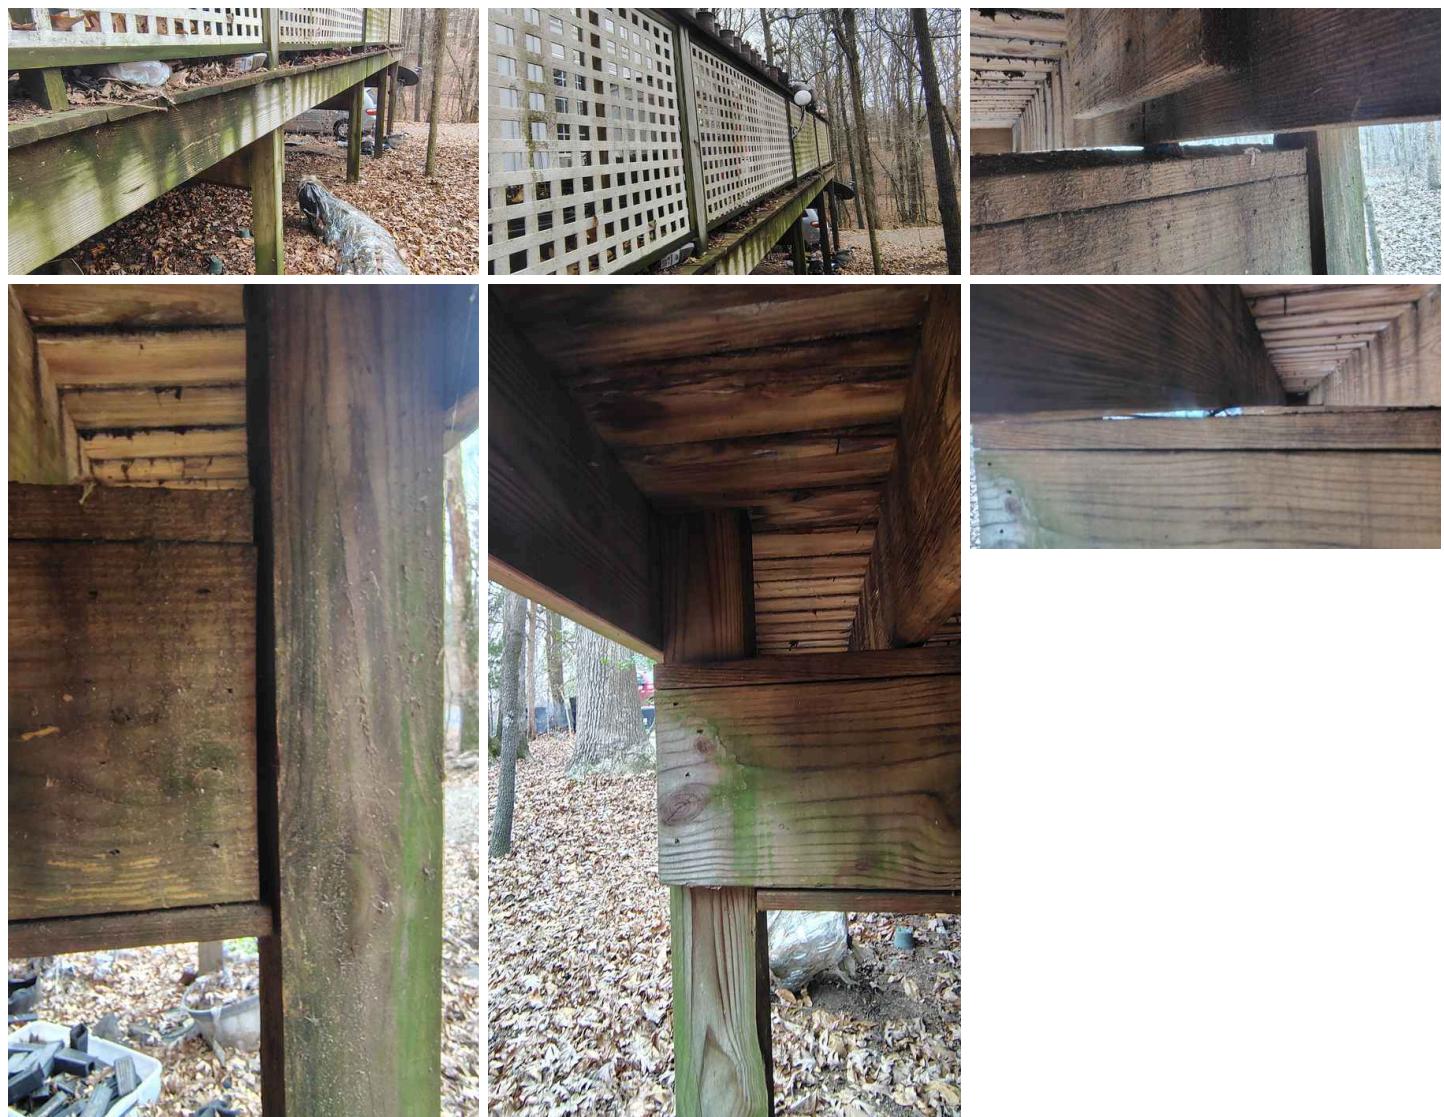
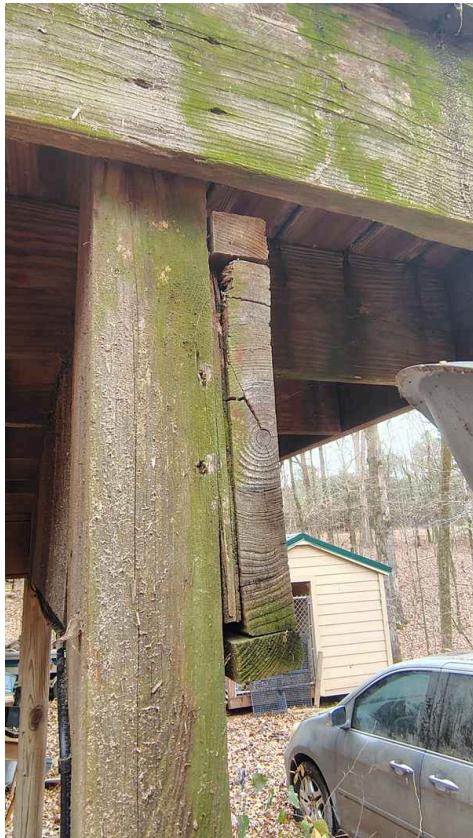
DECK – STRUCTURAL DAMAGE, DETERIORATION, AND IMPROPER SUPPORT

The observed conditions significantly reduce the structural integrity of the deck. Improper support and deteriorated framing increase the risk of movement, sagging, or partial or total structural failure. This condition presents a serious safety hazard to occupants and pets using the deck.

Recommend immediate evaluation by a qualified, licensed contractor. Repairs should include correction of all support deficiencies, replacement of deteriorated structural members, proper bearing on approved footings, and correction of any ledger or beam attachment issues. Due to the extent of deterioration, full reconstruction or replacement of the deck may be warranted.

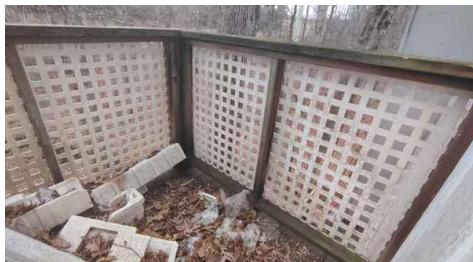
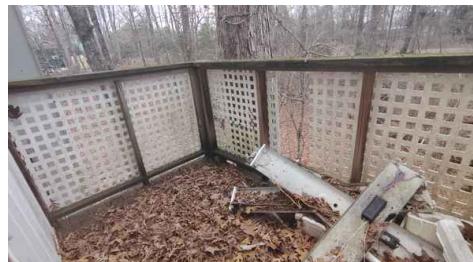
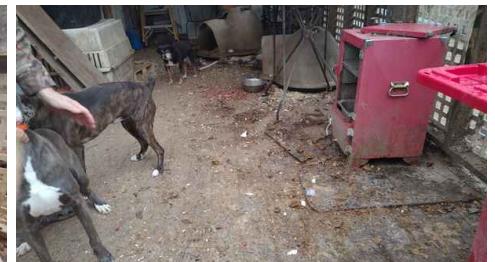
2.4.8 Decks, Balconies, Porches & Steps

DEBRIS (OTHER)

Significant amount of organic debris and animal feces has accumulated on the deck. Recommend removal and further evaluation by qualified professional.

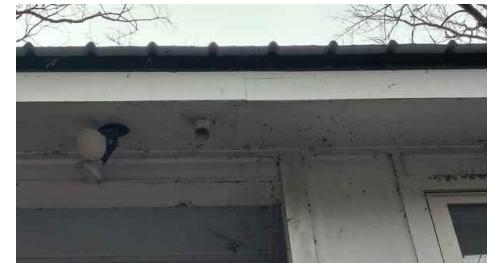
2.5.1 Eaves, Soffits & Fascia

SOFFIT - DAMAGED

One or more sections of the soffit or fascia are damaged. Recommend qualified roofer evaluate & repair.

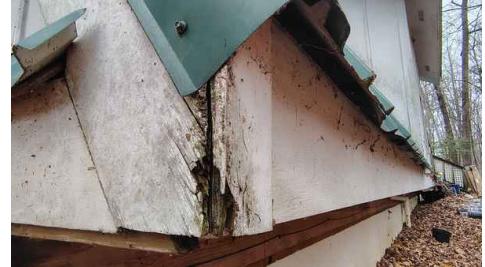
2.5.2 Eaves, Soffits & Fascia

Recommendation**EXTERIOR – FASCIA / ROOF EDGE TRIM**

The fascia board at the roof edge showed visible wood deterioration and moisture-related damage, including dark staining and material degradation. This condition is commonly associated with prolonged moisture exposure, debris accumulation, and/or inadequate drainage at the roof edge.

Deteriorated fascia can compromise attachment points for roofing materials and trim, contribute to continued moisture intrusion, and may allow concealed damage to adjacent structural components.

Recommend repair or replacement of the affected fascia by a qualified contractor. Any repairs should include addressing the underlying moisture source and ensuring proper drainage to help prevent recurrence.

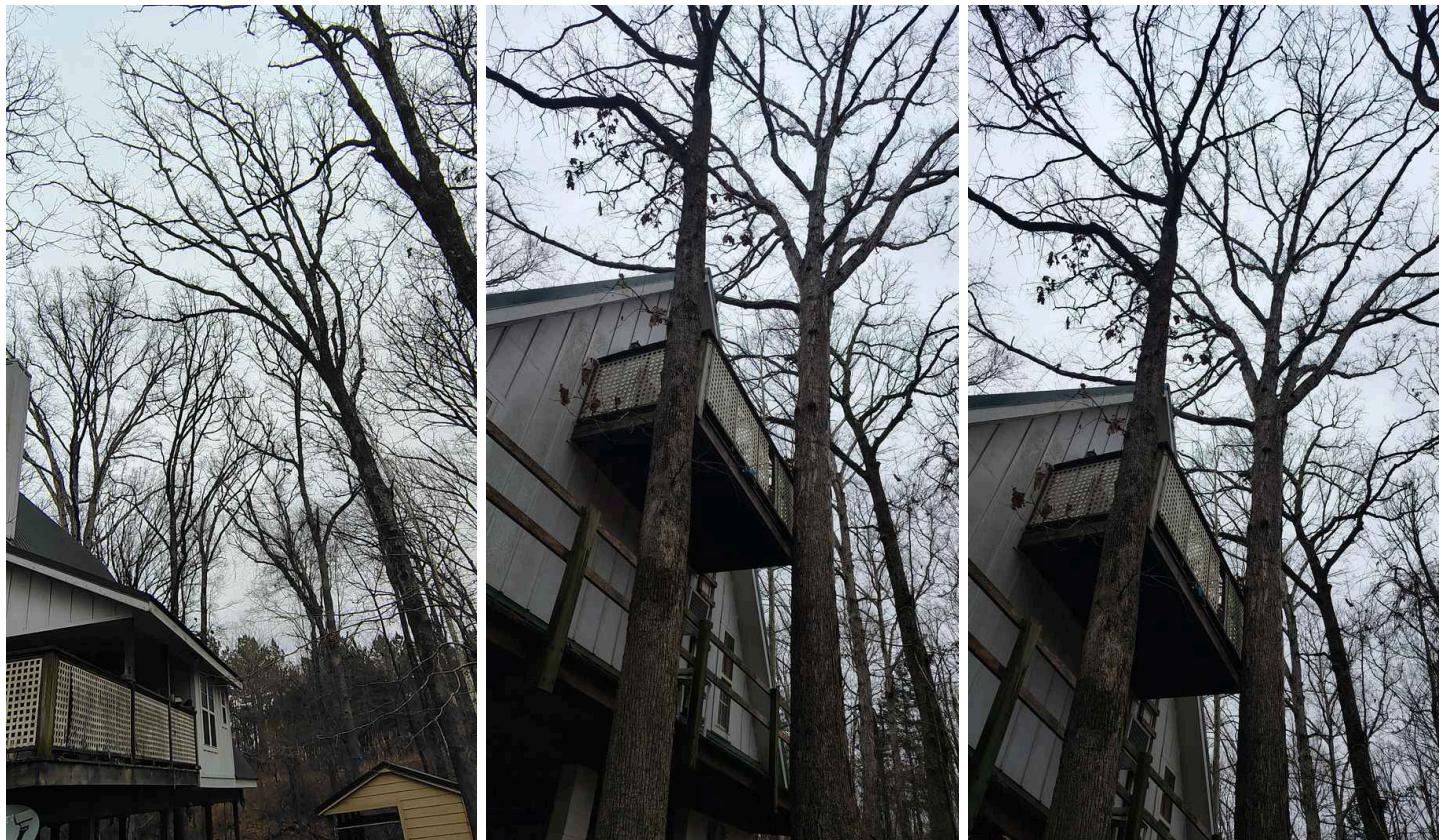
Recommendation**TREE OVERHANG**

Trees observed overhanging the roof. This can cause damage to the roof and prevent proper drainage. Recommend a qualified tree service trim to allow for proper drainage.

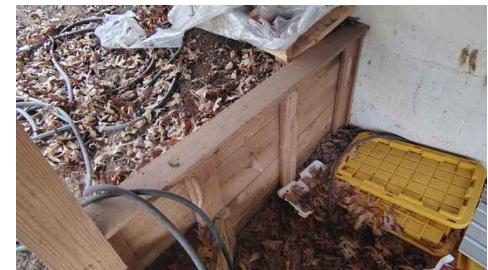
A wood retaining wall was observed beneath the deck/overhang area, retaining soil and organic debris directly against wood components. The wall appears to be constructed of untreated or minimally protected wood and is located in an area prone to moisture accumulation and limited drainage.

Observed conditions included:

- Soil and organic debris in direct contact with wood materials
- Lack of visible drainage provisions (e.g., weep openings or gravel backfill)
- Wood components exposed to prolonged moisture conditions
- Accumulation of leaves and debris, which can trap moisture against the structure

Wood retaining walls in contact with soil are susceptible to accelerated deterioration, rot, and pest activity, particularly when not pressure-treated or properly drained.

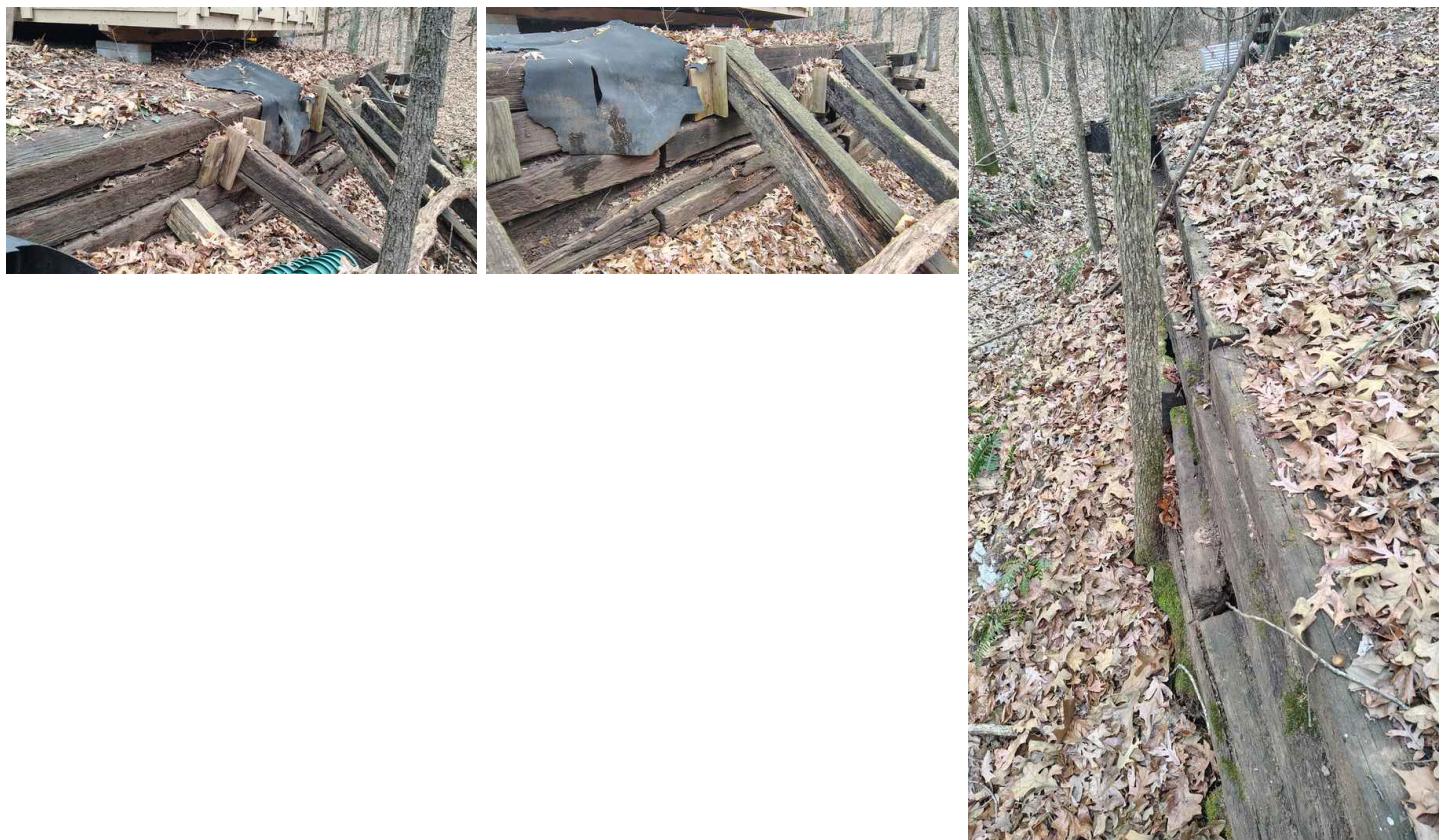
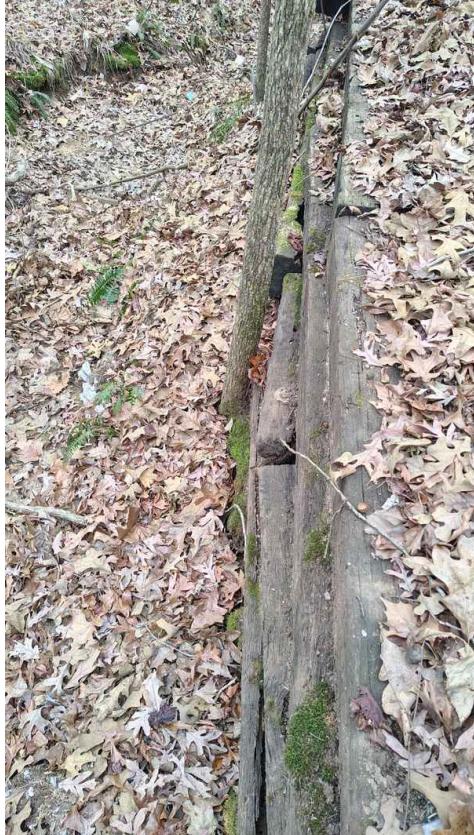
The wood retaining wall located in the yard was observed in poor condition. The wall shows advanced wood deterioration, displacement, and leaning structural members. Several timbers appear rotted, cracked, and no longer adequately retaining soil. Portions of the wall lack proper alignment and support, and no visible drainage system was observed behind the wall. Deteriorated and leaning retaining walls may fail without warning, allowing soil movement and erosion. Failure could result in property damage, create unsafe walking conditions, and negatively impact nearby structures or improvements.

Have a qualified contractor or landscape professional evaluate the retaining wall and repair or replace it as needed. Replacement should include proper structural support and drainage provisions to reduce future movement and deterioration.

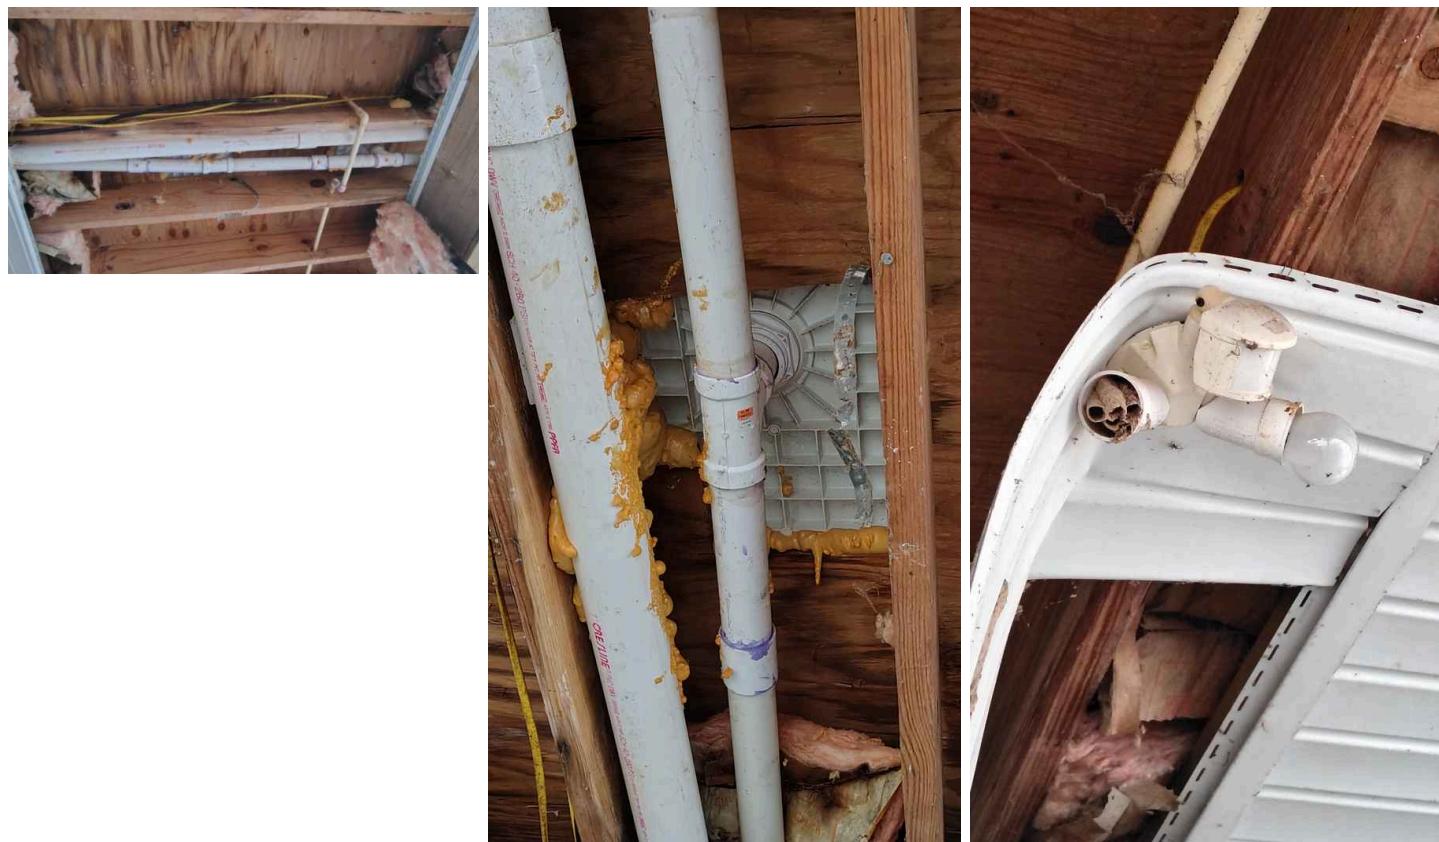
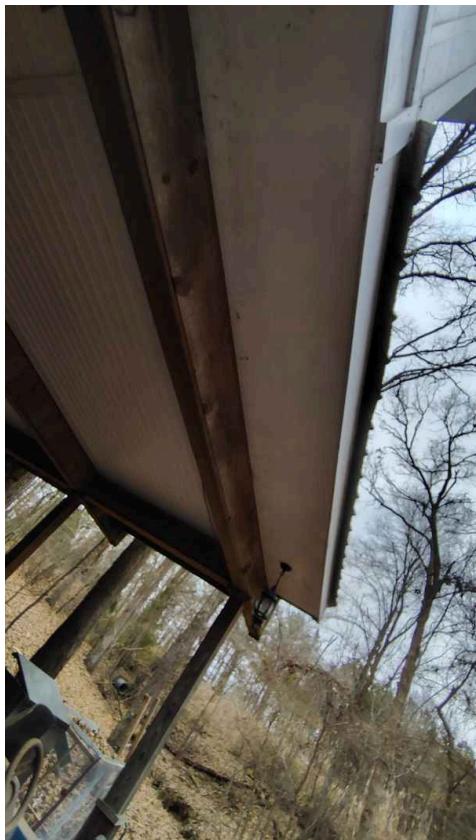
- Exposed and missing soffit panels, leaving framing and insulation visible
- Deteriorated wood framing, including cracked, split, and moisture-stained beams and posts
- Evidence of prolonged moisture exposure, including dark staining and fungal growth on wood members
- Improperly supported or altered framing, including cracked vertical support posts and questionable load paths
- Gaps and openings allowing pest entry and water intrusion
- Loose or damaged trim and soffit components not properly secured

These conditions indicate long-term water intrusion, inadequate detailing, and deferred maintenance.

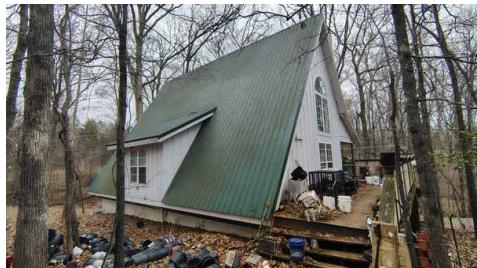
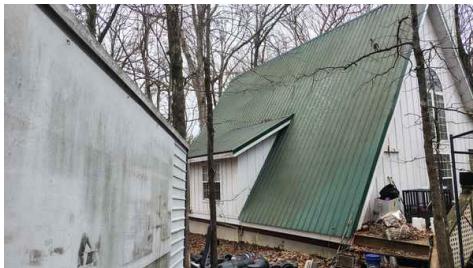
3.1.3 Coverings

ROOFING – METAL ROOF SURFACE CONDITION

The metal roof covering exhibited widespread surface discoloration and organic buildup consistent with dirt, debris, and biological growth (such as algae or mildew). While this condition did not appear to be actively leaking at the time of inspection, surface buildup can retain moisture against the roof panels and may accelerate corrosion or reduce the service life of the roofing materials.

Recommend periodic cleaning and ongoing monitoring of the roof condition. If concerns about corrosion, fastener condition, or roof longevity exist, further evaluation by a qualified roofing contractor is advised.

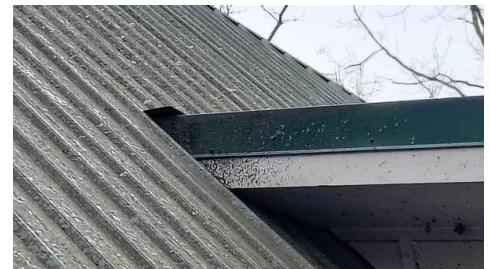
At the roof-to-wall intersection, a visible gap was observed between the metal roof panel and the trim/flashng. This condition may allow water intrusion behind the roofing or wall cladding, particularly during wind-driven rain or heavy precipitation. Evidence of surface staining and debris accumulation was also noted in this area, which can further contribute to moisture retention.

Recommend evaluation and correction by a qualified roofing contractor. Properly installed and sealed flashing should be provided to ensure a weather-tight transition and reduce the risk of leaks or concealed damage.

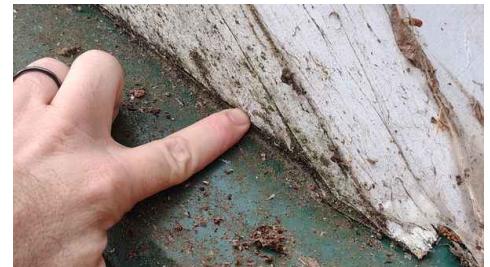
3.3.2 Flashings

The wood structural member at the top of the foundation wall (consistent with a sill plate or lower bearing member) exhibited visible wood deterioration and material loss. The wood appeared softened and degraded at the roof-to-foundation interface, consistent with prolonged moisture exposure.

In A-frame construction, this member serves as a primary load-bearing component transferring roof loads into the foundation. Deterioration at this location may compromise structural performance over time and may indicate concealed damage beyond what was visible at the time of inspection.

Recommend further evaluation and repair by a qualified contractor. Due to the structural nature of this component, evaluation by a licensed structural professional is advised to determine the extent of damage and appropriate corrective measures. Repairs should address both the deteriorated wood and the moisture intrusion source to help prevent recurrence.

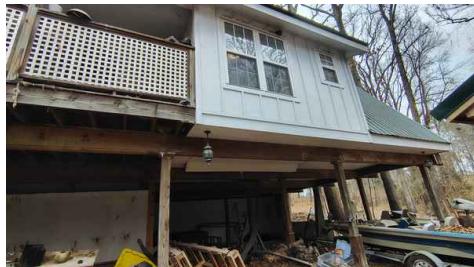
- Longitudinal splitting and cracking of wood members
- Signs of weathering and possible section loss
- Improper protection of wood exposed to the elements

Cracked and deteriorated posts may have reduced load-bearing capacity, particularly where supporting elevated structures.

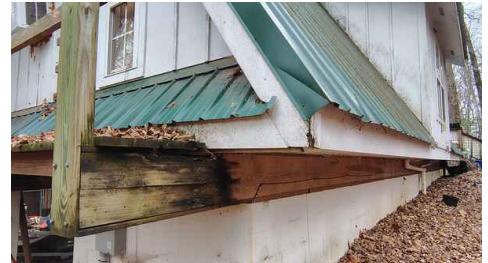
4.3.1 Wall Structure

EXTERIOR / FOUNDATION INTERFACE – SILL PLATE / STRUCTURAL BEARING MEMBER

A wood structural member located at the top of the foundation wall (consistent with a sill plate or lower bearing beam) showed visible moisture staining and wood deterioration. In A-frame construction, this member serves as a critical load-bearing component transferring roof loads to the foundation.

Moisture-related deterioration at this location may compromise structural performance over time and may indicate ongoing water management issues at the roof edge.

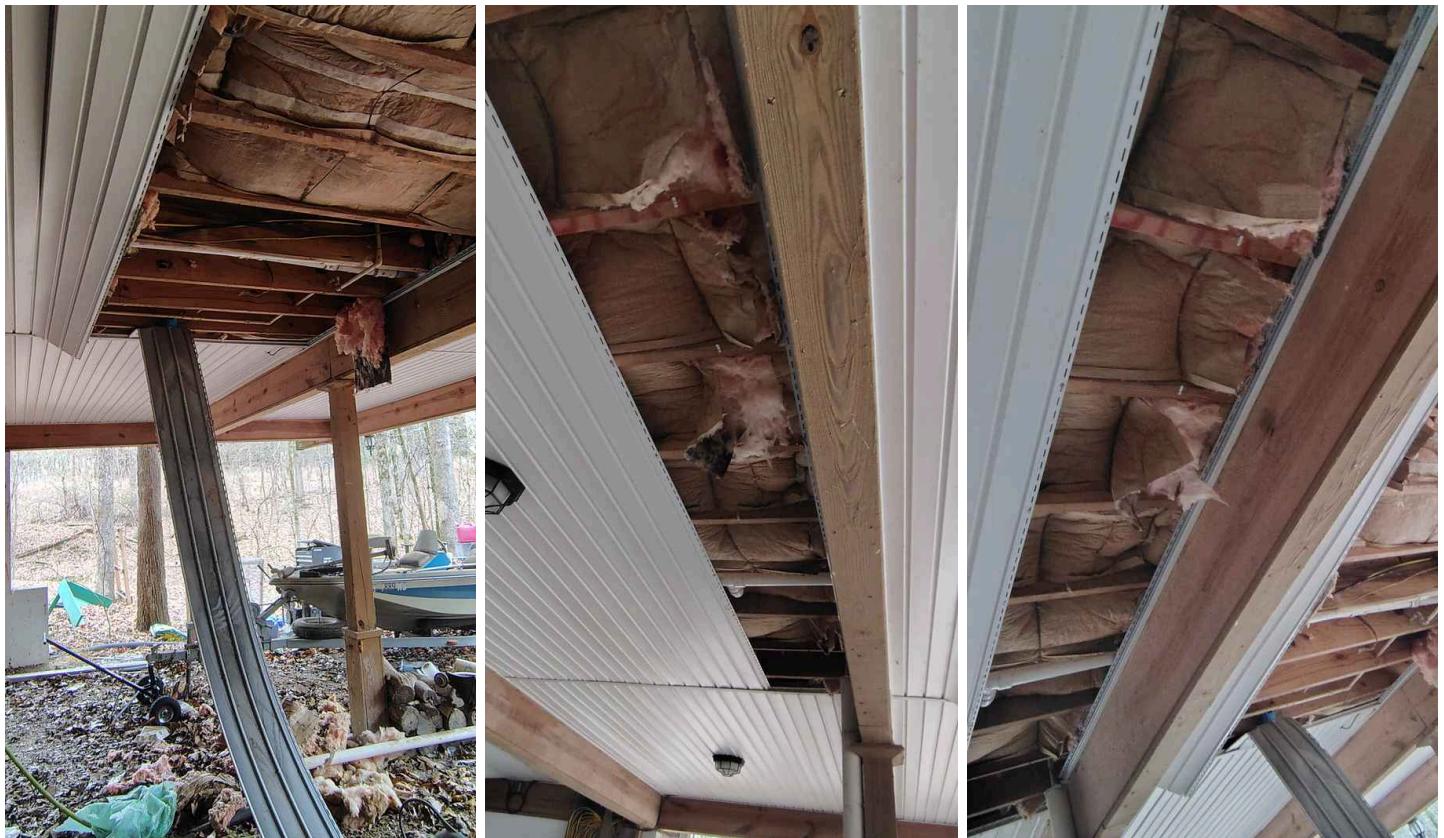
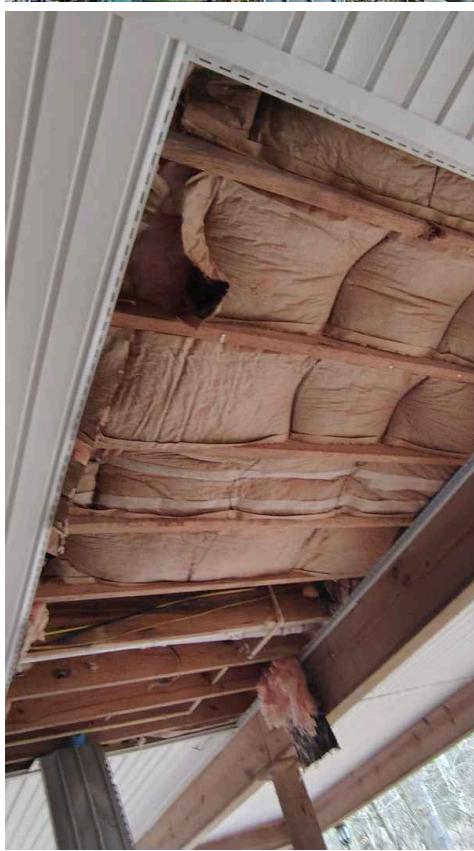
- Displaced and falling insulation
- Insulation exposed to outdoor conditions
- Potential loss of thermal performance
- Increased risk of moisture saturation and pest nesting

Exposed insulation is not designed for exterior exposure and may no longer perform as intended.

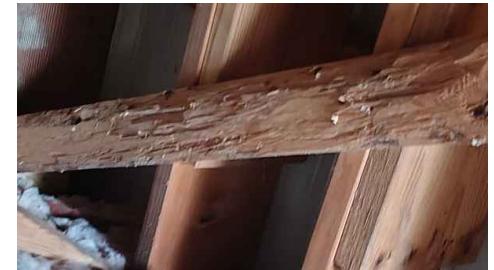
Localized wood deterioration and surface damage were observed on a roof framing member in the attic. The affected area shows roughened and irregular wood fibers with material loss.

Recommend evaluation by a qualified professional to determine the cause and whether corrective action is needed.

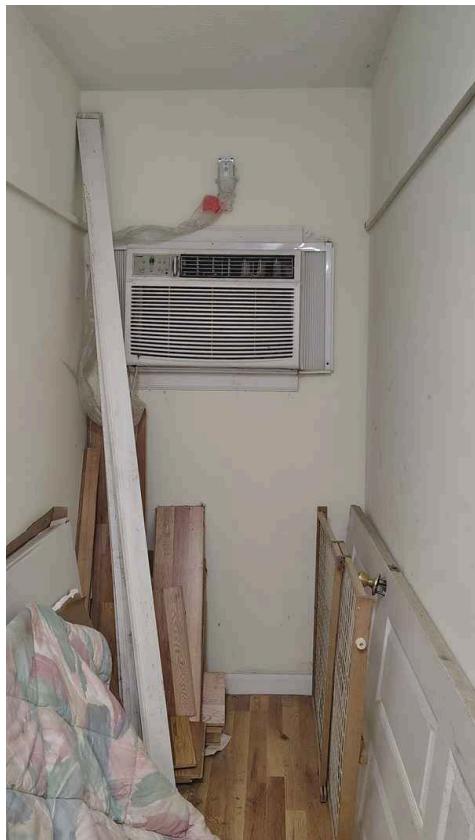
Window Unit is improperly installed, aged, and may be beyond it's useful life. Recommend replacement and proper installation by qualified professional.

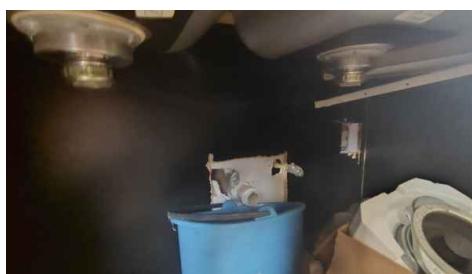
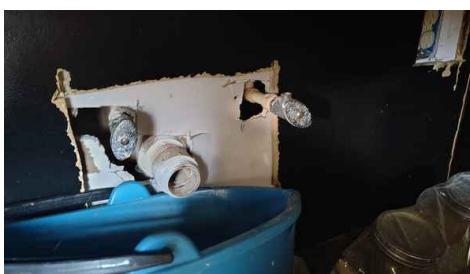
INCOMPLETE PLUMBING (UNDER SINK)

The kitchen sink plumbing was observed to be incomplete at the time of inspection. Drain piping and associated components beneath the sink were missing, leaving the drain connection open. Because the plumbing system was not fully installed, the sink could not be operated or tested for proper drainage or leakage. An incomplete plumbing system may allow water damage if the sink is used and does not meet normal functional expectations for a kitchen. Installation of proper drain piping and completion of the under-sink plumbing by a qualified plumber is recommended prior to use. The inspection was visual in nature, and plumbing performance could not be evaluated due to the missing components.

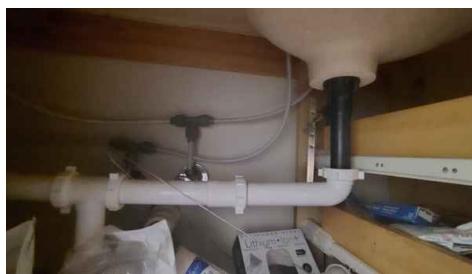
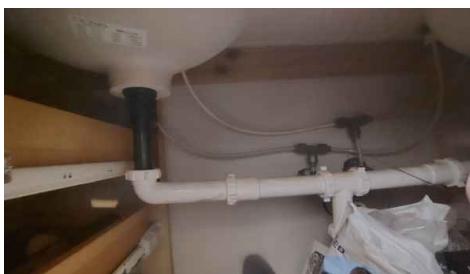
7.3.1 Water Supply, Distribution Systems & Fixtures

The P-trap is a crucial component of the plumbing system. It prevents sewer gases from entering the home by creating a water seal in the drain line. Without a P-trap, there is a risk of odors, gases, or even contaminants entering the living space. Additionally, without the trap, waste water may not flow correctly, leading to possible clogs or leaks.

Recommend having a licensed plumber install a P-trap under the bathroom sink to ensure proper drainage and to prevent sewer gases from entering the home. The installation should meet local plumbing codes to ensure functionality and safety. Verify that the rest of the drain system is clear and properly sealed to prevent leaks.

Contact a qualified plumbing contractor.

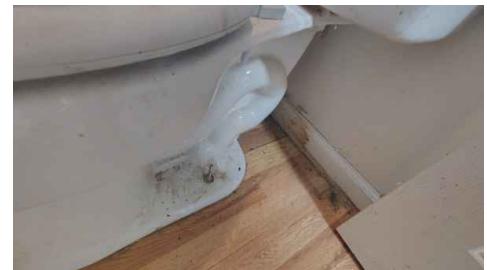
7.3.2 Water Supply, Distribution Systems & Fixtures

TOILET BOLTS MISSING CAPS AND SHOWING RUST:

The toilet mounting bolts are missing protective caps. While this is typically a minor cosmetic issue, rusted bolts may eventually weaken and compromise the toilet's secure attachment to the floor.

Recommend replacing the bolts if deteriorated and installing caps to protect against future corrosion and improve appearance.

Contact a qualified professional.

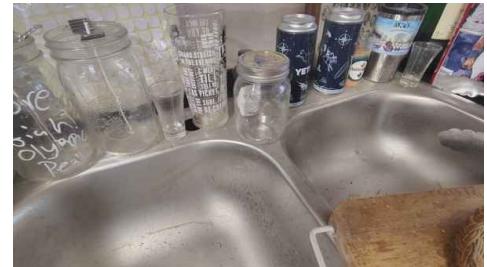
NO FAUCET

The kitchen sink was observed without a faucet or sprayer installed at the time of inspection. Without a faucet, the sink could not be operated or tested for proper water flow, drainage, or leakage. A functional faucet assembly is required for normal use of the sink and kitchen plumbing system. Installation of an appropriate faucet and any associated components is recommended, followed by verification of proper operation once installed. The inspection was visual in nature, and plumbing performance could not be evaluated due to the missing fixture.
