UPCHURCH INSPECTION

RESIDENTIAL REPORT

1234 Main Street
Memphis, TN 38117

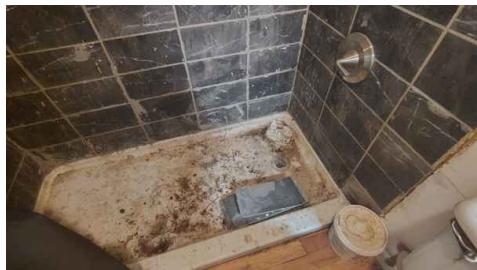
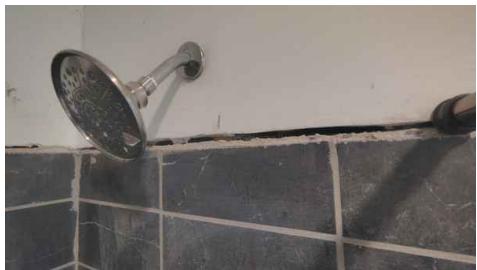
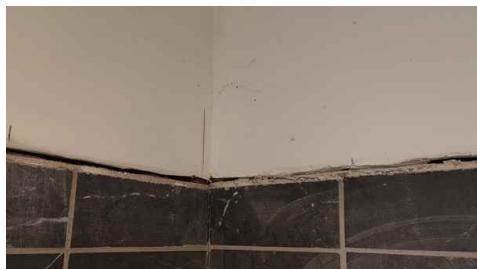
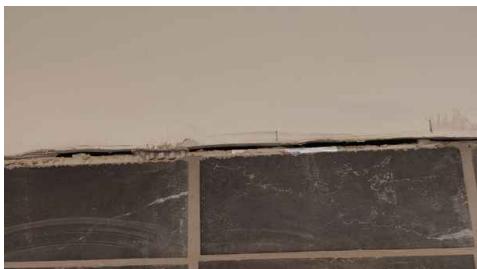
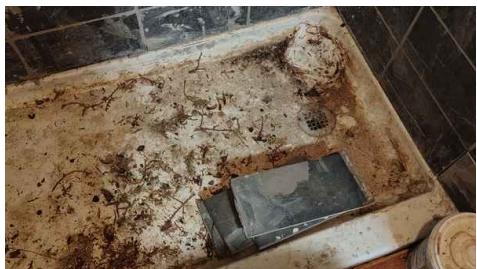
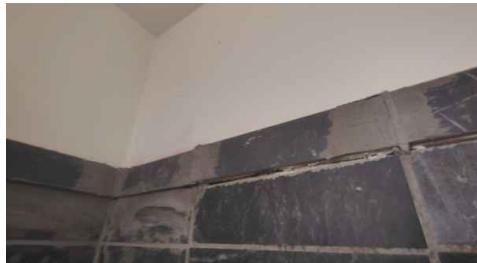
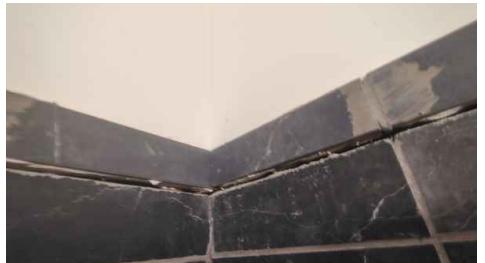
7.3.4 Water Supply, Distribution Systems & Fixtures

SHOWERS IN UNFINISHED STATE

The shower enclosure was observed to be in an unfinished condition at the time of inspection. Gaps were present between the shower wall tile and adjacent wall surfaces, and portions of the wall-to-tile transitions appeared incomplete or improperly sealed. Areas of missing or deteriorated grout, exposed backing materials, and unsealed penetrations were also observed. These conditions reduce the shower's ability to resist moisture intrusion and may allow water to migrate behind wall finishes, potentially leading to concealed moisture damage, deterioration, or microbial growth over time. Due to the unfinished condition, the shower could not be fully evaluated for proper waterproofing or long-term performance. Completion of the shower installation, including proper sealing, waterproofing, and finishing by a qualified contractor, is recommended prior to regular use. The inspection was visual in nature, and concealed conditions were not evaluated.

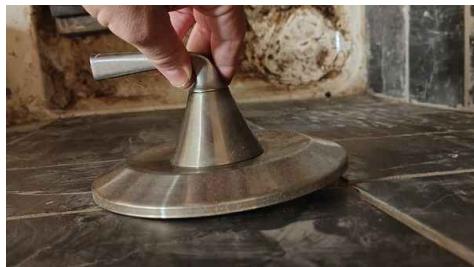
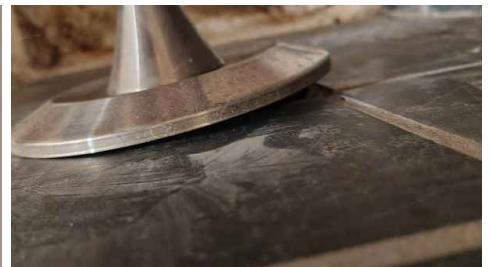
7.3.5 Water Supply, Distribution Systems & Fixtures
LOOSE SHOWERHEAD AND SHOWER FAUCET

The shower faucet and showerhead were observed to be loose at the wall. Plumbing fixtures should be securely mounted to prevent movement during normal use. Loose fixtures can stress plumbing connections behind the wall and may contribute to leaks, damage to wall finishes, or premature failure of the plumbing components over time. It is recommended that a qualified plumber or contractor properly secure the shower faucet and showerhead and verify that all connections are stable and leak-free. The inspection was visual in nature, and concealed plumbing connections were not evaluated.

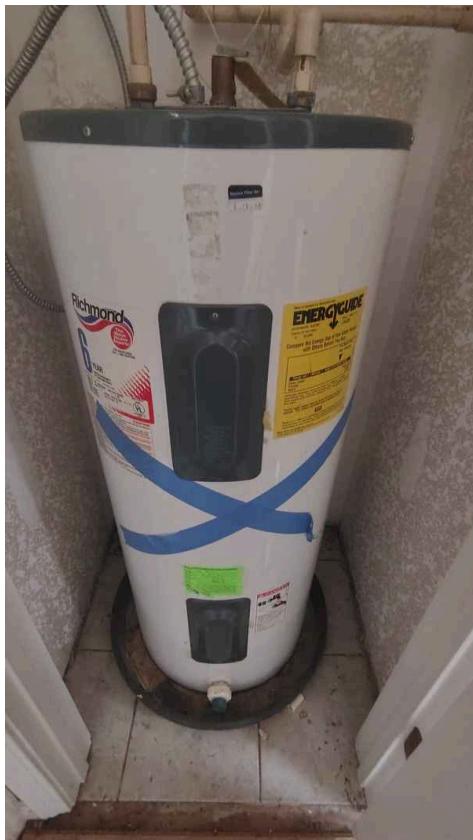
NEAR END OF LIFE

Water heater showed normal signs of wear and tear. Recommend monitoring it's effectiveness and replacing in the near future.

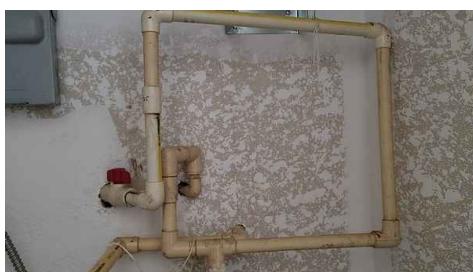
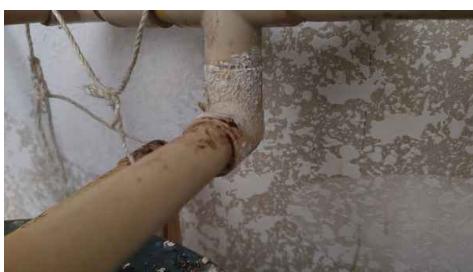
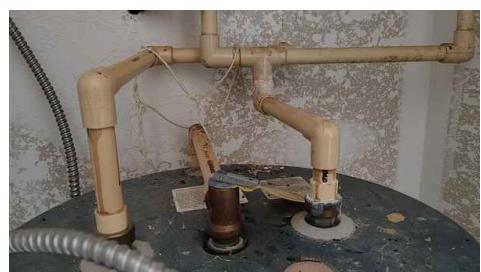
WATER HEATER – IMPROPER PIPING INSTALLATION

The water heater supply and distribution piping is constructed primarily of CPVC with multiple hard 90-degree fittings, nonstandard routing, and visible signs of age, mineral buildup, and deterioration at several joints. Portions of the piping appear unsupported and routed in a manner inconsistent with typical best practices.

In addition, CPVC piping is connected directly to the water heater without a visible metallic transition (such as copper or a listed dielectric connector) at the tank nipples. This can subject the CPVC to excessive heat, which may accelerate material degradation over time.

Evidence of prior leakage, corrosion staining, or mineral deposits was observed at several fittings. String and improvised materials were also noted in contact with the piping, indicating nonprofessional or temporary modifications.

Improperly installed or deteriorated water heater piping increases the risk of leaks, water damage, and premature failure. CPVC piping exposed to elevated temperatures can become brittle over time, increasing the likelihood of cracking or joint failure. Leakage in this area can cause damage to finishes, promote mold growth, and impact the serviceability of the water heater.

A licensed plumber should further evaluate the water heater piping system and make repairs or upgrades as necessary. Corrections may include installing proper metallic transition piping at the water heater, improving pipe support, replacing deteriorated sections, and reconfiguring the piping to meet current standards and manufacturer recommendations.

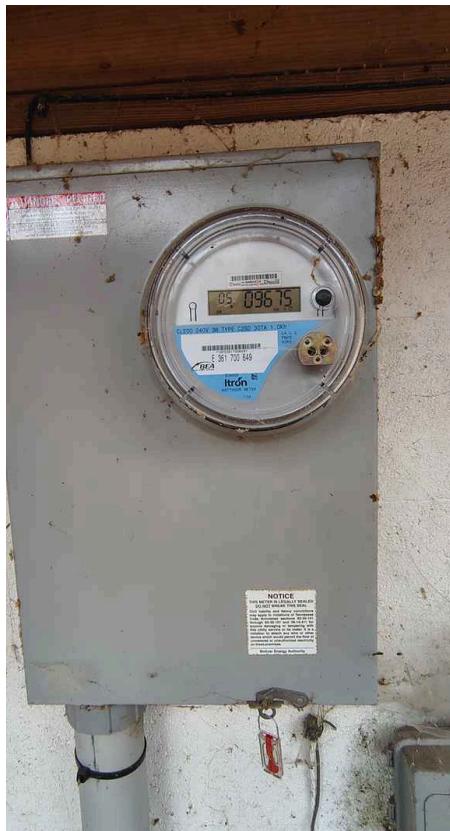
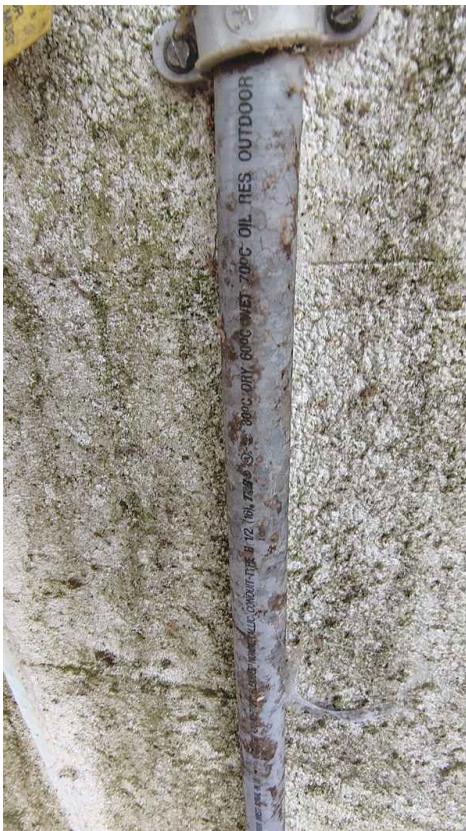
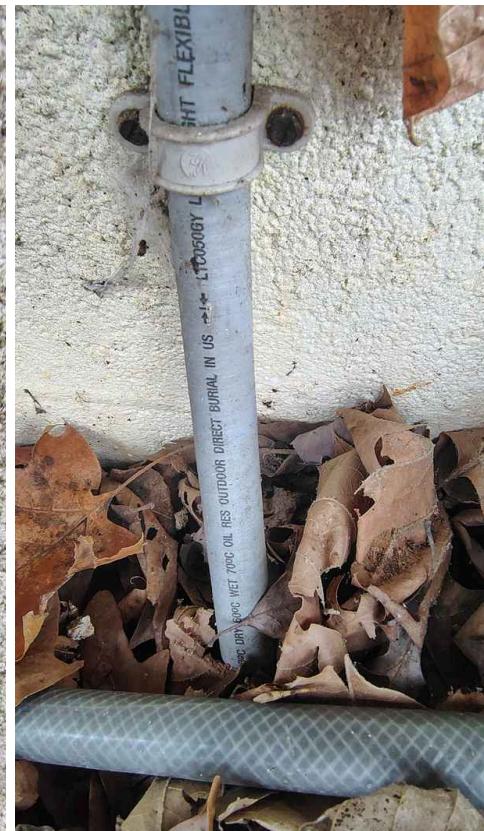
Service Entrance Conductors: Electrical Meter

The electric meter located on the exterior of the property was inspected for condition and functionality. The electric meter is mounted securely on the exterior wall, positioned at a height that allows for easy reading and access. Upon examination, the meter appears to be in good condition, with no visible signs of damage or wear. The glass face is clear, allowing for easy visibility of the dials and digital display.

Overall, the electric meter is in satisfactory condition, functioning properly, and compliant with local regulations. Regular monitoring of the meter readings is recommended to ensure efficient energy use and identify any potential issues with electrical consumption.

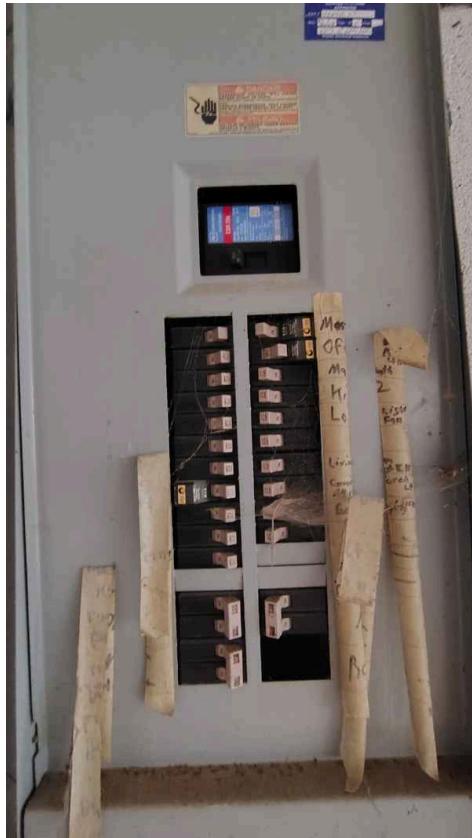
8.2.2 Main & Subpanels, Service & Grounding, Main Overcurrent Device

CONDITION: IMPROPERLY SEATED DEAD FRONT COVER

A gap was observed between the electrical panel dead front cover and the circuit breakers. The cover does not appear to be properly seated or aligned, leaving portions of the breaker assembly exposed.

The dead front cover is designed to prevent accidental contact with energized components. Gaps or misalignment reduce this protective function and may expose occupants to an increased risk of electric shock if the panel is accessed.

Recommend evaluation and correction by a qualified electrician.

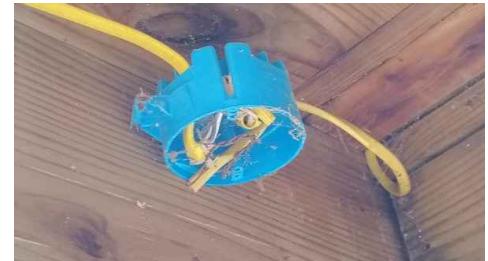
8.3.3 Branch Wiring Circuits, Breakers & Fuses

LIGHT FIXTURE MISSING (EXPOSED WIRING)

Light fixture not installed. Wiring exposed. Recommend correction by a qualified electrician.

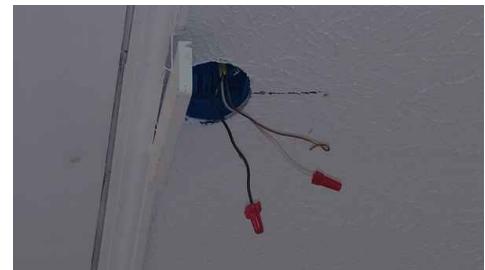
8.3.4 Branch Wiring Circuits, Breakers & Fuses

WIRE IMPROPERLY TERMINATED (IN ATTIC)

Wire Improperly Terminated in Attic. Recommend having electrician correct.

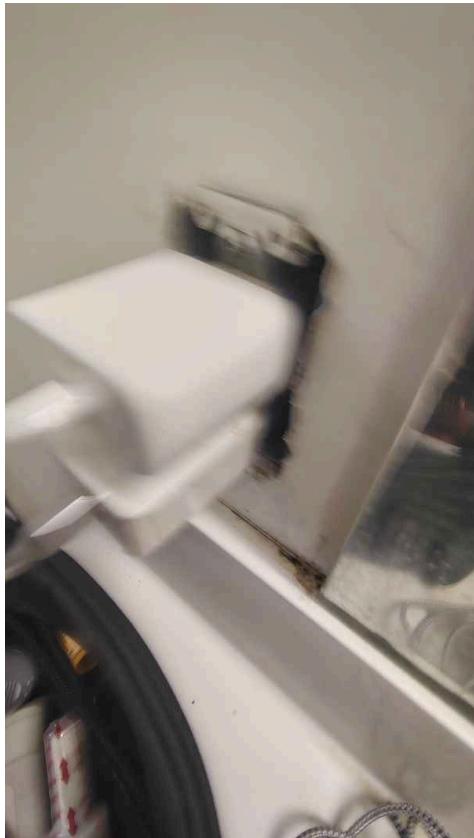
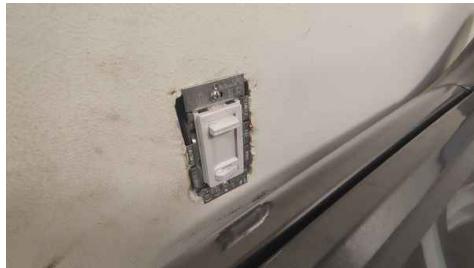
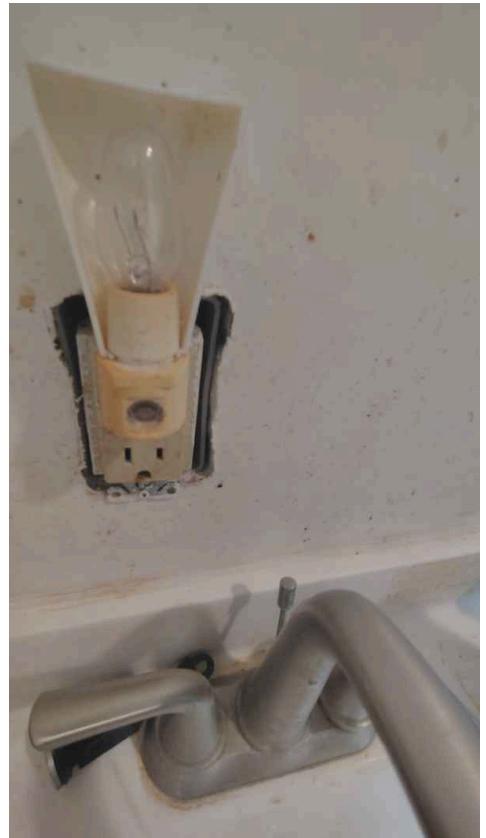
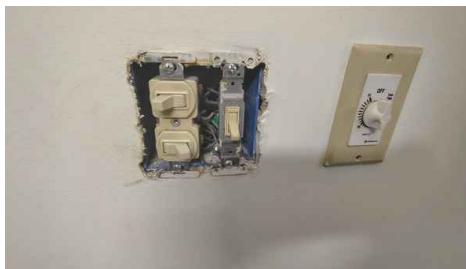
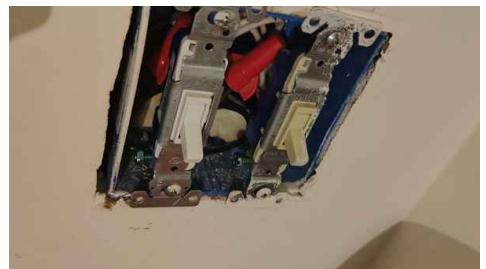
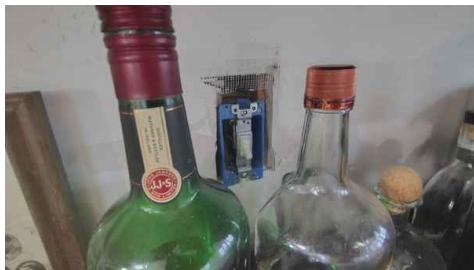
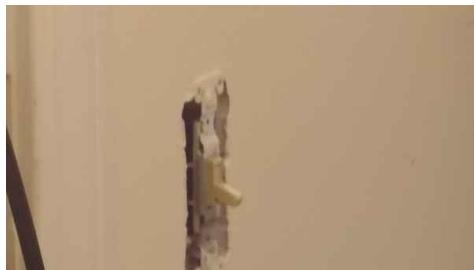
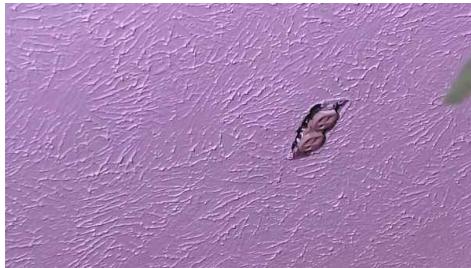
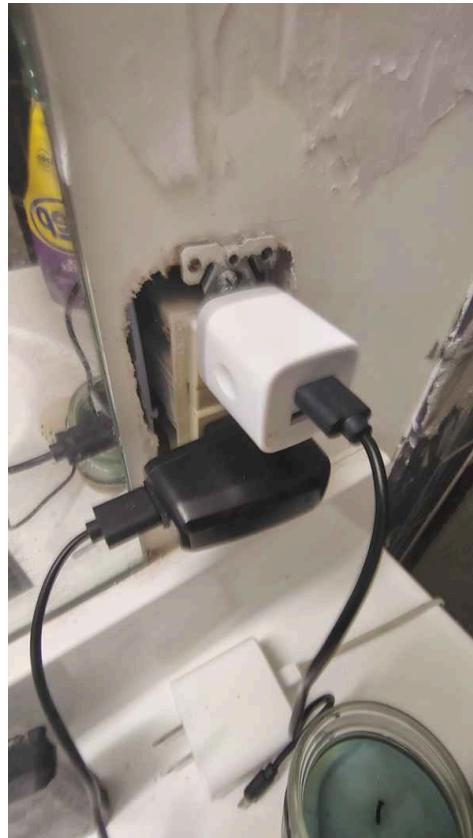
COVER PLATES MISSING

Many receptacles and lightswitches are missing a cover plate. This causes short and shock risk. Recommend installation of plates.

Under Kitchen Sink

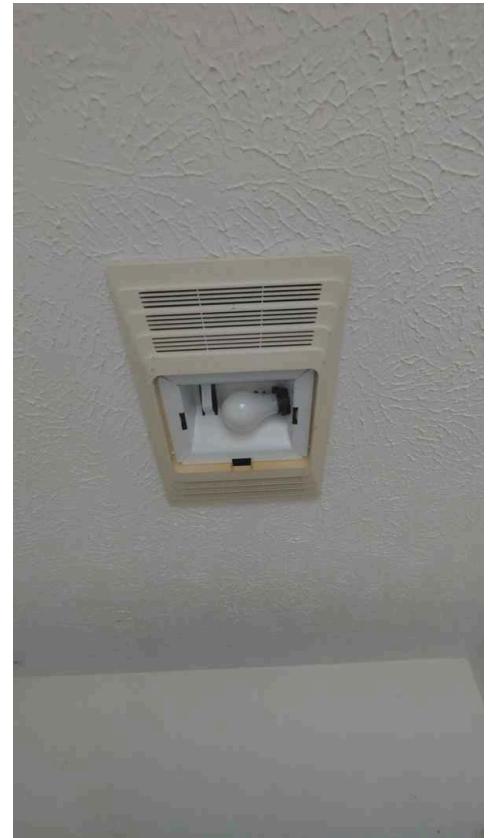
8.4.5 Lighting Fixtures, Switches & Receptacles

LIGHT NOT FUNCTIONAL

Light not functional, may need bulb replacement.

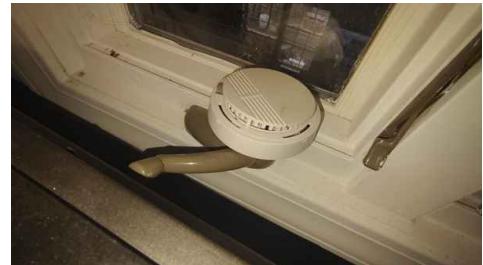
8.6.2 Smoke Detectors

MISSING / INADEQUATE SMOKE DETECTDORS

The home has missing and/or inadequate smoke detectors in key areas. Current safety standards recommend smoke detectors in every bedroom, outside sleeping areas, and on every level of the home.

Smoke detectors are essential for early fire detection and occupant safety. Missing or non-functional detectors significantly increase the risk of injury or property damage in the event of a fire.

Recommend installing new smoke detectors in all required locations per National Fire Protection Association (NFPA) guidelines. Test existing detectors to ensure they are operational, and replace any units that are more than 10 years old. Consider interconnected smoke detectors for enhanced safety. A qualified electrician or fire safety professional can assist with proper installation.

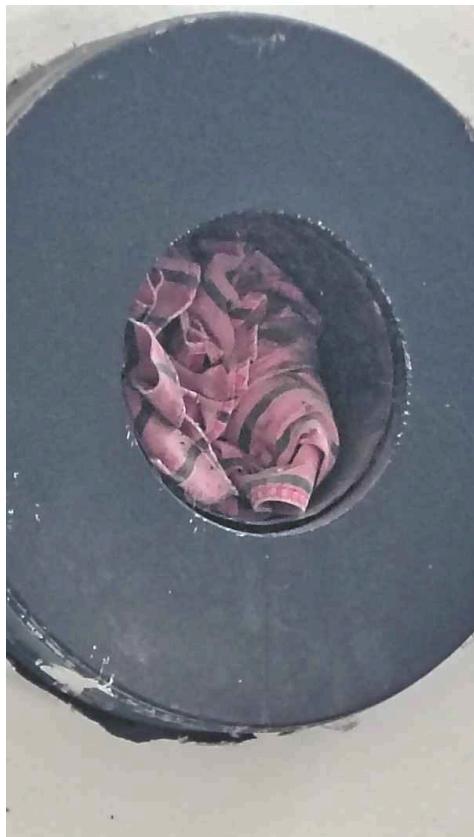
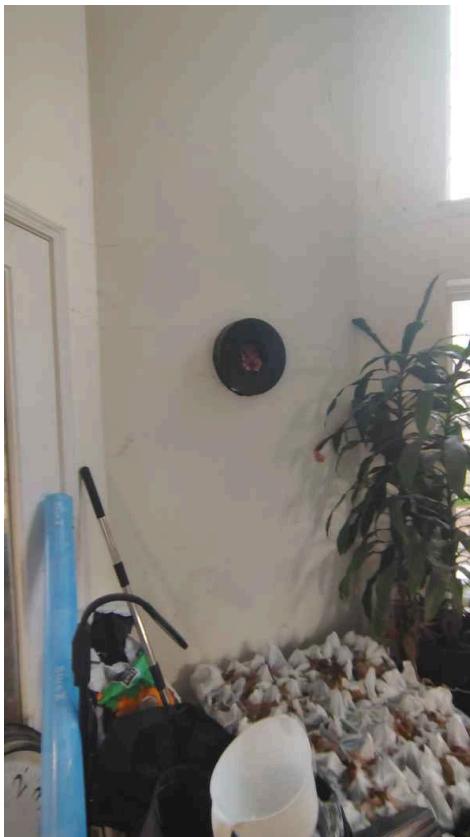
9.1.2 Vents, Flues & Chimneys

WEATHED SIDING

The chimney exterior was observed with weathered siding and visible gaps at the roof-to-chimney intersection. The flashing and termination details appear worn and may not provide adequate long-term protection against moisture intrusion. Chimneys are common sources of roof leaks when flashing or sealing is deteriorated or improperly installed. Moisture entry at this location can contribute to concealed damage to roof framing, sheathing, and interior finishes over time. It is recommended that a qualified roofing contractor or chimney professional evaluate the chimney exterior and flashing and perform repairs or sealing as needed to reduce the risk of water intrusion. The inspection was visual in nature, and no determination was made regarding concealed conditions within the chimney or roof assembly.

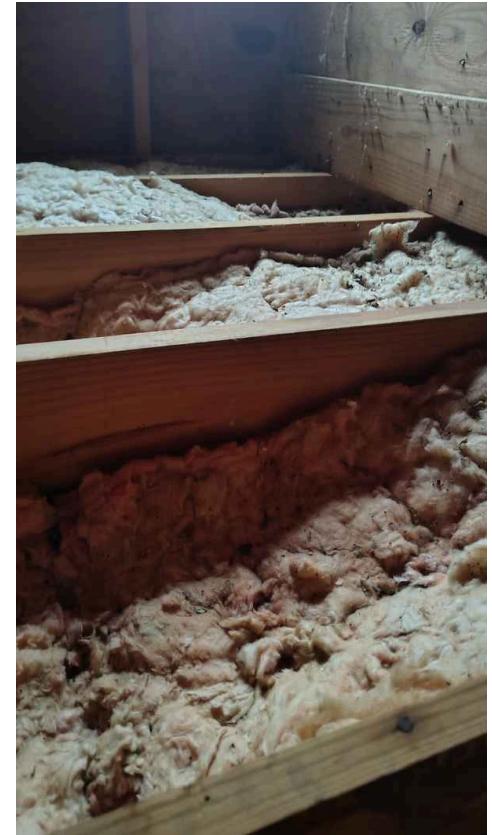
10.1.2 Attic Insulation

PORTIONS OF ATTIC WERE NOT INSULATED

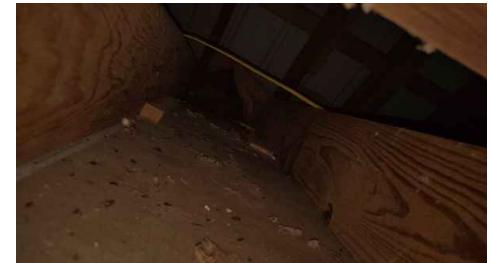
Some portions of the attic were not insulated, particularly over areas extending beyond the interior, such as those above the back patio.

Insulating all areas of the attic, including those that extend beyond the interior, is crucial for maintaining consistent temperatures throughout the home. Uninsulated areas can lead to heat loss during the winter and excessive heat gain during the summer, reducing energy efficiency and increasing utility bills. In addition, uninsulated spaces may contribute to the formation of ice dams or moisture issues in colder months.

It is recommended to insulate all areas of the attic, including those extending over non-living spaces like the back patio. This will improve energy efficiency, help regulate indoor temperatures, and prevent potential moisture-related problems.

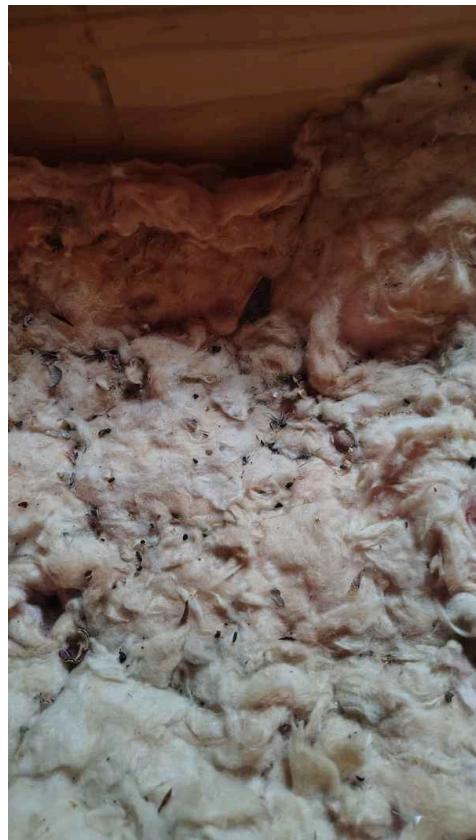
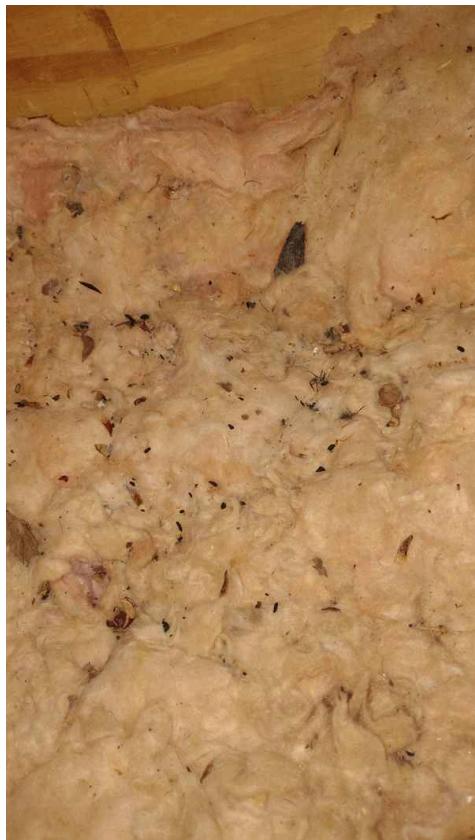
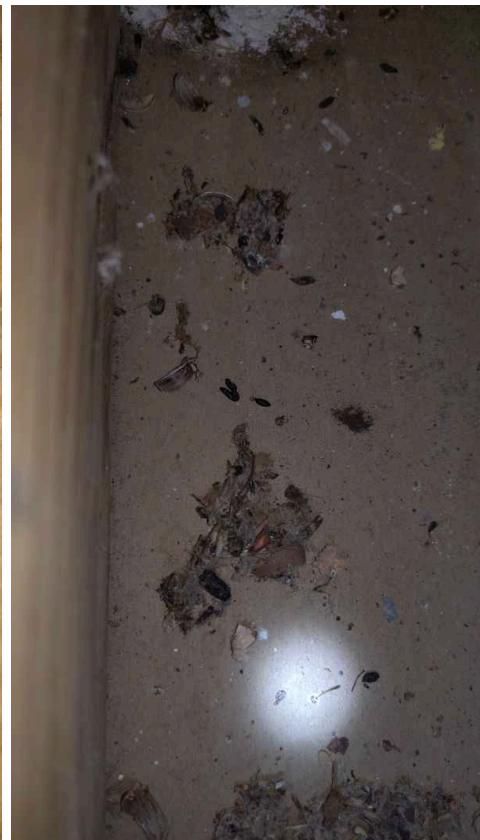
EVIDENCE OF RODENT ACTIVITY

Rodent Feces observed in attic. Recommend further evaluation by licensed pest control specialist.

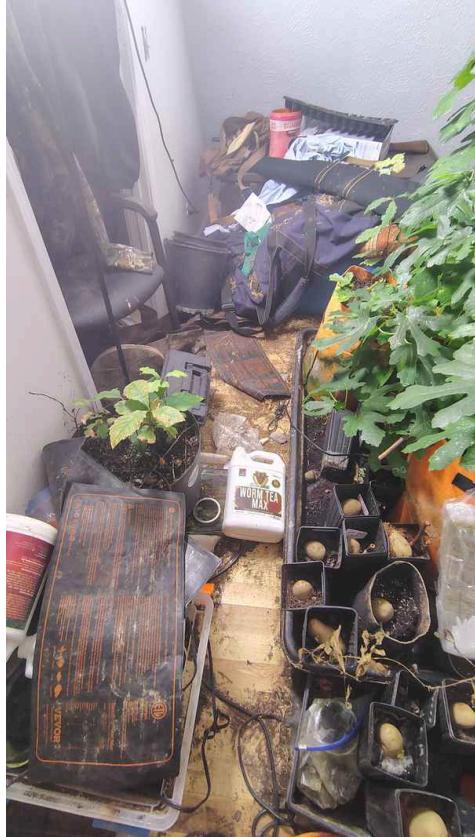
OCCUPANT BELONGINGS LIMITATION

The presence of occupant belongings limited the scope of the inspection. Furniture, a large number of pots, and stored personal items restricted access to certain areas and components of the home. As a result, some surfaces, systems, and conditions may not have been visible or fully evaluated at the time of inspection. The inspection was limited to accessible areas only, and concealed or obstructed conditions were not assessed.

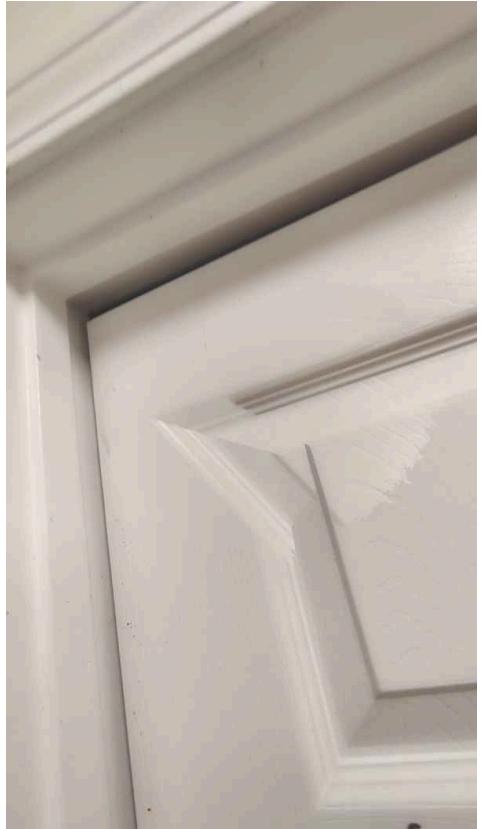
11.2.2 Doors

DOOR HARDWARE MISSING

The door was observed with missing or incomplete hardware at the time of inspection. The latch mechanism was not properly installed, and the door did not latch or secure when closed. Doors that do not latch properly may not provide adequate privacy, security, or fire separation, depending on location. Repair or replacement of the missing hardware and proper adjustment of the latch by a qualified contractor is recommended to restore normal operation. The inspection was visual in nature, and no disassembly was performed.

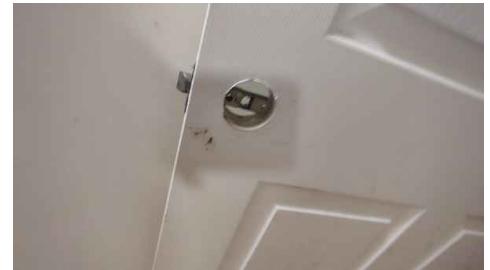
11.2.3 Doors

DOOR HARDWARE LOOSE

Door hardware is loose, recommend correction by qualified handyman.

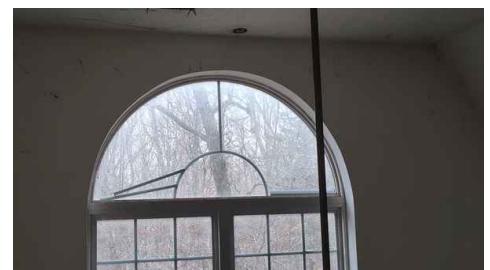
11.3.2 Windows

WINDOW LOCK MECHANISM BROKEN

The window lock mechanism (or other hardware) is broken. A broken lock compromises security and may allow drafts or water intrusion.

Recommend having window repair professional repair or replace the lock to restore proper function and security.

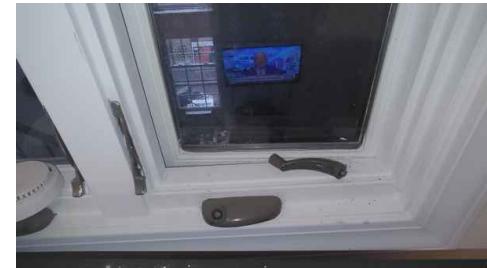
11.3.3 Windows

WINDOWS MISSING SCREENS

Screens are missing from one or more windows.

Missing window screens can allow insects and pests to enter the home while windows are open. They also reduce the ability to ventilate the home naturally, especially during warmer months. In some cases, missing screens may also indicate potential maintenance or damage issues.

Recommend replacing the missing screens to restore proper ventilation and protect the interior from insects. Ensure that the replacement screens are the correct size and type for the windows, and install them securely to avoid future issues.

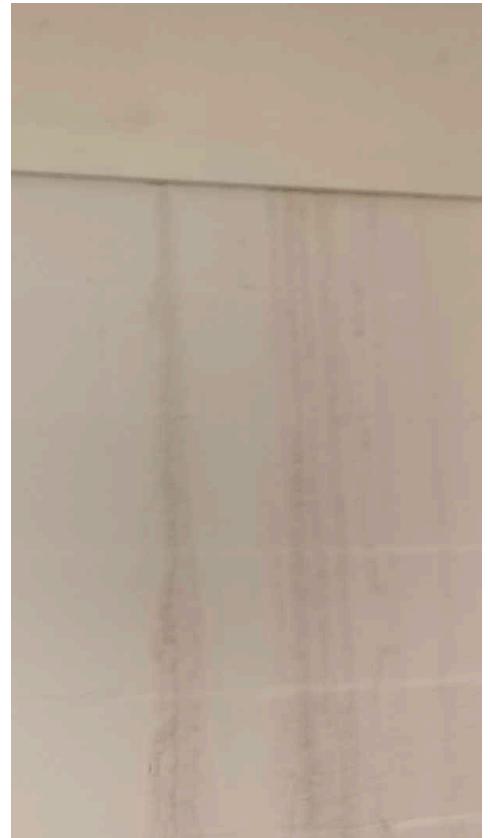
MOISTURE STAINING

Stains on the walls visible at the time of the inspection appeared to be the result of moisture intrusion. The source of moisture may have been corrected. Recommend further examination by a qualified contractor to provide confirmation.

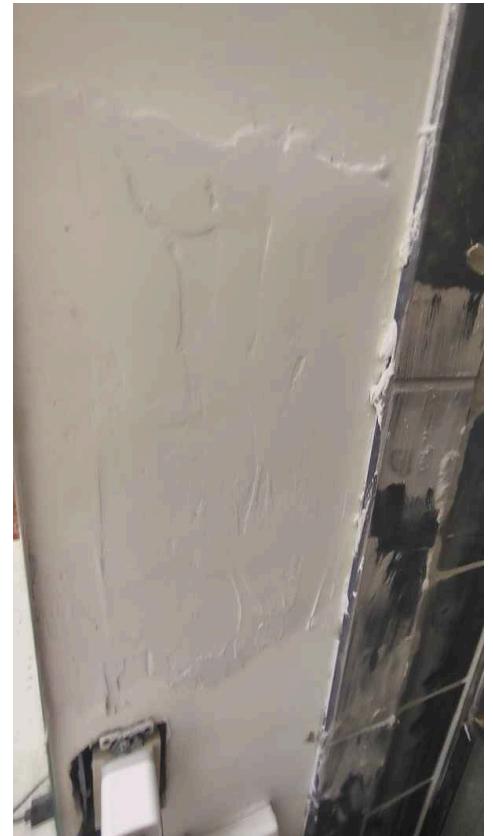
POOR PATCHING

Sub-standard drywall patching observed at time of inspection.
Recommend re-patching.

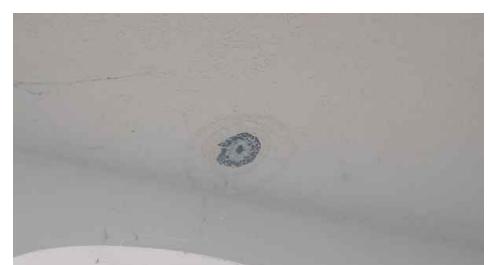
11.6.3 Ceilings

SEVERE DAMAGE

Severe ceiling damage with moisture staining observed. Recommend a qualified drywall or structural engineer evaluate and advise.

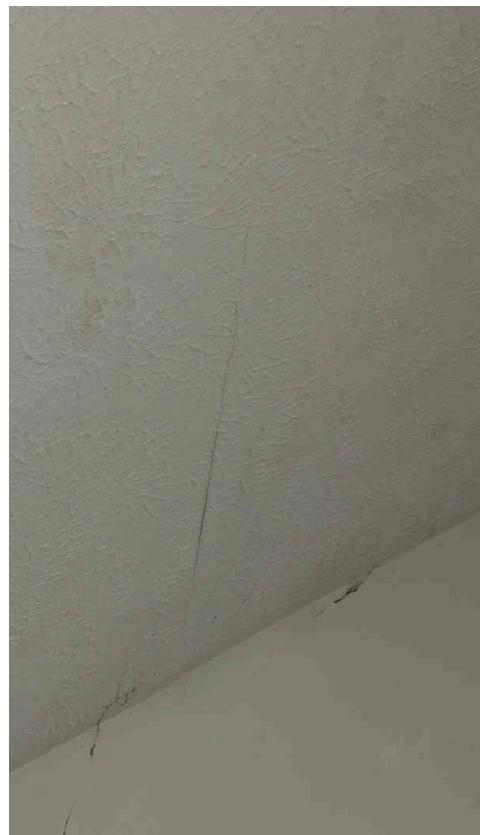
11.6.5 Ceilings

HOLES IN CEILING / DISCOLORATION

Multiple openings and areas of damage were observed in the ceiling surface. These include unsealed cutouts/openings and areas of staining or discoloration. Some openings appear to expose the ceiling cavity above. A circular stained area was also noted, consistent with prior moisture intrusion or past ceiling repair.

Assessment: The observed ceiling openings appear inconsistent with a finished interior condition and may be related to prior fixture removal, abandoned electrical boxes, or unfinished repairs. The staining pattern is suggestive of previous moisture intrusion, though no active leakage was observed at the time of inspection. The exact source, timing, and extent of any prior moisture exposure could not be determined.

Ceiling staining may indicate past roof, plumbing, or HVAC-related moisture issues and may conceal hidden damage above the ceiling surface.

Recommend repair of all ceiling openings and damaged areas by a qualified contractor. Prior to cosmetic repairs, the source of any past moisture intrusion should be identified and corrected as necessary. If staining reappears, further evaluation by a qualified professional is advised.

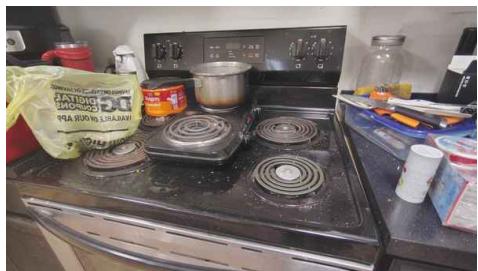
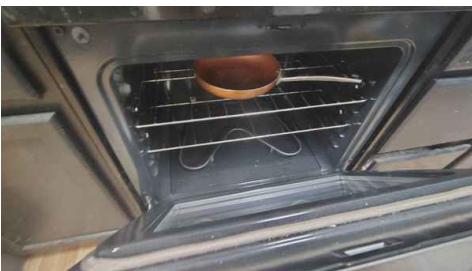
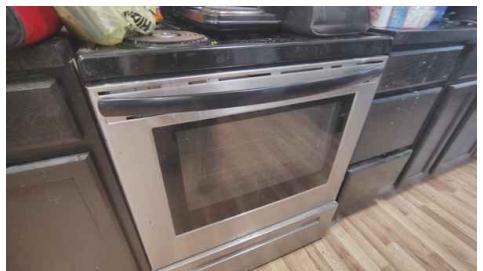
12.3.2 Range/Oven/Cooktop

**NON-FUNCTIONAL**

The oven & range did not function using normal operating controls. A hotplate appears to be used in place. Recommend evaluation by an appliance repair professional.
