UPCHURCH INSPECTION

RESIDENTIAL REPORT

1234 Main Street
Memphis, TN 38117

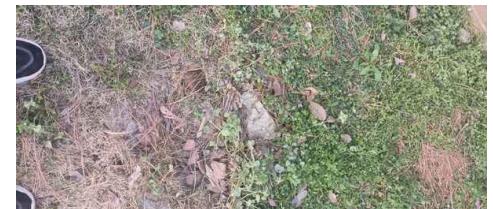
The presence of specific rock formations and soil conditions at side of house suggest the possible existence of a filled-in well.

A filled-in well may indicate a previous water source that was abandoned. If not properly decommissioned, old wells can present hazards such as ground instability, potential contamination pathways for groundwater, or unexpected subsidence over time.

Contact a qualified well service contractor.

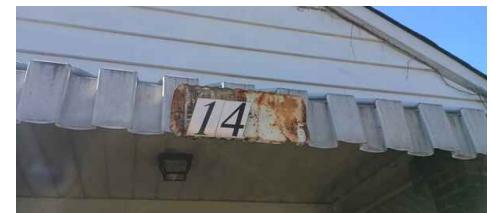
2.1.2 General

HOUSE NUMBER MISSING OR INCOMPLETE

The house number is missing, incomplete, or not clearly visible from the street.

A missing or unclear house number can make it difficult for emergency responders, delivery services, and visitors to locate the home. In an emergency, delayed response times due to unclear addressing could pose a safety risk. Many municipalities have regulations requiring clearly displayed house numbers for safety and identification purposes.

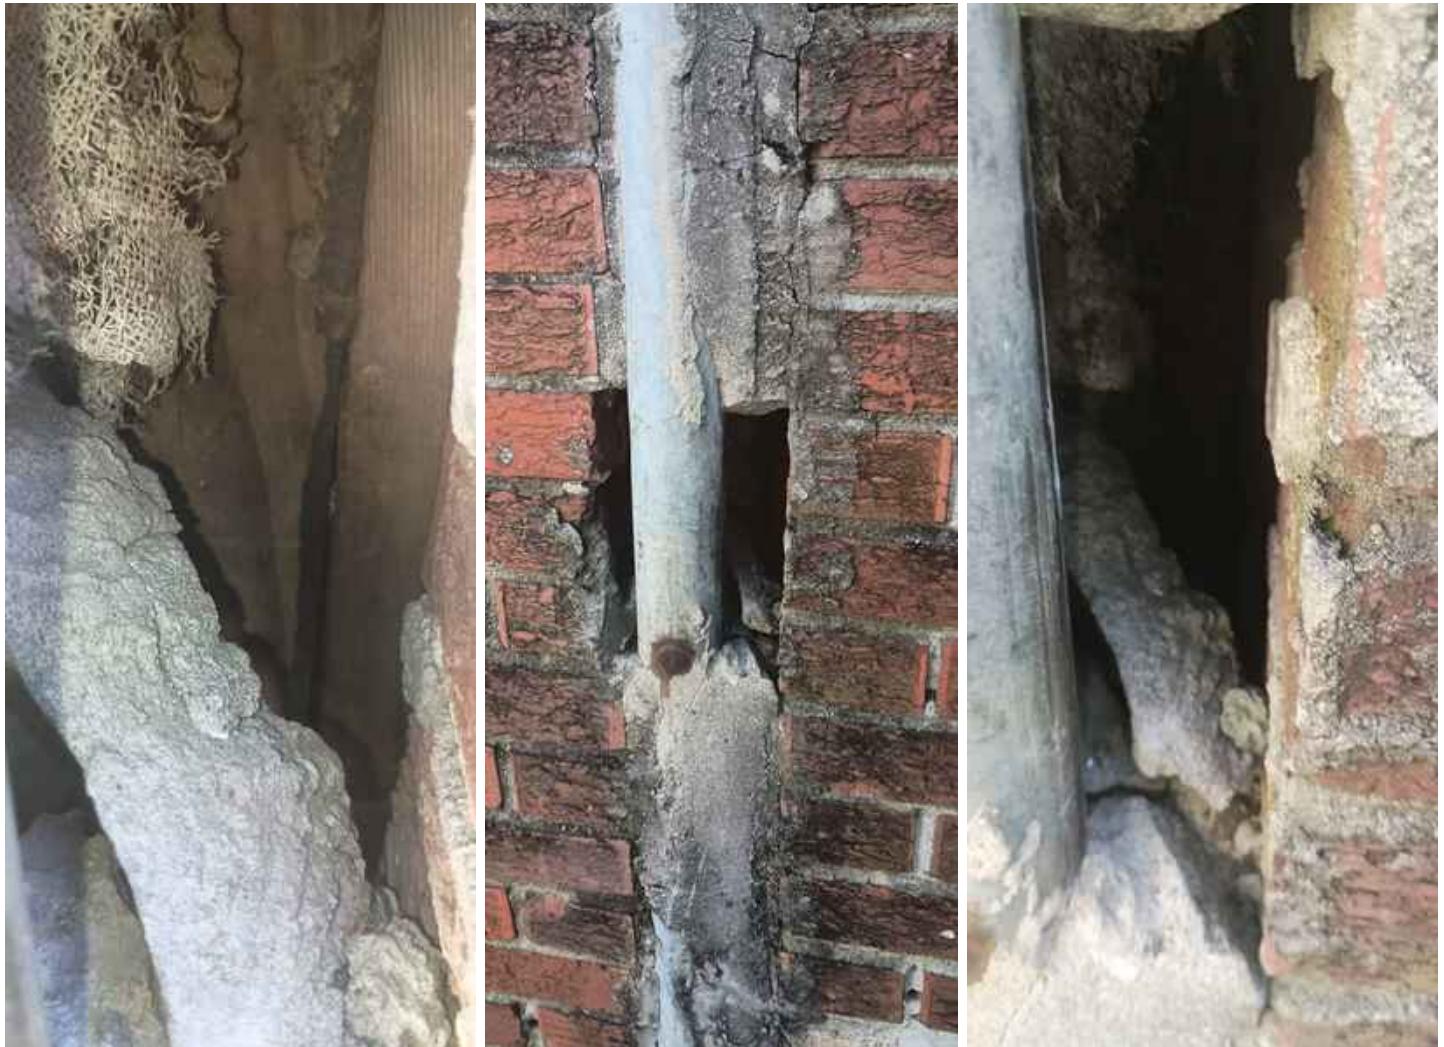
A fence post pipe has been improperly installed through the brick veneer siding at side of house. The surrounding mortar is damaged or missing, leaving gaps that could allow water intrusion or pest entry.

Implications: Gaps in the brick veneer can lead to moisture penetration, which may cause deterioration of the underlying structure, mold growth, or interior water damage. Additionally, openings can provide entry points for pests, such as insects or rodents. Over time, continued exposure to the elements may worsen the damage, leading to costly repairs.

A qualified mason or contractor should properly seal the opening with mortar or an appropriate weather-resistant sealant to prevent further deterioration and water intrusion. If necessary, the fence post pipe installation should be reevaluated to ensure it does not compromise the integrity of the brick veneer.

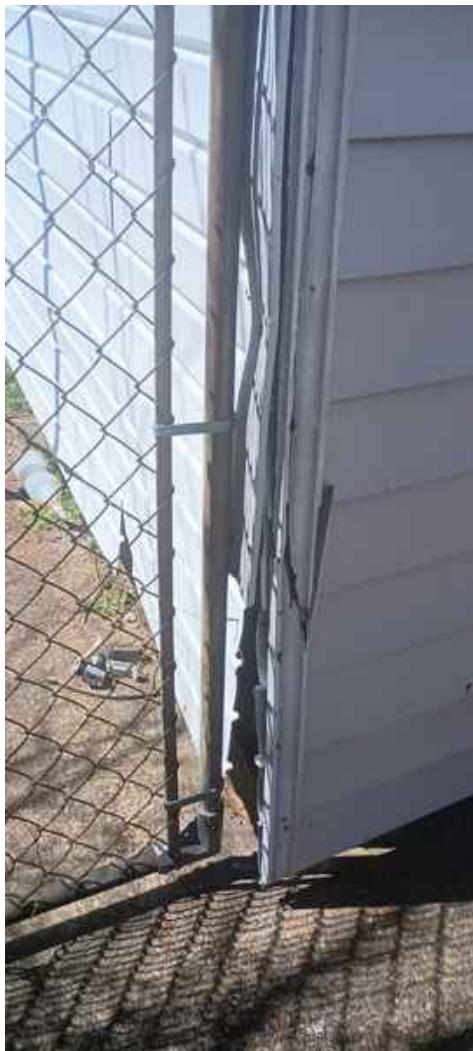
2.2.2 Siding, Flashing & Trim

DAMAGE TO SIDING / CORNER OF HOUSE

Siding at corner damaged by fence gate. Recommend repair.

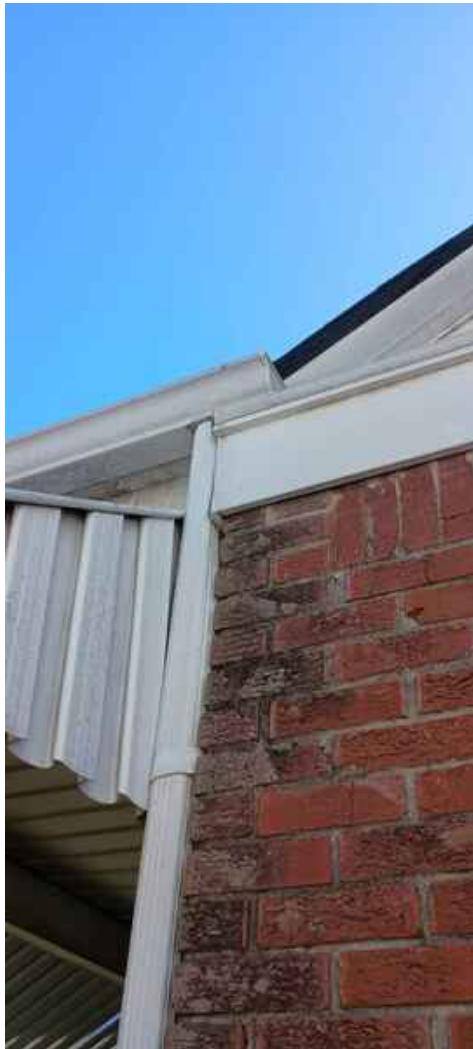
2.2.3 Siding, Flashing & Trim

DISCOLORATION OF BRICK (DARKER)

Dark discoloration on brick can result from moisture retention, algae or mildew growth, efflorescence, or environmental staining. If caused by excess moisture, this could indicate poor drainage, leaking gutters, or water intrusion issues that may lead to long-term damage, such as mortar deterioration or interior moisture problems.

A qualified professional should evaluate the cause of the discoloration. Cleaning with a mild detergent, brick cleaner, or pressure washing (at a low setting) may help restore the brick's appearance. If moisture is contributing to the issue, address any underlying water management problems, such as improving drainage, repairing leaks, or resealing the brick if necessary.

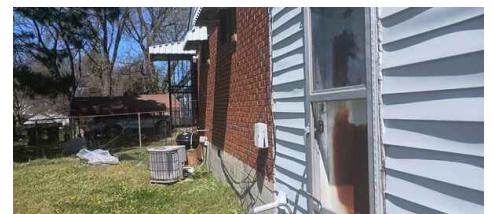
2.5.1 Eaves, Soffits & Fascia

FASCIA - DAMAGED

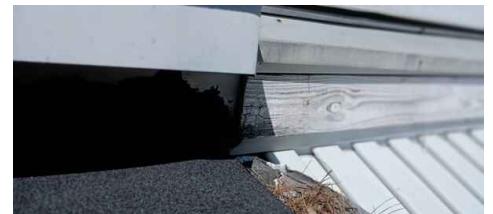
One or more sections of the fascia are damaged. Recommend qualified roofer evaluate & repair.

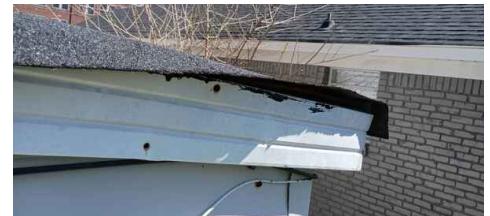
2.5.2 Eaves, Soffits & Fascia

FASCIA - LOOSE

One or more sections of the fascia are loose. Recommend qualified roofer evaluate & repair.

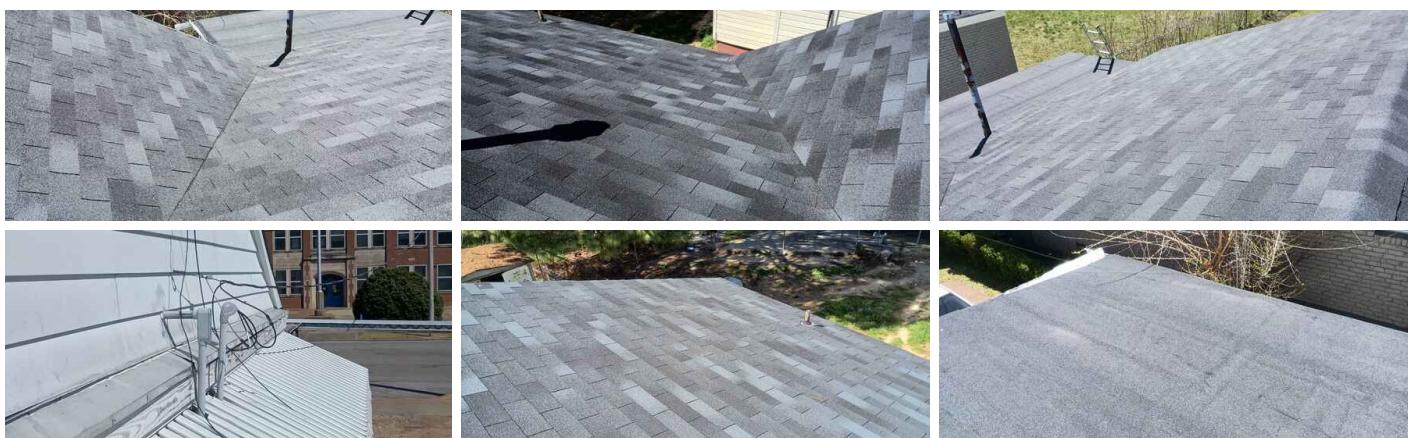
Coverings: Overview

Newer shingles over main portion of house; addition has asphalt roll roofing. Most of the new roof appears to be correctly installed with exceptions noted, related to attachment. Gutters have significant issues and need to be replaced.

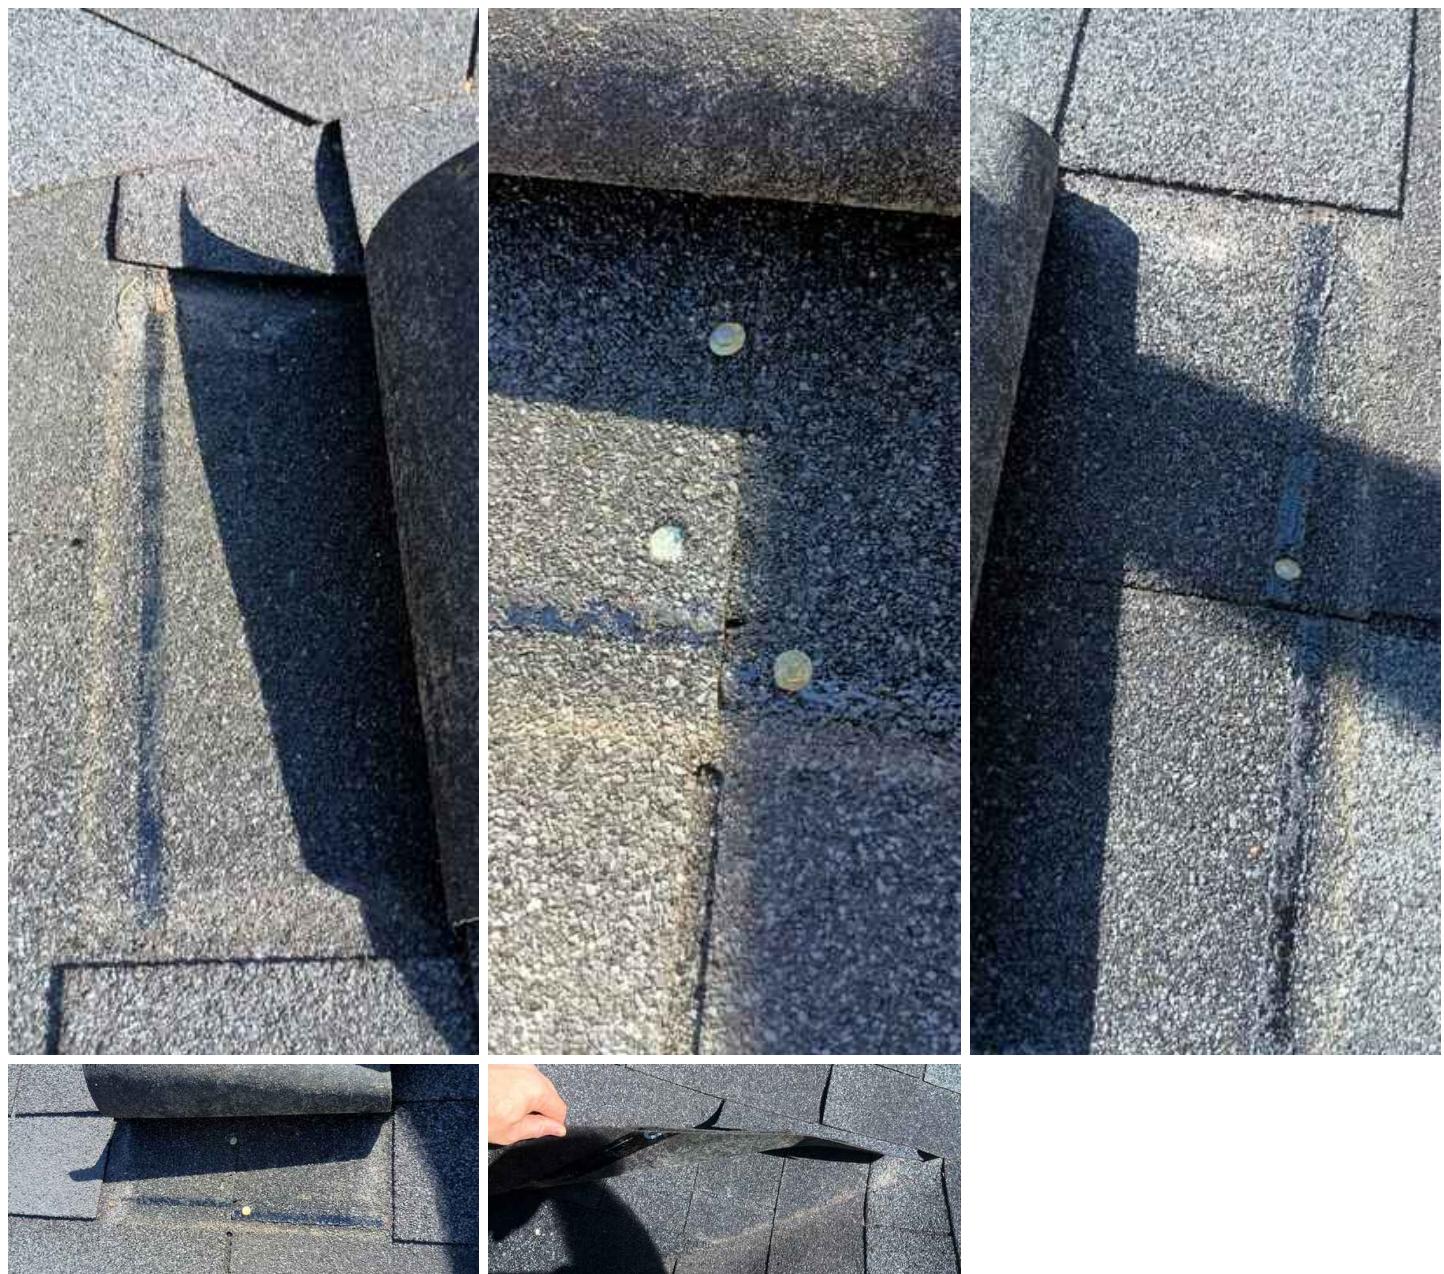
IMPROPER/INCOMPLETE NAILING

NEAR ROOF VALLEY OPPOSITE DRIVEWAY

Roof coverings showed signs of improper installation and fastening. Recommend a qualified roofing contractor evaluate and repair.

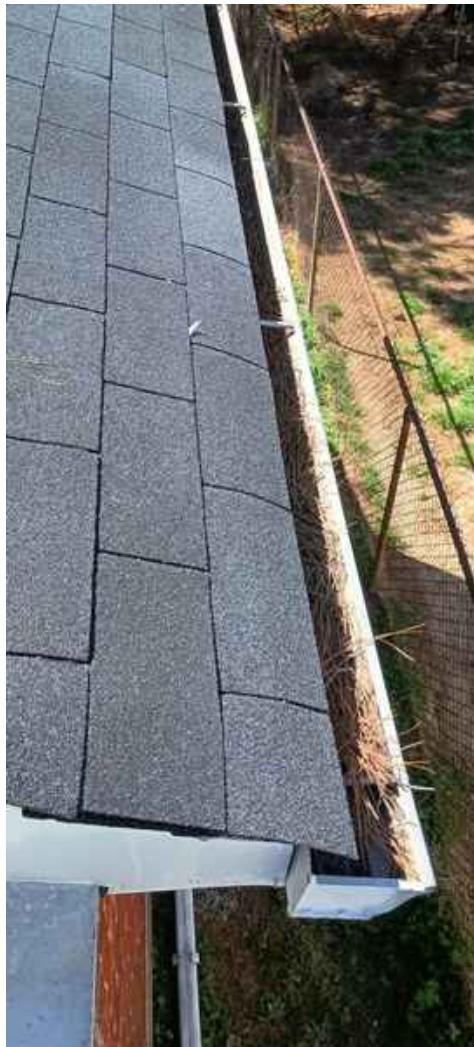
3.2.1 Roof Drainage Systems

Debris has accumulated in the gutters. Recommend cleaning to facilitate water flow.

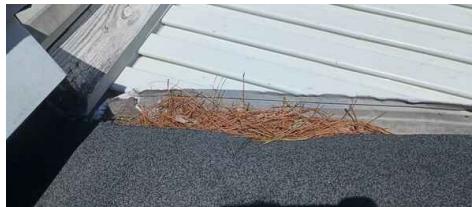
3.2.2 Roof Drainage Systems

DOWNSPOUTS DRAIN NEAR HOUSE

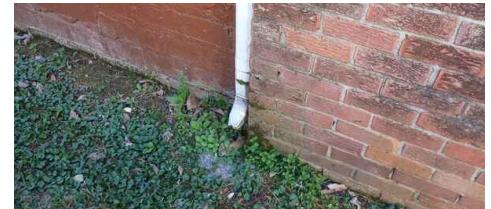
3.2.3 Roof Drainage Systems

DOWNSPOUTS MISSING

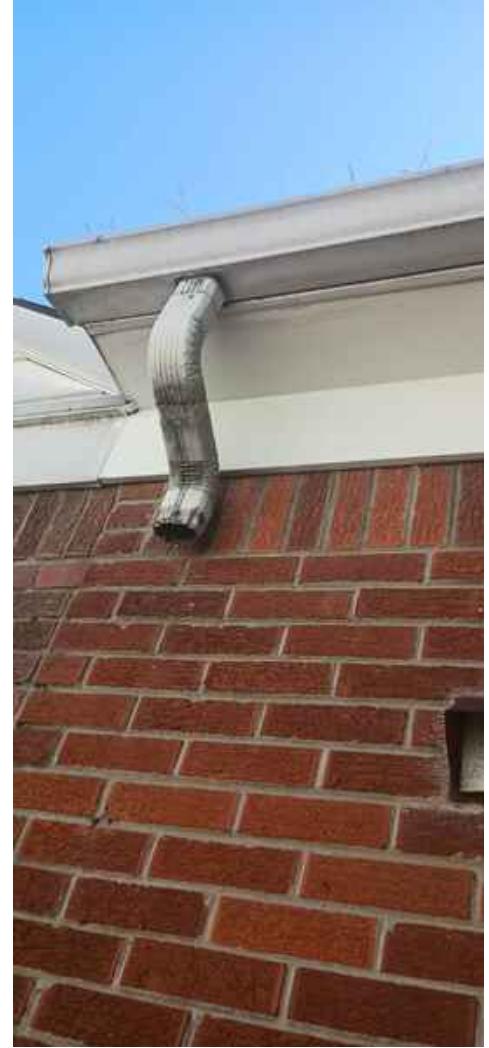
Home was missing downspouts in one or more areas. This can result in excessive moisture in the soil at the foundation, which can lead to foundation/structural movement. Recommend a qualified contractor install downspout extensions that drain at least 6 feet from the foundation.

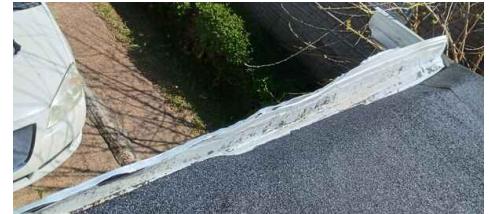
3.2.5 Roof Drainage Systems

GUTTER LOOSE

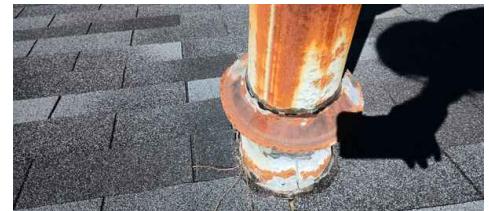
3.3.2 Flashings

MISSING

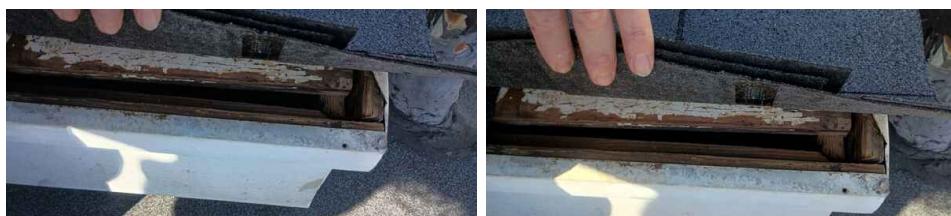
DRIP EDGE MISSING / IMPROPERLY INSTALLED

The drip edge is either missing or improperly installed, leaving a gap along the roofline inspected areas.

A missing or improperly installed drip edge can allow water to infiltrate behind the fascia and under the roofing materials, potentially leading to moisture damage, wood rot, and deterioration of the roof decking or eaves. Over time, this can compromise the structural integrity of the roof and lead to costly repairs.

A qualified roofing contractor should install or correct the drip edge to ensure proper water runoff and protection of the roof structure. This should be done in accordance with local building codes and manufacturer recommendations to prevent future water damage.

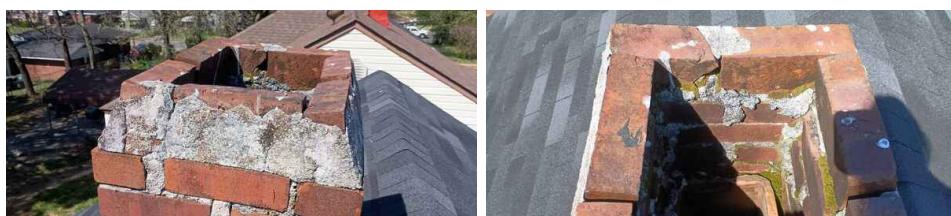
3.4.1 Skylights, Chimneys & Other Roof Penetrations

CHIMNEY CAP MISSING

No chimney cap was observed. This is important to protect from moisture intrusion and protect the chimney. Recommend a qualified roofer or chimney expert install.

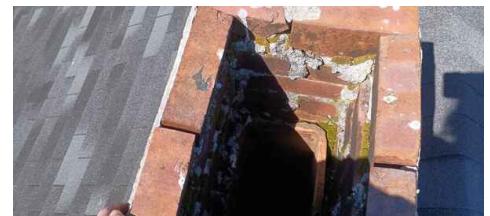
3.4.2 Skylights, Chimneys & Other Roof Penetrations

CHIMNEY UNLINED

A portion of the chimney was unlined, which can deteriorate the chimney structure and allow harmful gasses to enter home. Recommend a qualified masonry or chimney contractor evaluate and remedy.

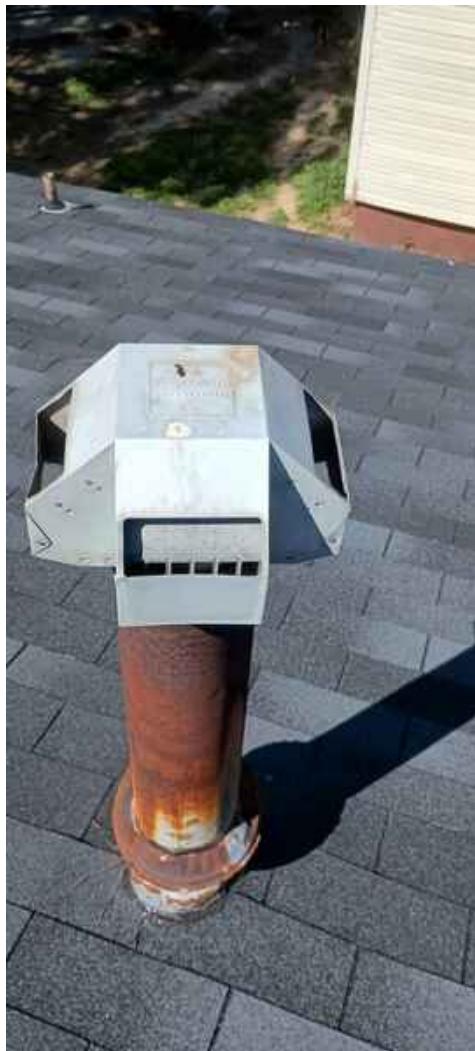
3.4.5 Skylights, Chimneys & Other Roof Penetrations

VENTS SHOW RUST

The roof vent piping at [location] shows visible rust and corrosion.

Rust on vent piping can weaken the metal over time, potentially leading to deterioration, leaks, or failure of the vent system. This could allow water intrusion into the home or compromise proper ventilation of plumbing gases. If left unaddressed, advanced corrosion may require full pipe replacement.

A qualified roofing or plumbing professional should assess the extent of the rust and determine if cleaning, sealing, or replacement is necessary. Applying a rust-inhibiting primer and weatherproof sealant may help extend the life of the vent piping.

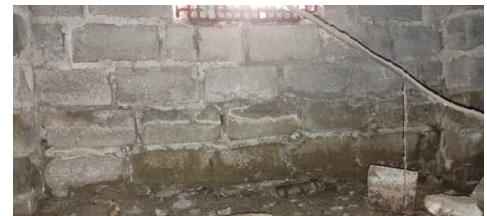
4.3.2 Basements & Crawlspaces

VENT COVERED

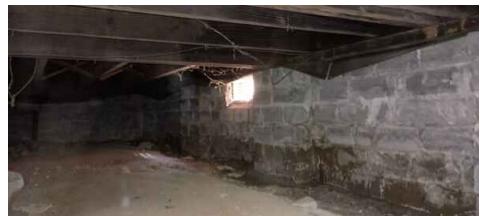
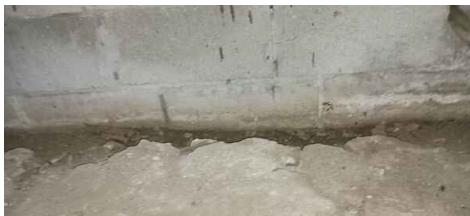
Wall structure showed signs of water intrusion, which could lead to more serious structural damage. Recommend a qualified contractor identify source or moisture and remedy.

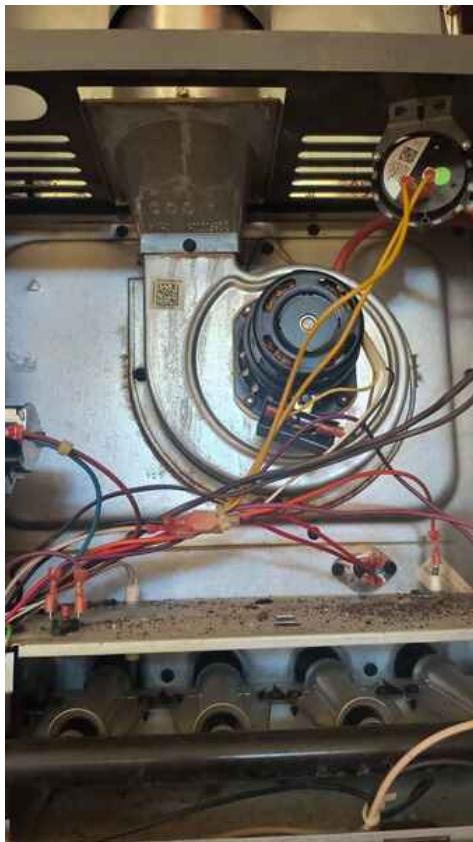
Furnace should be cleaned and serviced annually. Recommend a qualified HVAC contractor clean, service and certify furnace.

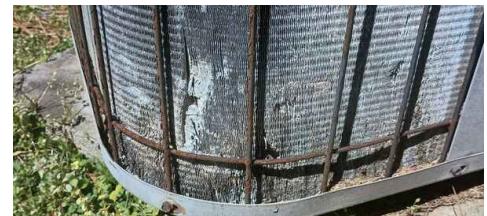
6.1.2 Cooling Equipment

INSULATION MISSING OR DAMAGED

Missing or damaged insulation on refrigerant line can cause energy loss and condensation.

Contact a qualified HVAC professional.

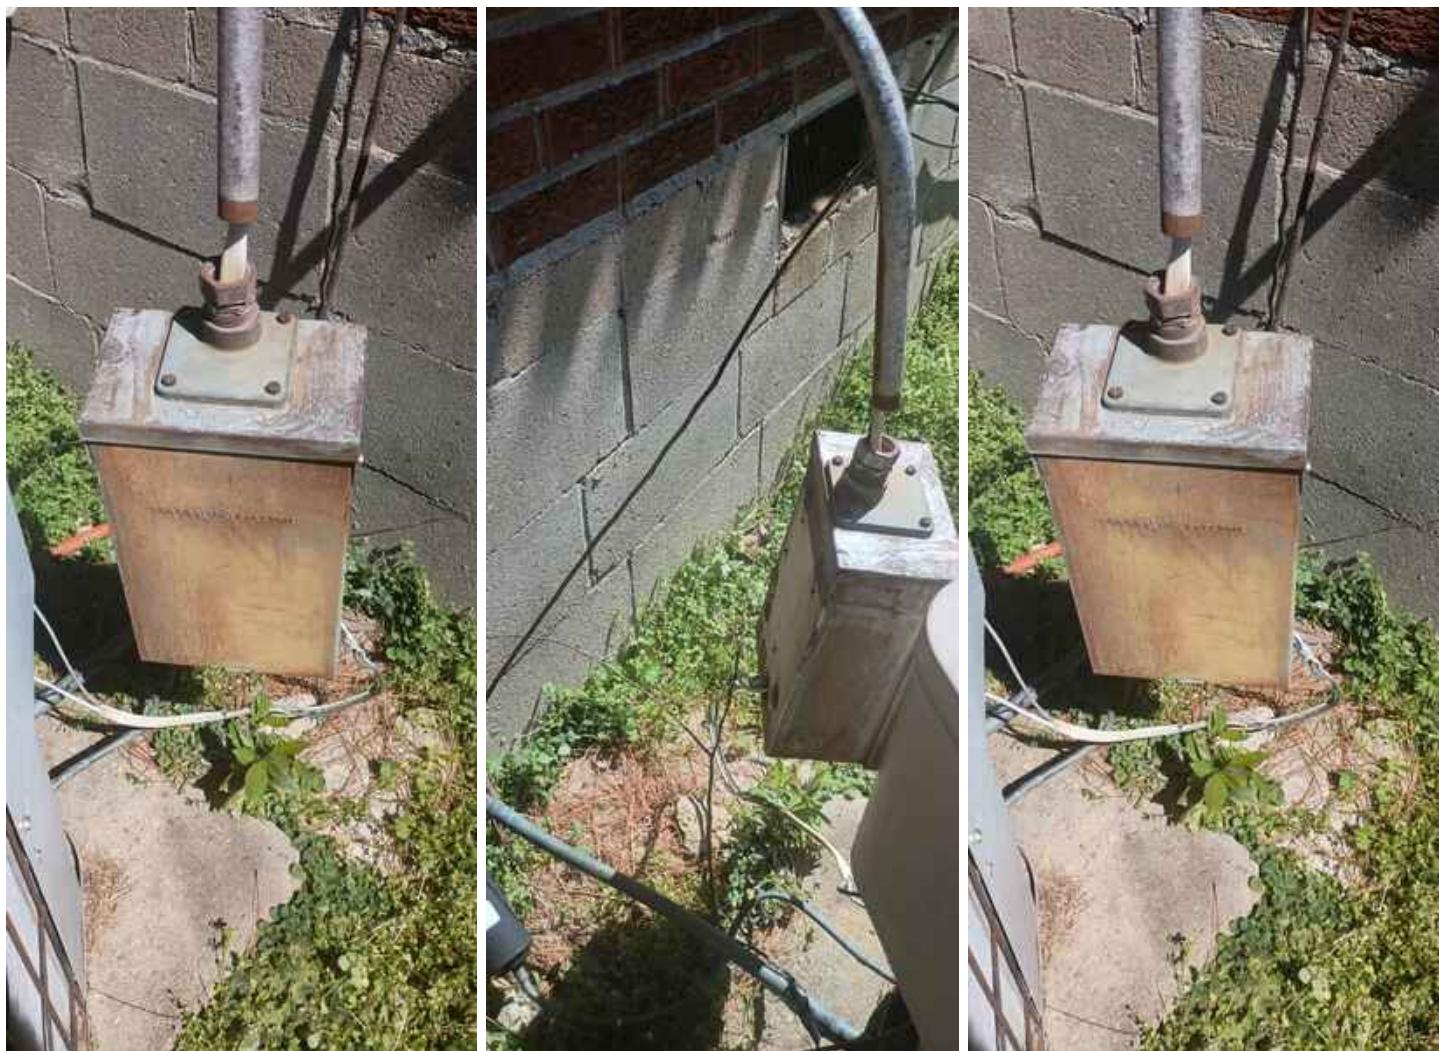
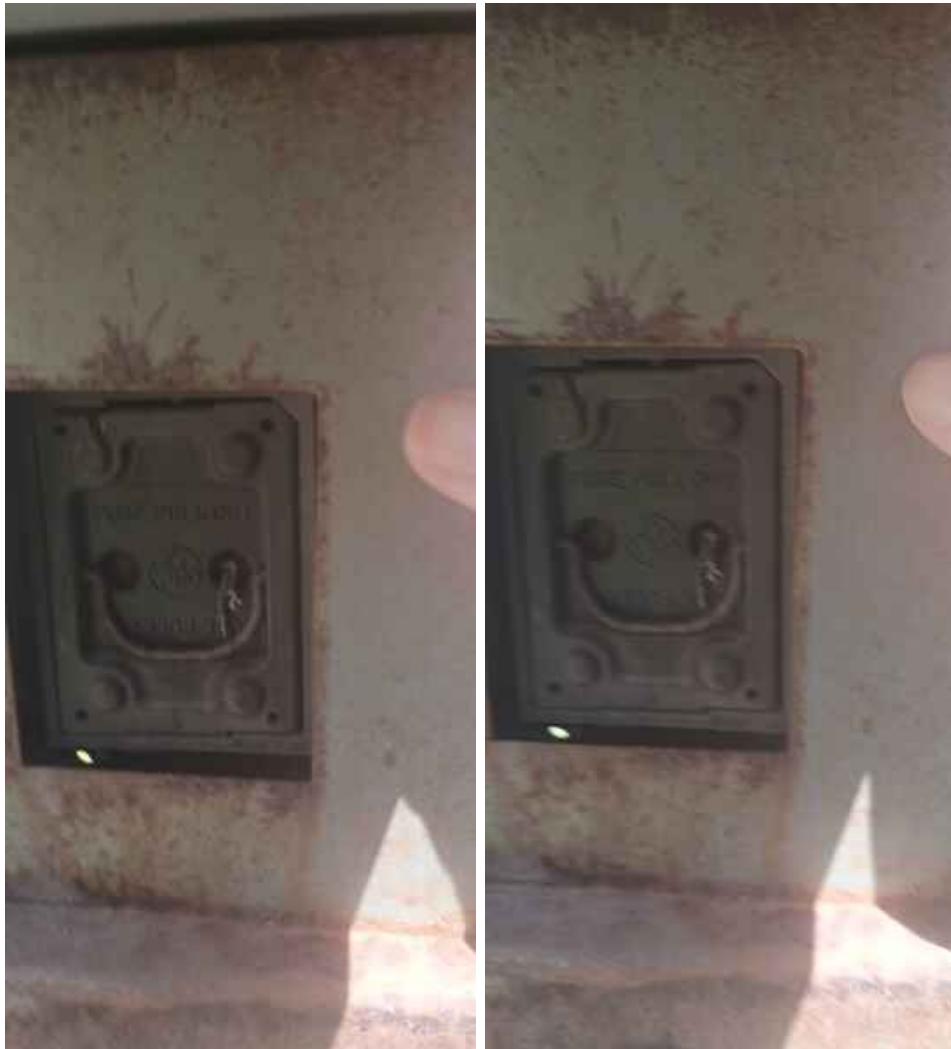
A loose or improperly secured fuse box can strain electrical connections, leading to potential damage, exposed wiring, or electrical hazards. This condition also increases the risk of weather-related deterioration, physical damage, or accidental disconnection, which could impact the operation of the air conditioning system.

A qualified electrician should properly secure the fuse box to the building or install a dedicated mounting post to ensure stability and compliance with electrical safety codes. All connections should be inspected to verify they are intact and free from damage.

Contact a qualified professional.

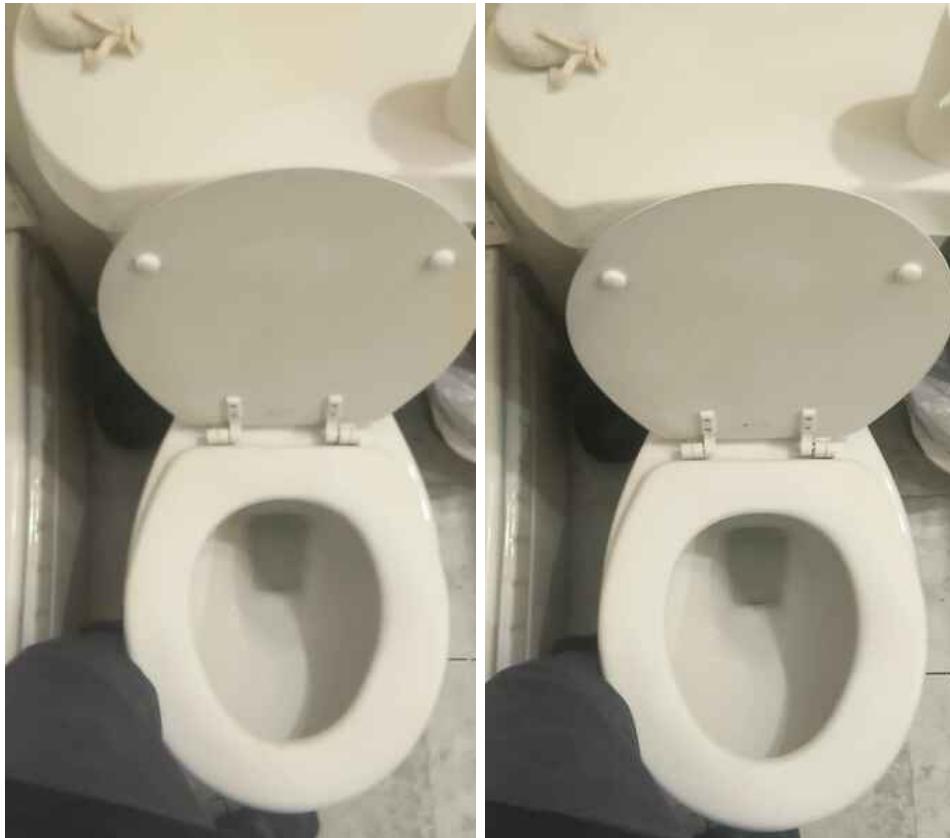
7.3.1 Water Supply, Distribution Systems & Fixtures

TOILET HAD LOOSE CONNECTION

The toilet has a loose connection, causing instability when used. A loose toilet can lead to leaks at the base, potential water damage to flooring and subflooring, and compromised sealing of the wax ring, which may allow sewer gases to escape. If not addressed, prolonged movement may worsen the issue and lead to costly repairs.

A qualified plumber should inspect the toilet, tighten or replace the mounting bolts as needed, and assess the wax ring for potential replacement. If there are signs of water damage, further evaluation of the subfloor may be necessary.

Contact a qualified plumbing contractor.

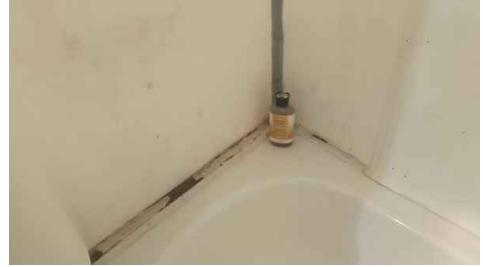
7.3.2 Water Supply, Distribution Systems & Fixtures

BATHTUB NEEDS RECAULKED

The caulking around the tub at is deteriorated, cracked, or missing in some areas. Gaps or failing caulk can allow water to seep behind walls and under flooring, leading to moisture damage, mold growth, and potential structural issues over time.

Recommend removing the old caulk and apply a new, high-quality, mold-resistant bathroom caulk to ensure a proper seal. This will help prevent water intrusion and maintain the integrity of surrounding surfaces. A qualified contractor or homeowner with appropriate experience can complete this repair.

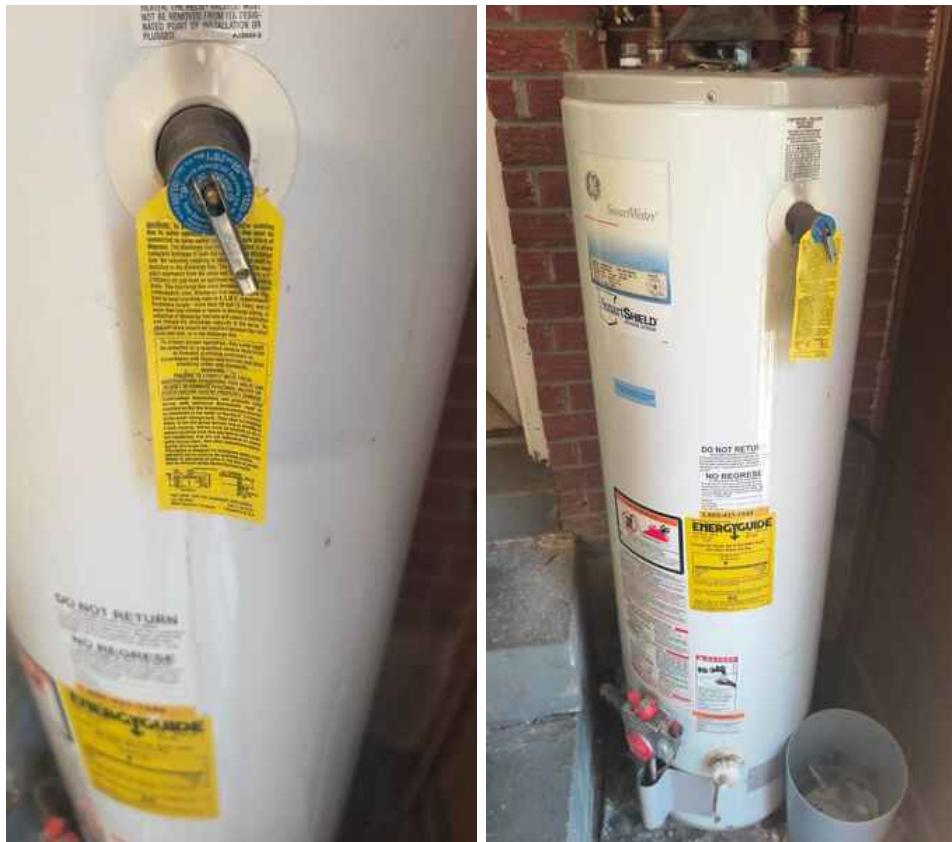
7.4.4 Hot Water Systems, Controls, Flues & Vents

The TPR valve is a critical safety feature designed to release excess pressure and prevent potential water heater explosions. Without an extension pipe, scalding hot water or steam could be discharged in an unsafe manner, posing a burn hazard and potential water damage to surrounding areas.

Contact a qualified plumbing contractor.

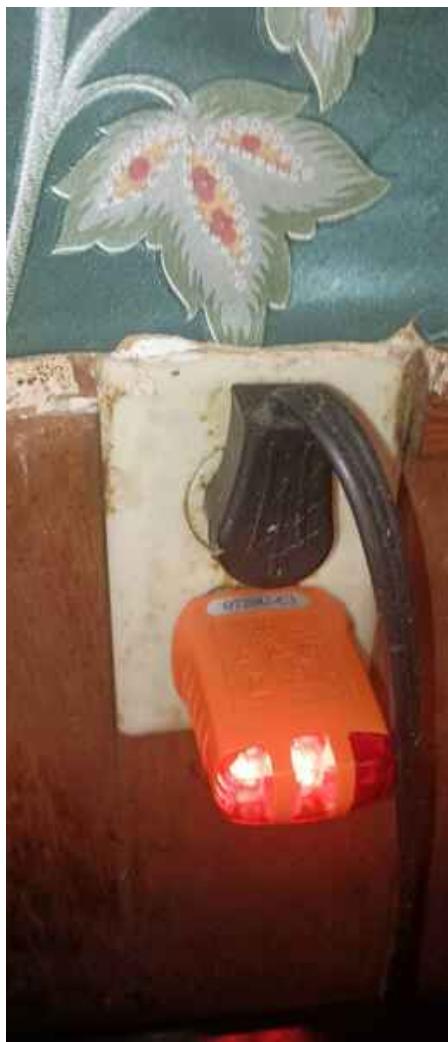
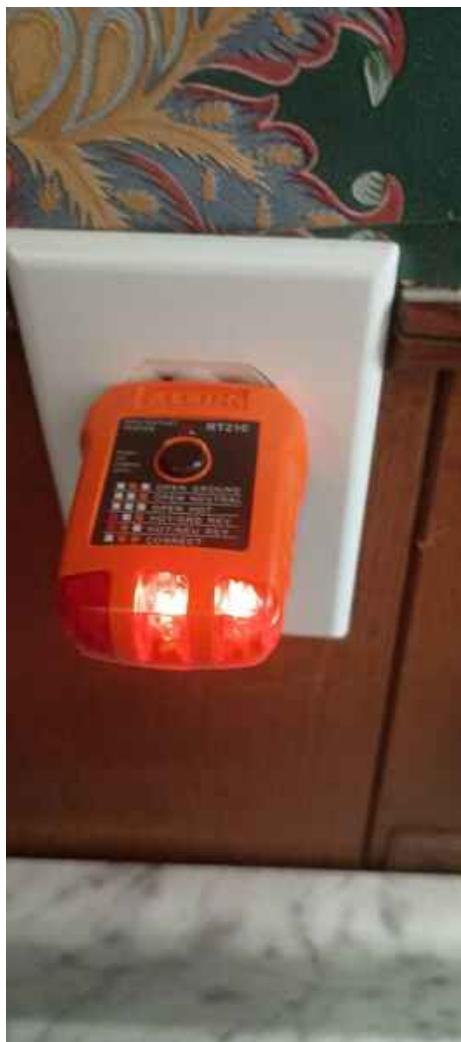
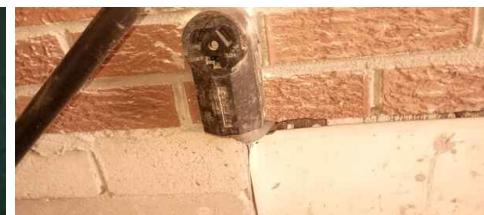
Checked lighting fixtures, switches, and receptacles for proper wiring, functionality, and grounding.

Kitchen receptacles were grounded, however, receptacles in much of the rest of the house were not grounded.

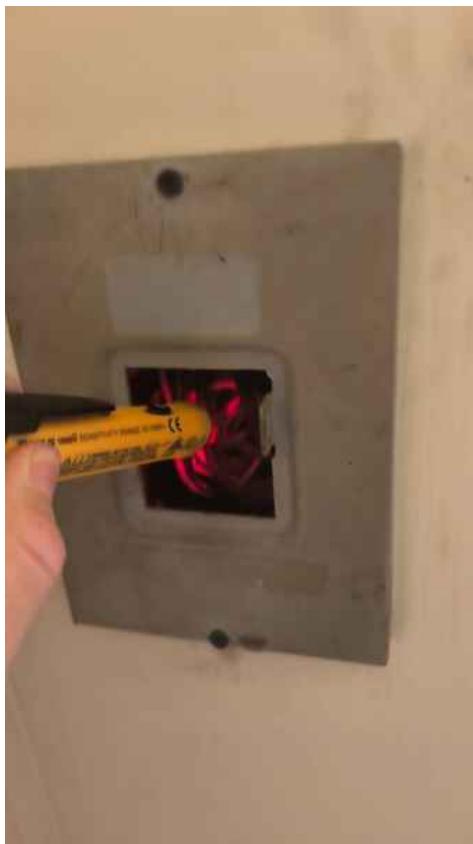
Cover needed at electrical junction box / former panel. The lack of a cover could pose an electrocution hazard to children or other individuals who reach inside. Note that live components are inside.

Contact a qualified electrical contractor.

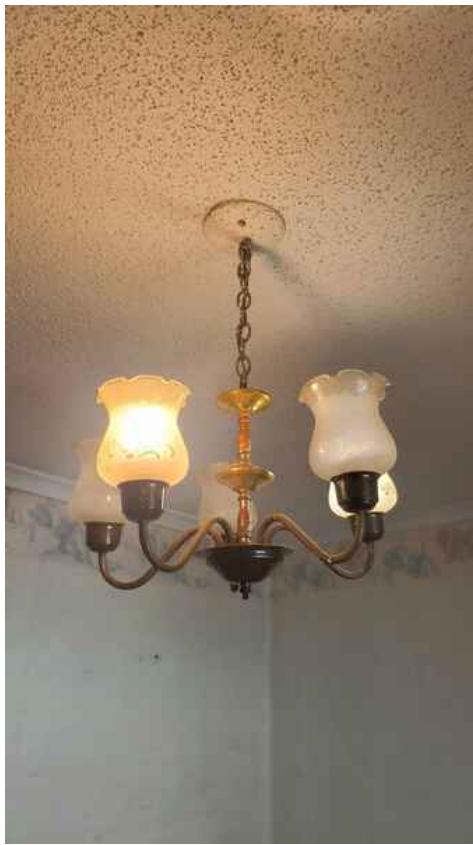
8.4.2 Lighting Fixtures, Switches & Receptacles

MISSING GLOBES ON SOME LIGHTS

Missing globes on some light fixtures. Exposed bulbs can create glare, be more susceptible to damage, and pose a potential safety hazard, especially if the fixture is within reach.

Recommend replacing missing globes to protect bulbs, improve lighting aesthetics, and reduce the risk of breakage or accidental contact.

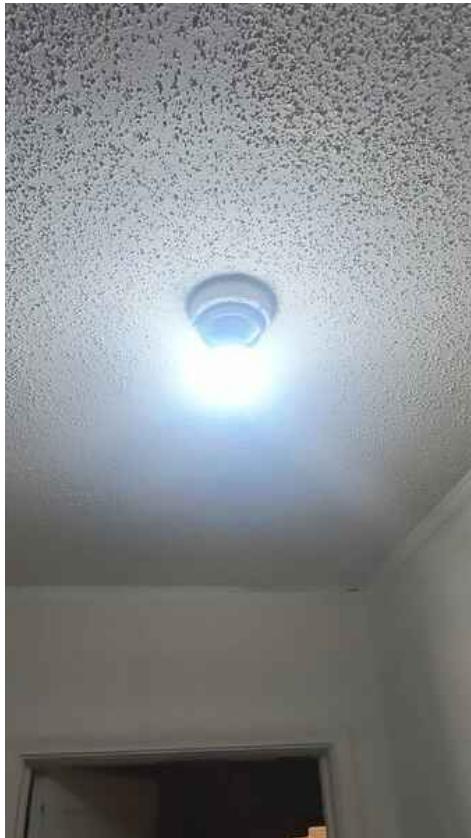
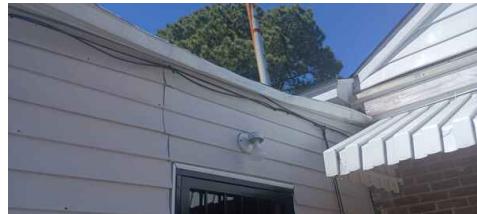
8.4.3 Lighting Fixtures, Switches & Receptacles

UNGROUNDED RECEPTACLE

To eliminate safety hazards, all receptacles in kitchen, bathrooms, garage & exterior should be grounded.

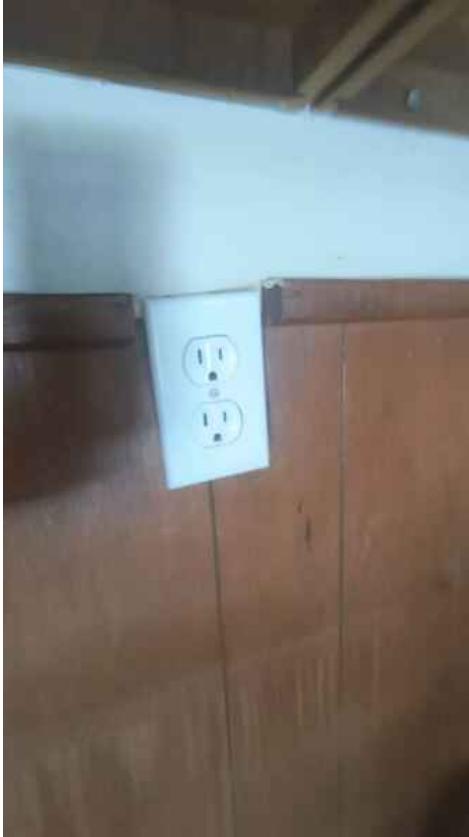
8.5.1 GFCI & AFCI

NO GFCI PROTECTION INSTALLED

No GFCI protection present in all locations. Recommend licensed electrician upgrade by installing ground fault receptacles in all locations.

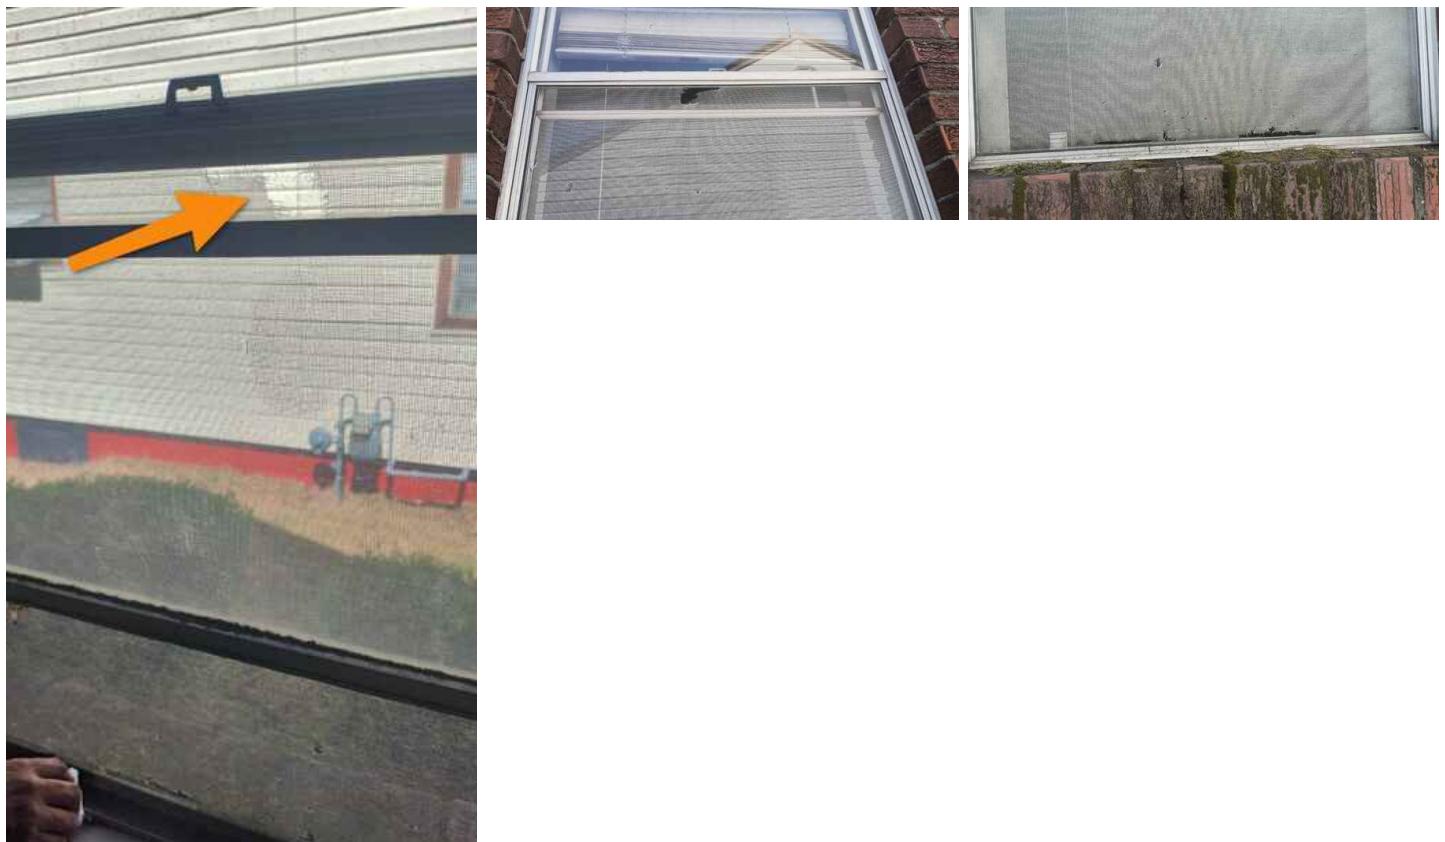
11.3.1 Windows

DAMAGED SCREEN

Damaged screen. Recommend replacement.

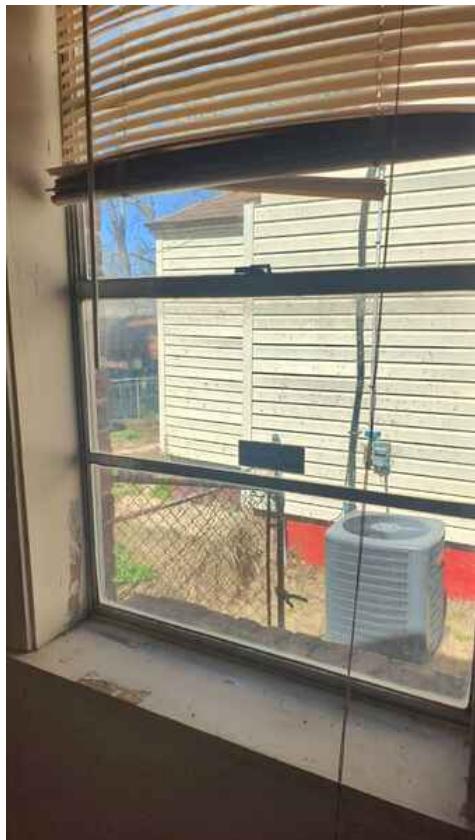
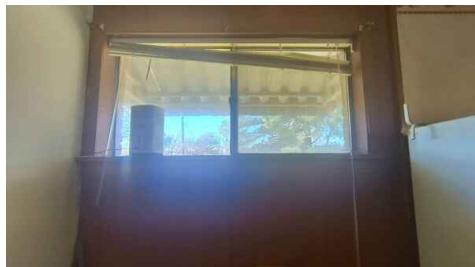
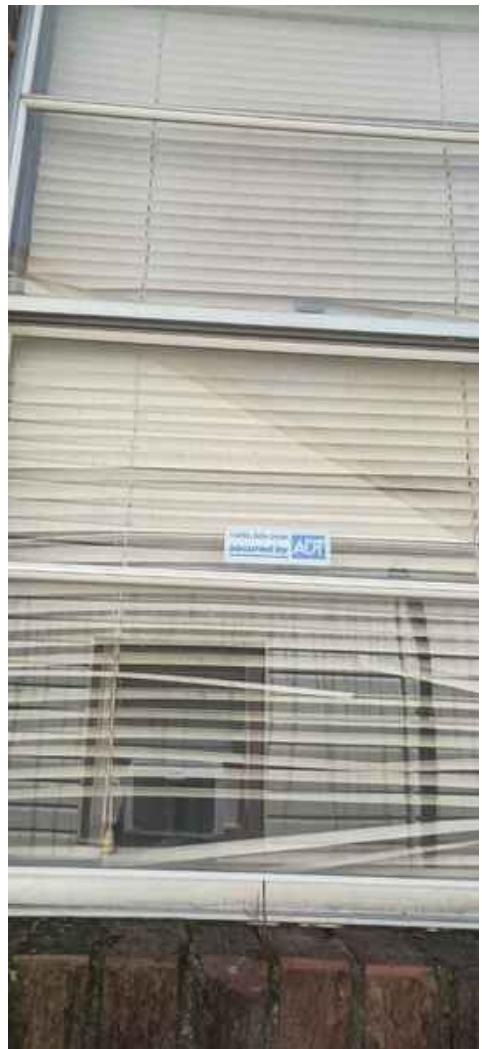
11.3.3 Windows

WINDOW LOCK MECHANISM BROKEN

The window lock mechanism is broken. A broken lock compromises security and may allow drafts or water intrusion.

Recoommend having window repair professional repair or replace the lock to restore proper function and security.

Contact a qualified window repair/installation contractor.

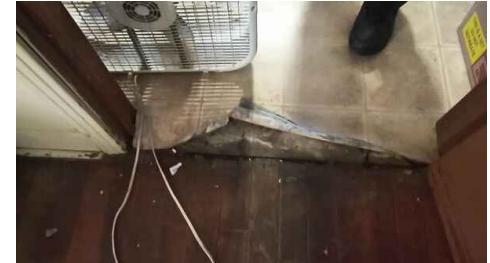
11.4.1 Floors

DAMAGED (GENERAL)

The home had general moderate damage visible at the time of the inspection. Recommend service by a qualified contractor.

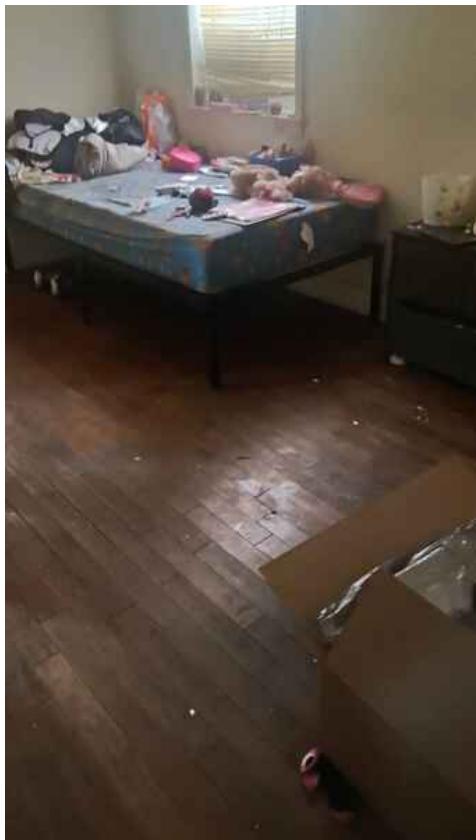
11.4.2 Floors

MODERATE WEAR

Floors in the home exhibited moderate surface wear along major paths of travel. Recommend a qualified flooring contractor evaluate for possible re-finish.

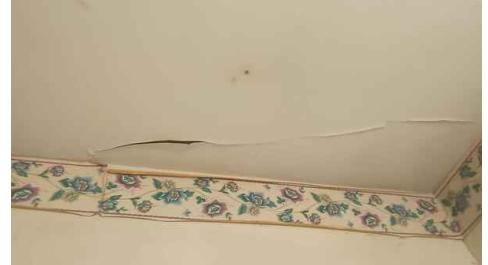
CRACK ON CEILING (BATHROOM)

A visible crack is present on the ceiling above the tub at [location].

Ceiling cracks in this area may result from moisture exposure, settling of the home, or structural movement. If the crack is accompanied by staining, it could indicate an active moisture issue or a previous leak. Left unaddressed, the damage may worsen over time, potentially leading to peeling paint, plaster deterioration, or further structural concerns.

Monitor the crack for any changes in size or new signs of water damage. If moisture intrusion is suspected, further evaluation by a qualified contractor is recommended. Repair options may include sealing the crack with joint compound, repainting, or addressing any underlying issues if present.

Recommendation

Contact a qualified professional.

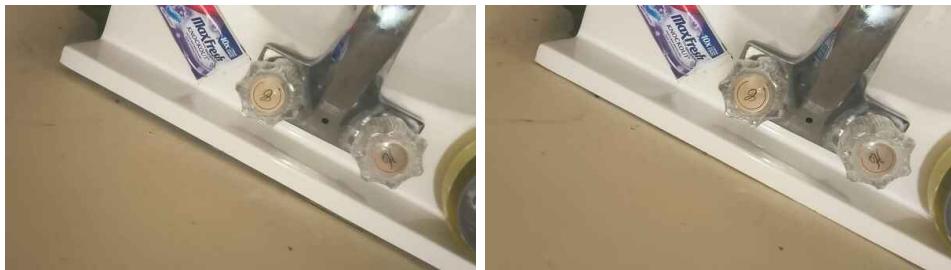
11.8.1 Countertops & Cabinets

VANITY LOOSE

Vanity was improperly installed and not secured. Recommend qualified contractor secure vanity properly.

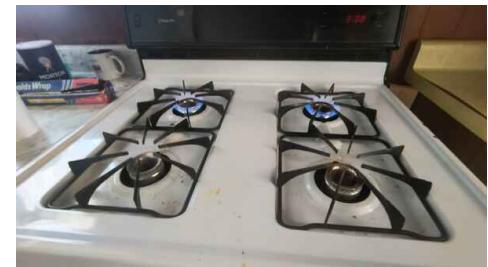
BURNER NOT LIGHTING

One or more heating elements did not heat up when turned on.
Recommend qualified professional evaluate & repair.

[Here is a DIY resource](#) on possible solutions.
