UPCHURCH INSPECTION

INTERNACHI COMMERCIAL

1234 Main Street
Memphis, TN 38117

03/17/2026 9:00AM

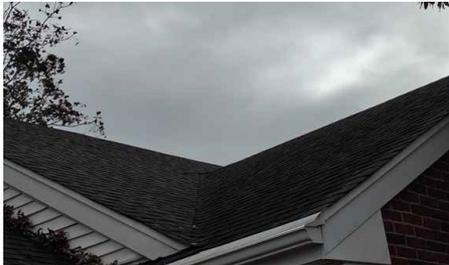
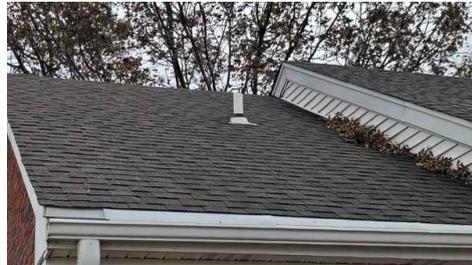
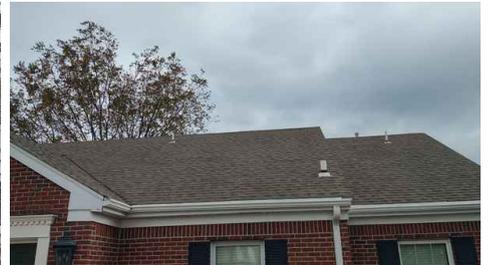
General Roof Photos

The roof covering shows widespread deterioration and multiple defect types across the surface. Numerous shingles exhibit granule loss, cracking, exposed fiberglass mat, and mechanical damage. Many areas show improper prior repairs, including coating or sealant applied directly to shingles, which is now peeling and accelerating deterioration. Several shingles are loose, lifted, or unsealed. Roof penetrations show rust, aging components, and deteriorated flashing boots. Granules are accumulating in the gutters, indicating advanced wear. Roof-to-wall flashing and trim details show potential installation deficiencies and areas vulnerable to moisture intrusion. Debris is also present on the roof surface.

Based on the extent and distribution of defects, the roof is at or near the end of its service life. Spot repairs are unlikely to be effective. Recommend full evaluation by a qualified roofing contractor, with budgeting for roof replacement in the near term.

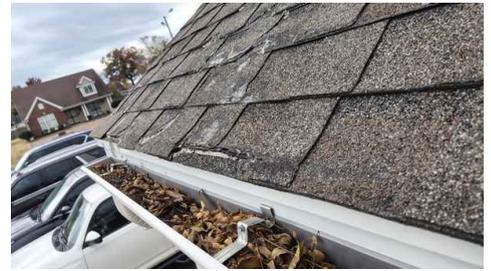
2.1.2 Coverings

DELAMINATION

The asphalt shingle roof shows signs of delamination. Delamination is separation of the surface layer of asphalt. Recommend a qualified roofing contractor evaluate and repair to prevent further deterioration that results in leaking and moisture intrusion.

Contact a qualified roofing professional.

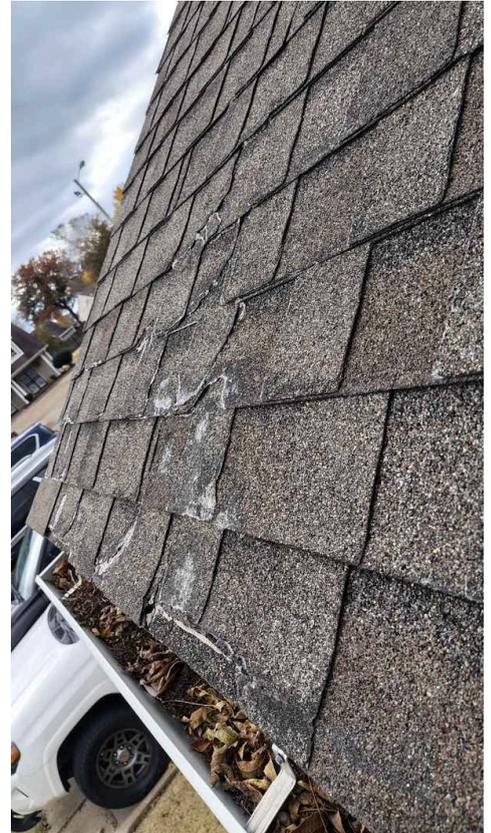
2.1.3 Coverings

LOSS OF GRANULES

Noted Loss of Granules on Shingles. Granule loss reduces the shingles' ability to protect against UV rays and water damage, potentially shortening the roof's lifespan. It may also indicate aging or storm-related wear.

Monitor affected areas for further deterioration. If granule loss is widespread, consider a roof evaluation to determine if repairs or replacements are needed. Clean gutters regularly, as excessive granules may accumulate there.

Contact a qualified roofing professional.

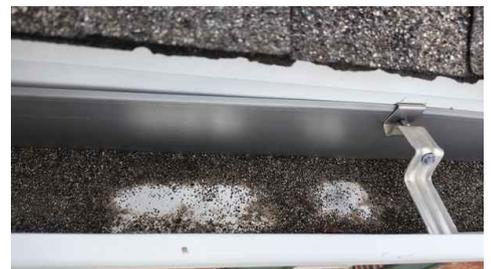
2.1.4 Coverings

TORN, CRACKED, AND LIFTED SHINGLES

Several shingles are torn, cracked, or lifted. Damage may be from wind, foot traffic, or occurred before the coating was applied. Damaged shingles do not shed water properly and are prone to wind uplift and leaks. A roofing contractor should replace damaged shingles and evaluate the overall condition of the roof.

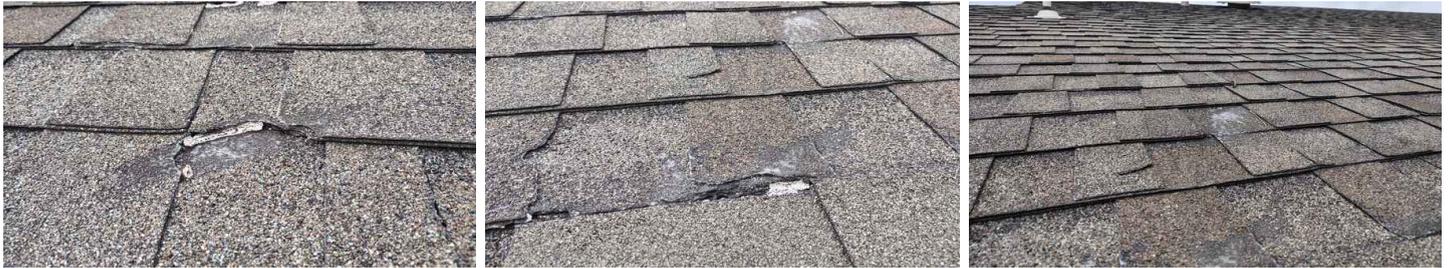
2.1.5 Coverings

SHINGLE SURFACE DETERIORATION (EXPOSED FIBERGLASS MAT)

Multiple shingles show advanced wear, including granule loss, surface cracking, and exposed fiberglass mat. These conditions indicate material failure and reduced remaining service life. Exposed mat increases the risk of leaks and UV damage. A qualified roofer should evaluate and recommend repair or roof replacement.

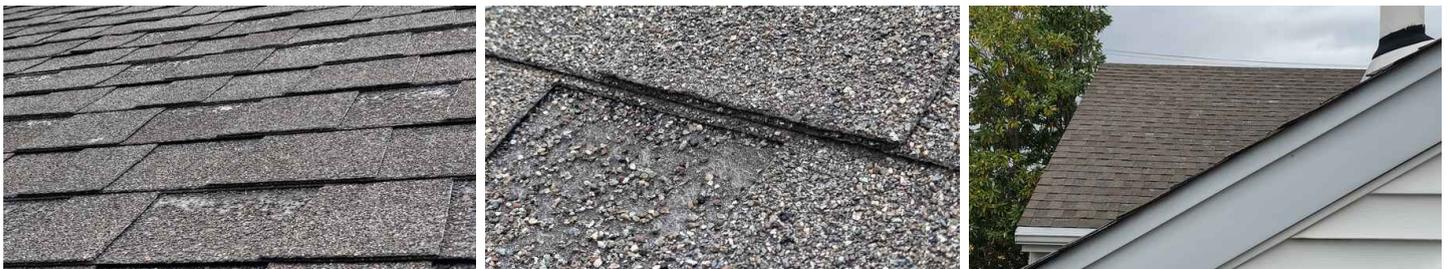
2.1.6 Coverings

IMPROPER PRIOR REPAIRS / COATING APPLIED TO SHINGLES

A white/gray sealant or coating has been applied directly to numerous shingles. This material is cracking, peeling, and deteriorating. The coating appears to have been used to glue or seal damaged shingles, which is not an accepted roofing repair method. Improper coatings accelerate shingle deterioration, trap moisture, void warranties, and reduce the roof's ability to shed water. A licensed roofing contractor should evaluate and perform proper repairs or replacement. Full replacement of this slope is likely.

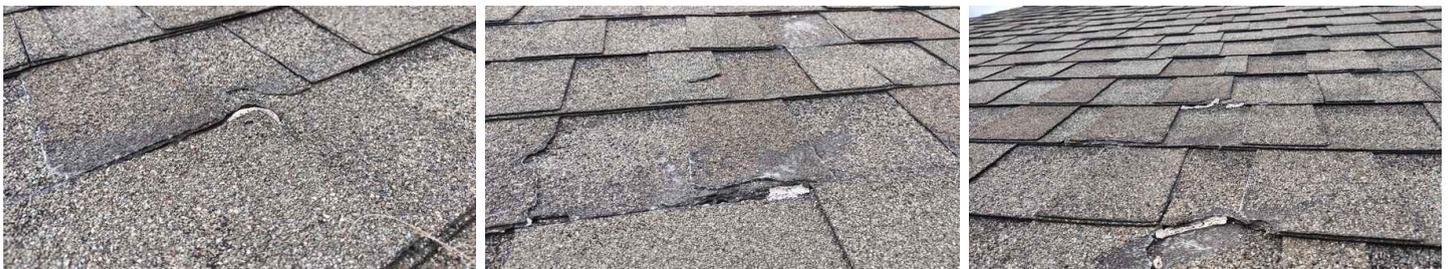
2.1.7 Coverings

UNSEALED / LOOSE SHINGLE TABS

Shingle adhesive strips are not bonded in multiple areas, leaving tabs loose. Some shingles never sealed properly or have lost adhesion due to age. Loose shingles are vulnerable to wind damage and water intrusion at the seams. A roofer should reseal or replace affected areas as needed.

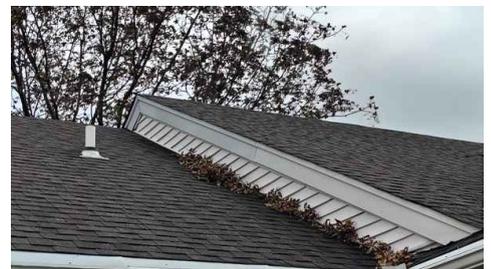
2.2.1 Roof Drainage Systems

DEBRIS

Debris has accumulated in the gutters. Recommend cleaning to facilitate water flow.

Contact a qualified roofing professional.

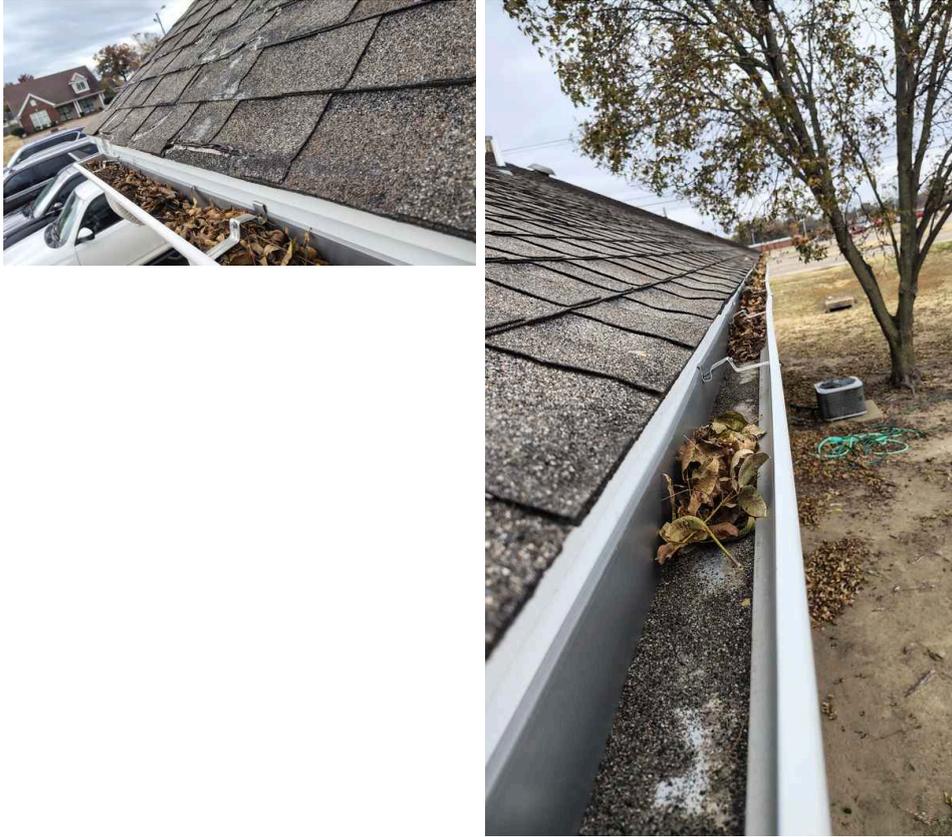
2.2.2 Roof Drainage Systems

DOWNSPOUTS DRAIN NEAR BUILDING

One or more downspouts drain too close to the building's foundation. This can result in excessive moisture in the soil at the foundation, which can lead to foundation/structural movement. Recommend a qualified contractor adjust downspout extensions to drain at least 6 feet from the foundation.

Contact a qualified roofing professional.

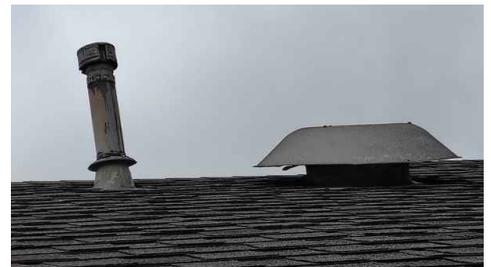
2.4.2 Skylights, Chimneys & Other Roof Penetrations

RUSTED AND DETERIORATED METAL VENT

The metal flue vent shows significant rusting and surface deterioration. Rust on roof penetrations can weaken the metal, compromise weather-resistance, and eventually cause leakage at the roof penetration. A qualified contractor should repair or replace the deteriorated vent flashing and confirm the vent is functioning safely.

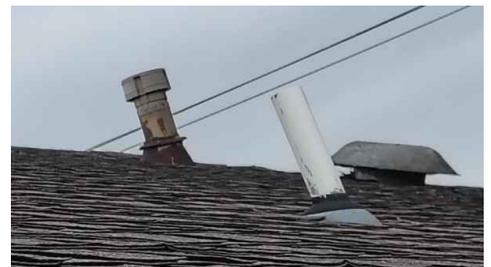
2.4.3 Skylights, Chimneys & Other Roof Penetrations

PLUMBING VENT FLASHING SHOWS WEAR

The rubber boot around the white plumbing vent shows noticeable aging and surface deterioration. Aging boots are prone to cracking and leaking. Recommend replacement by a qualified roofer.

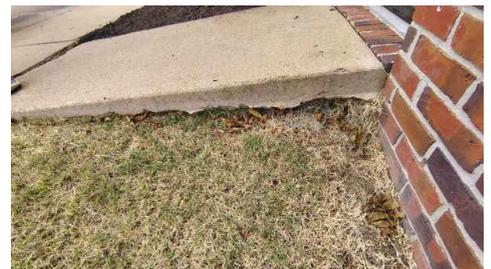
EROSION/UNDERMINING AT SIDEWALK SLAB

Erosion and soil loss were observed beneath the sidewalk slab near the building. A void has formed under the edge of the concrete, leaving the slab partially unsupported. This condition can lead to further settlement, cracking, or displacement, and may become a trip hazard if the slab drops or shifts.

Have a qualified concrete or sitework contractor evaluate the area. Repairs may include filling the void, stabilizing the soil, and addressing any drainage issues contributing to erosion. Monitor the slab for movement and repair as needed.

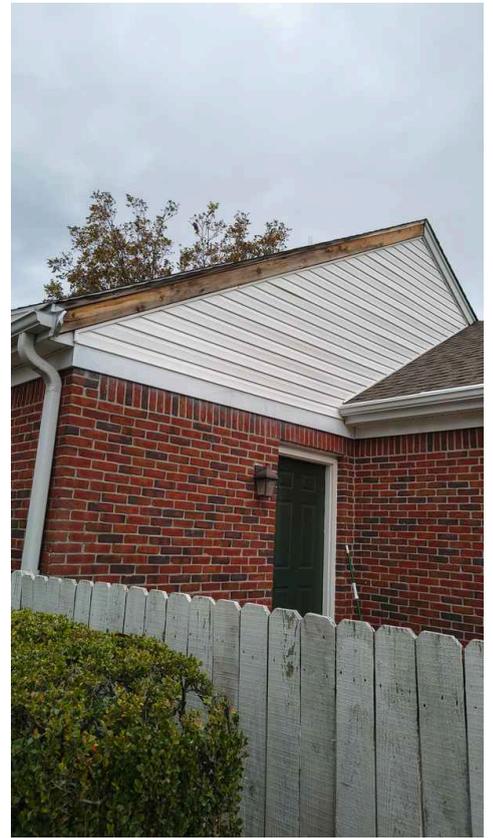
The fascia cover (metal/vinyl trim) is missing along the right-side roof edge, leaving the underlying wood fascia exposed to weather. Exposed fascia can deteriorate over time and may affect the gutter system. Recommend installation of proper fascia covering by a qualified contractor to restore weather protection.

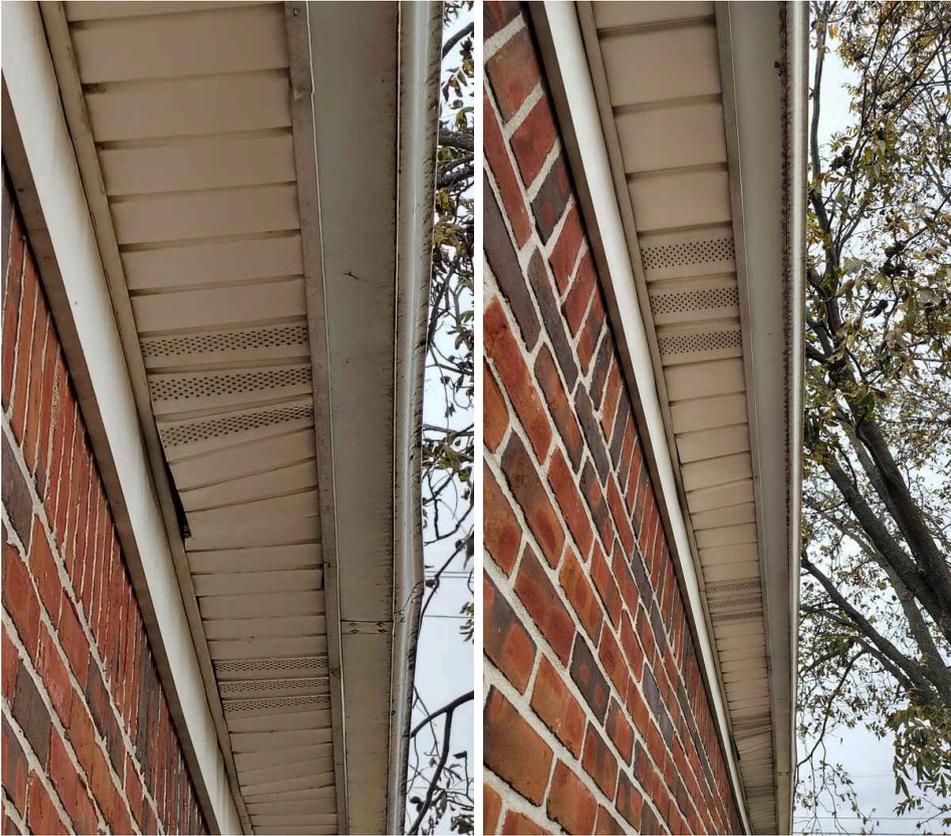
3.4.2 Eaves, Soffits & Fascia

LOOSE SOFFIT PANELS – EXTERIOR

Soffit panels along the eaves are loose and not fully secured in multiple locations. Loose soffit material can allow pest entry, wind damage, and moisture intrusion into the attic or roof structure. Recommend securing or reinstalling the soffit panels to maintain proper ventilation and protect the building envelope.

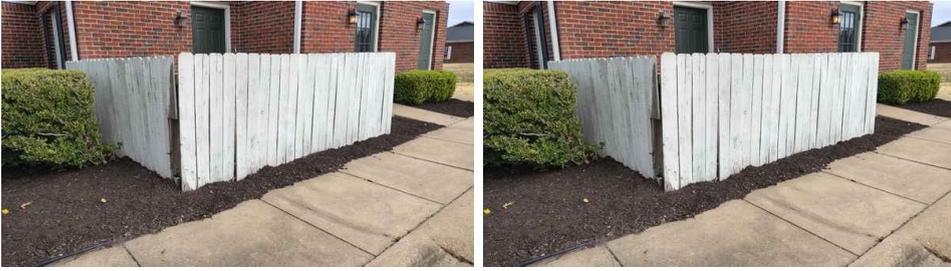
3.5.2 Patio

CONCRETE SURFACE CRACKING

The patio's concrete surface has multiple cracks consistent with age and settlement. While no major displacement was observed, cracks can widen over time and allow moisture intrusion, leading to further deterioration. Recommend sealing as part of routine maintenance and monitoring for changes.

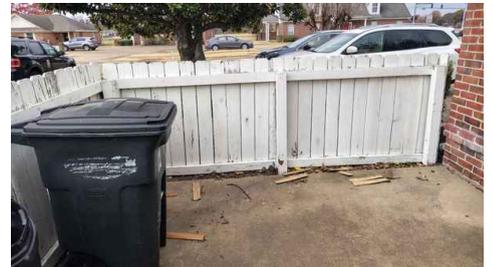
3.5.3 Patio

DEBRIS ACCUMULATION ALONG FENCE LINE

Loose debris, broken wood pieces, and leaves were observed along the base of the fence and on the concrete surface. Accumulated debris can trap moisture against building components and accelerate deterioration of wood fencing and adjacent structures. Recommend cleaning the area and maintaining regular debris removal.

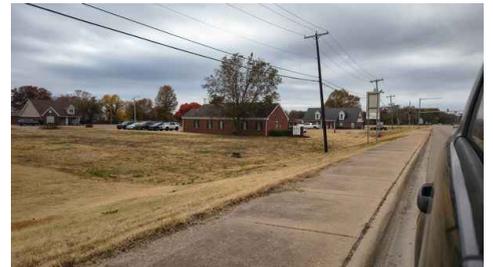
GRADING SLOPES TOWARD BUILDING NEAR ROADWAY

The grading near the roadway slopes toward the building before leveling off more than 10 feet of the structure. Although no moisture intrusion related to this grading pattern was observed during the inspection, grading that directs runoff toward the building can become a concern over time. Monitoring is advised, and regrading may be beneficial if site conditions change.

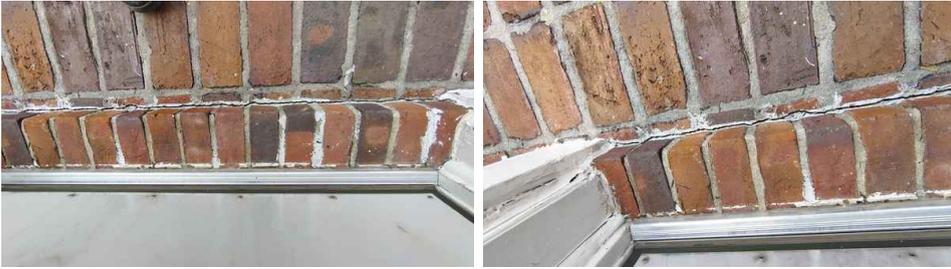
3.7.1 Steps

SEPARATION CRACK AT STAIR ENTRY MASONRY

A horizontal separation crack was observed in the brick veneer at the stair entry area, directly above the doorway. The mortar joint has opened, and prior patching/caulking is visible. This indicates movement between the stair assembly/landing and the adjacent masonry wall. Such separation can occur from settlement, seasonal movement, or differential load between the stair structure and the building façade.

Have a qualified masonry or structural contractor evaluate and repair the separation. Repairs may include removing failed caulking, repointing mortar, sealing the joint, and assessing whether structural movement needs further correction.

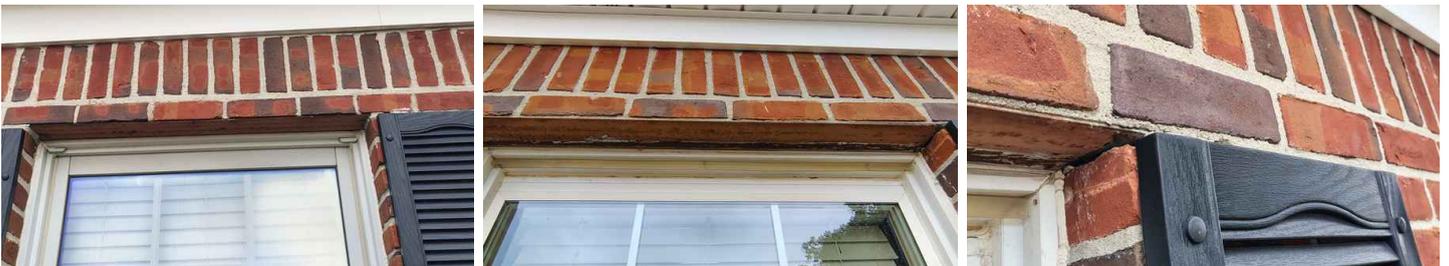
RUSTED STEEL LINTEL ABOVE WINDOW

The steel lintel above the window shows visible surface rust and deterioration. The paint/coating has failed in multiple areas, allowing oxidation to occur. If left unaddressed, ongoing rusting can weaken the lintel, cause expansion, and lead to cracking or displacement in the surrounding brick veneer.

Have a qualified contractor clean and treat the rusted lintel, apply a rust-inhibiting primer, and repaint or reseal the steel. If significant deterioration is present, further evaluation by a masonry or structural professional may be needed.

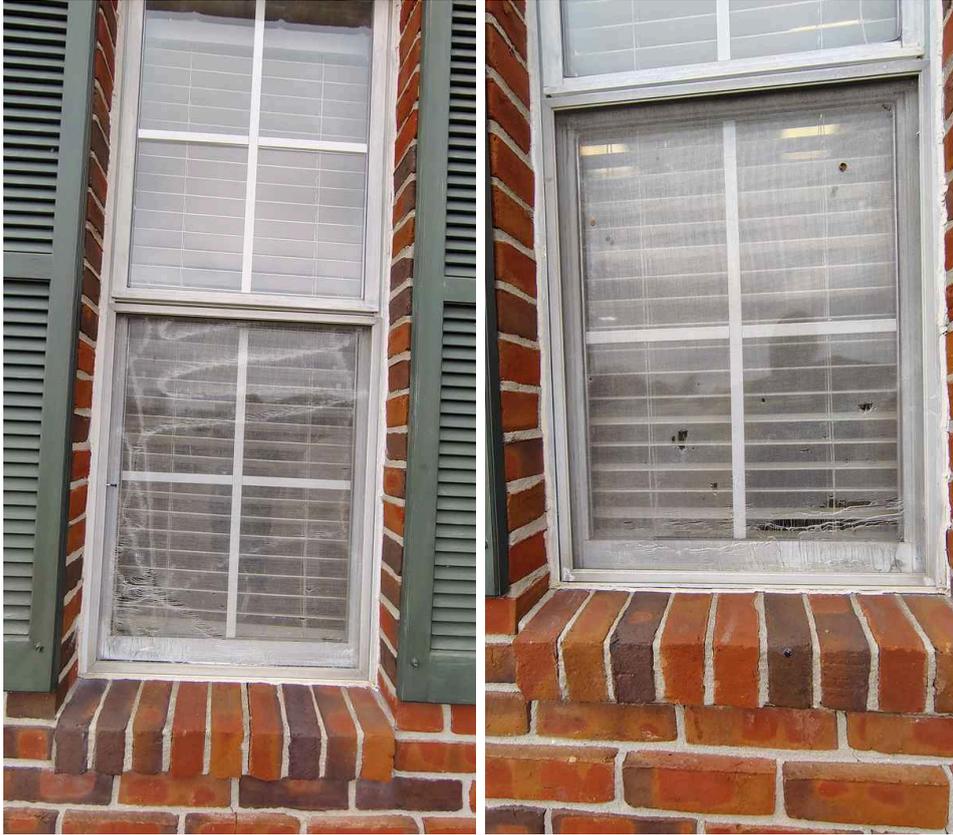
Window screens are damaged. Recommend replacement.

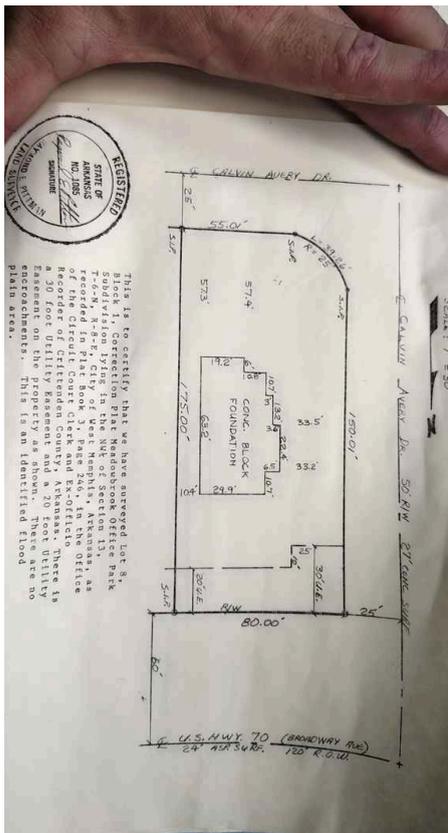
Foundation Identification – Clarification of Construction Type

During the inspection, no crawlspace access, vents, or openings were observed anywhere on the building. All visible indicators (exterior grade level, interior slab appearance, plumbing penetrations, and mechanical equipment placement) are consistent with a slab-on-grade foundation.

However, the provided site plans/blueprints label the structure as having a “Concrete Block Foundation.” This terminology refers to the perimeter foundation stem walls constructed from concrete masonry units (CMU), not to the presence of a crawlspace.

- The building appears to be constructed on concrete block stem walls with a poured concrete slab floor (commonly called slab-on-stem-wall construction).
- This type of foundation does not include an accessible crawlspace beneath the structure.
- Brick veneer extends to or near grade, which may obscure the underlying block foundation from view.

- No subfloor or crawlspace system is present to inspect.
- Utilities such as plumbing and electrical lines enter through the slab instead of beneath a floor system.
- Because the block foundation is concealed behind brick veneer and grade, the foundation walls themselves are not fully visible, limiting inspection of hidden areas.

No defects are noted with this foundation configuration based on what was visible at the time of inspection. This write-up is provided for clarification only. If the client desires further confirmation of the construction design, consultation with the builder, local building department, or review of full architectural drawings may be helpful.

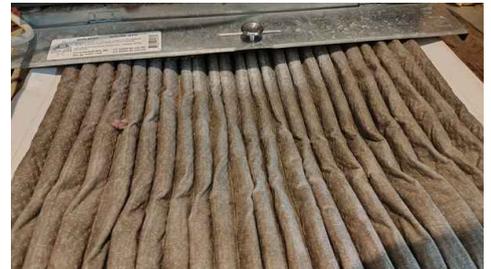
The furnace filter is dirty and needs to be replaced every 6 months.

Contact a qualified HVAC professional.

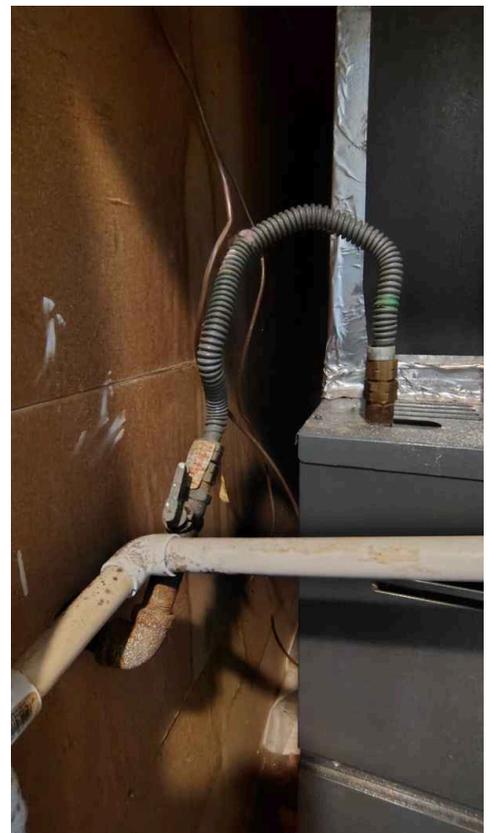
A sediment trap (drip leg) was not installed on the gas supply line serving the furnace. Current industry standards and most manufacturer installation requirements call for a sediment trap to be located near the appliance to catch debris, scale, or moisture before it enters the gas valve or burner assembly. Without this component, contaminants can enter the furnace and reduce reliability or damage components over time. A qualified HVAC or plumbing contractor should install a proper sediment trap.

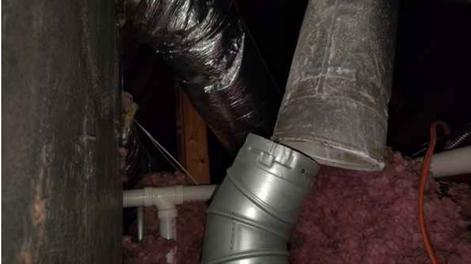
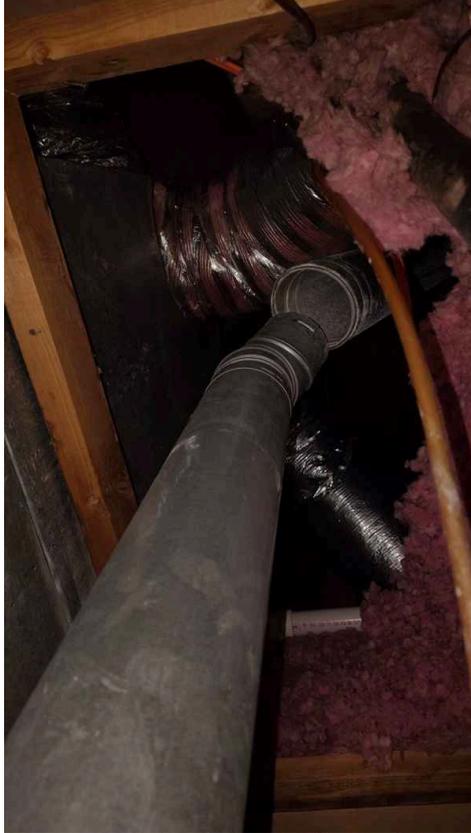
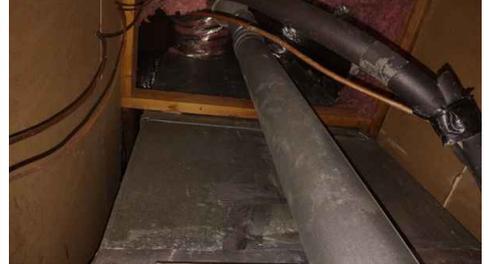
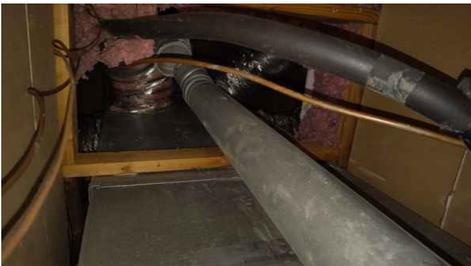
**FURNACE VENT CONNECTOR - DISCONNECTED (SAFETY HAZARD)**

A section of the furnace's metal vent connector in the attic is disconnected from the main vent piping. This prevents proper drafting of combustion gases. When a gas furnace operates without a fully connected and sealed vent, exhaust fumes—including carbon monoxide—can spill into the attic or occupied areas instead of being safely discharged outdoors.

This condition poses a significant safety hazard and can also affect furnace performance. A qualified HVAC contractor should reconnect the venting system, ensure proper fastening and sealing, and verify safe operation of the furnace before the system is used again.

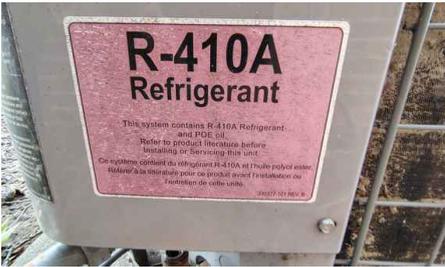
R-410A Refrigerant Noted

The HVAC system is charged with R-410A refrigerant, which is the industry standard replacement for R-22. R-410A operates at higher pressures and is not interchangeable with older R-22 systems. Only EPA-certified technicians should service or recharge this system.

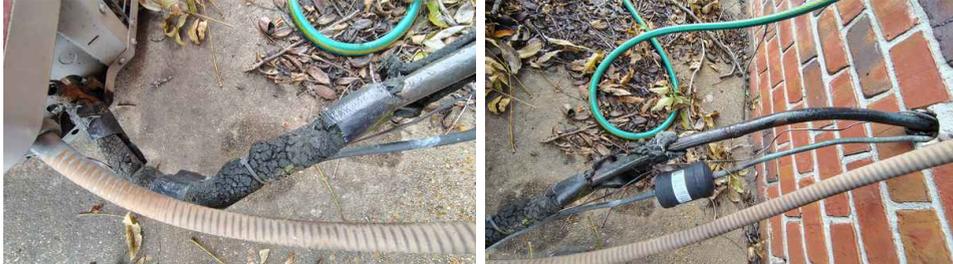
7.1.1 Cooling Equipment

DETERIORATED / MISSING REFRIGERANT LINE INSULATION

The insulation on the refrigerant suction line is significantly deteriorated, cracked, and missing in several areas. Tape and makeshift repairs were also observed. Proper insulation is necessary to prevent energy loss, reduce condensation, and ensure efficient system operation.

Have a licensed HVAC technician replace the damaged insulation with exterior-grade refrigerant line insulation. Correction will improve system efficiency and help prevent moisture-related issues.

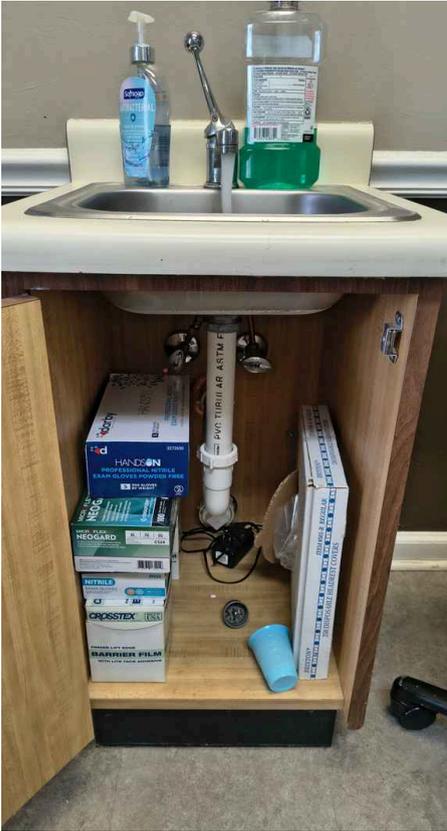
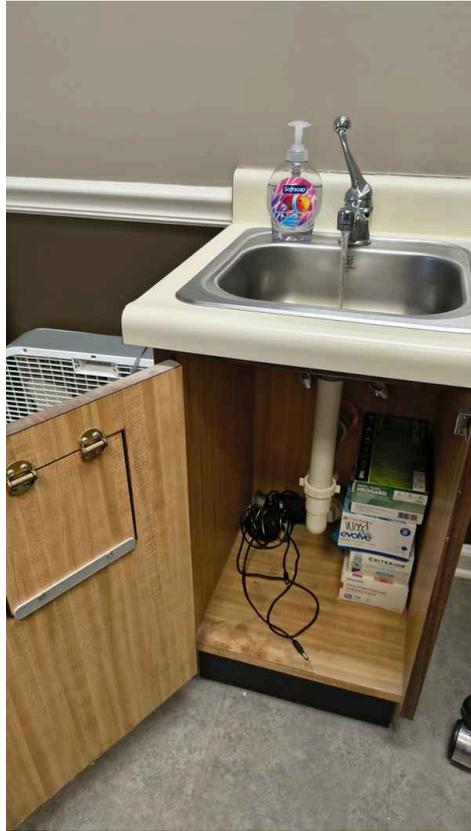
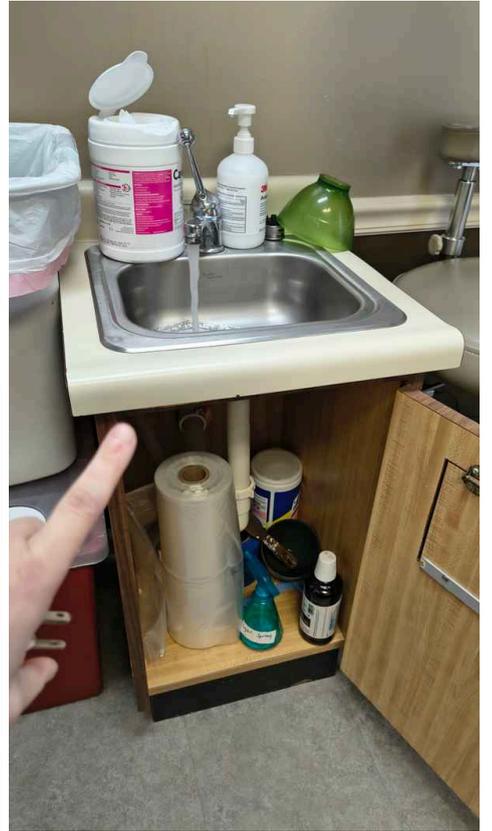
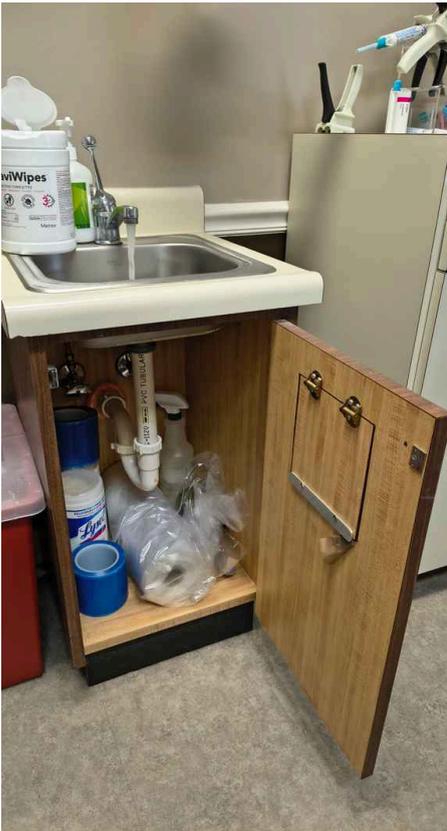
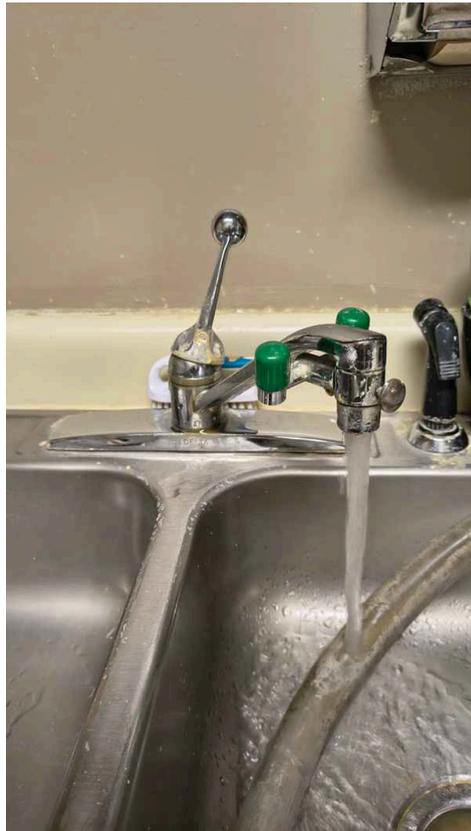
Water Supply, Distribution Systems & Fixtures: Toilet Fixtures Toilet Fixtures – General Observations

Multiple sinks were present throughout the facility, including in bathrooms and patient rooms. Each unit was operated using normal controls to verify basic functionality. Water flow and drainage appeared adequate at the time of inspection, and no leaks were observed at accessible supply lines, traps, or valves. This inspection does not include evaluation of concealed plumbing, specialty dental plumbing systems, or long-term performance. Any specific issues noted in the accompanying photos should be reviewed and corrected by a qualified plumbing contractor.

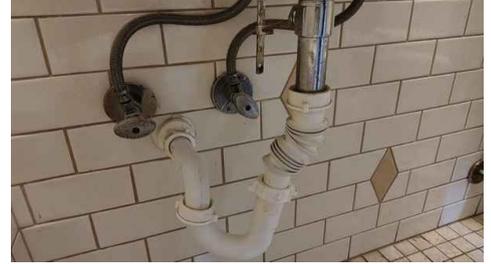
8.3.2 Drain, Waste, & Vent Systems

SPECIALTY EQUIPMENT – AMALGAM SEPARATOR / DENTAL WASTE SYSTEM

A dental amalgam separator and associated specialty waste plumbing were present beneath the sink. These systems are specialized dental equipment and are outside the scope of a commercial property inspection. Their internal condition, performance, filtration media, and compliance with EPA dental amalgam regulations were not evaluated. Only general visible conditions were observed.

The separator and surrounding plumbing show evidence of staining, corrosion, and leakage around the top of the collection unit, as well as multiple chemical containers stored directly beneath the assembly. Because this system is not part of a standard plumbing configuration and is tied to dental waste processing, a qualified dental equipment technician should evaluate the separator, seals, and connections for proper function, cleanliness, and compliance.

Have a licensed dental equipment service provider or plumbing professional with experience in dental wastewater systems evaluate the amalgam separator for leaks, required maintenance, proper installation, and any needed cleaning or repair.

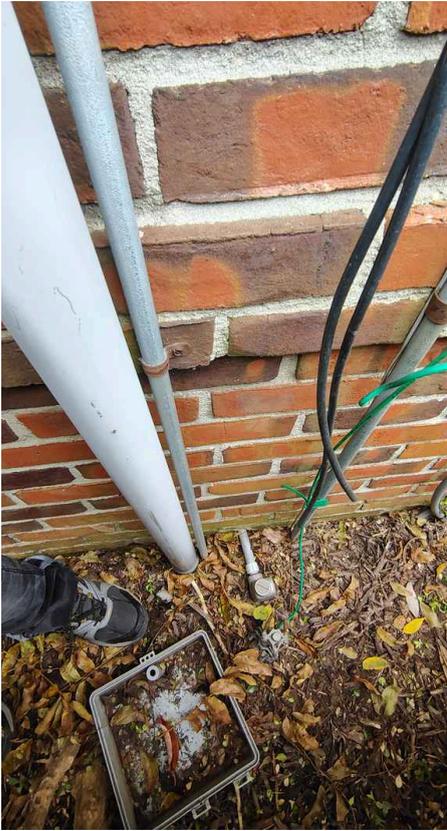
Main & Subpanels, Service & Grounding, Main Overcurrent Device: Grounding Method

The grounding electrode conductor (GEC) was observed bonding to the exterior metal conduit near the electrical service location. This appears to be serving as part of the building's grounding electrode system rather than water piping. Only visible, accessible components were inspected; concealed or buried grounding electrodes (such as ground rods or UFER/concrete-encased electrodes) could not be confirmed. If verification of proper grounding and bonding is required, further evaluation by a licensed electrician is recommended.

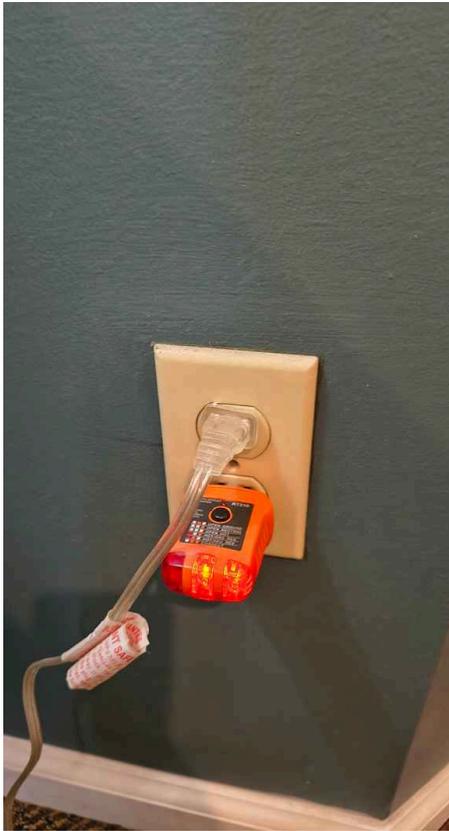
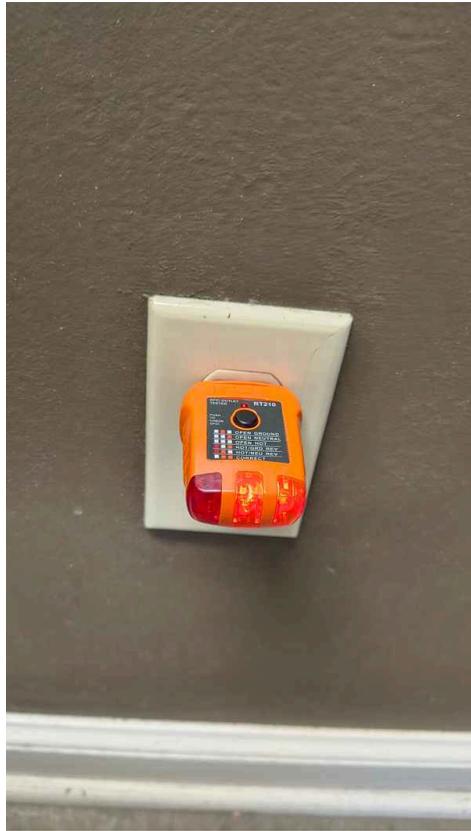
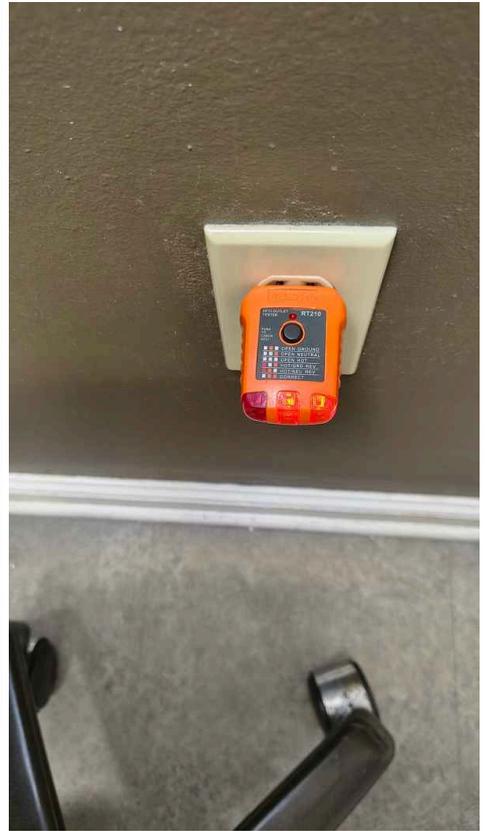
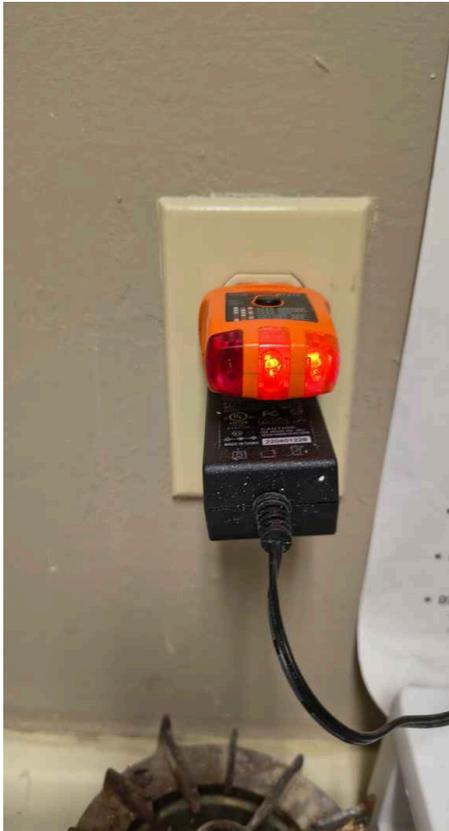
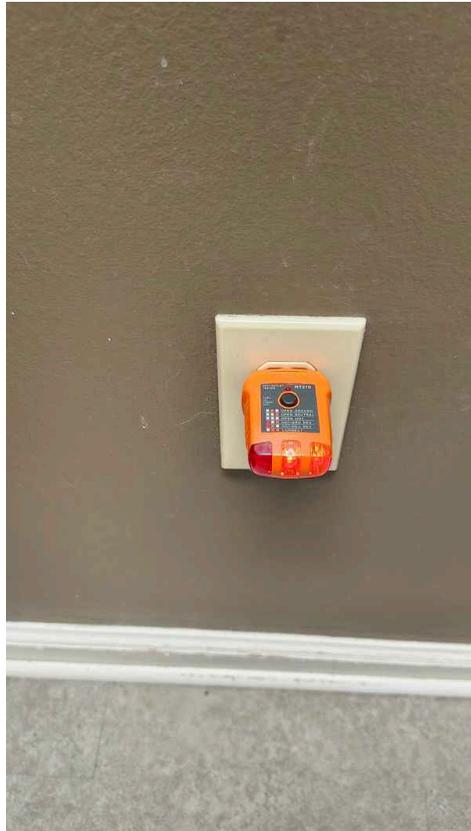
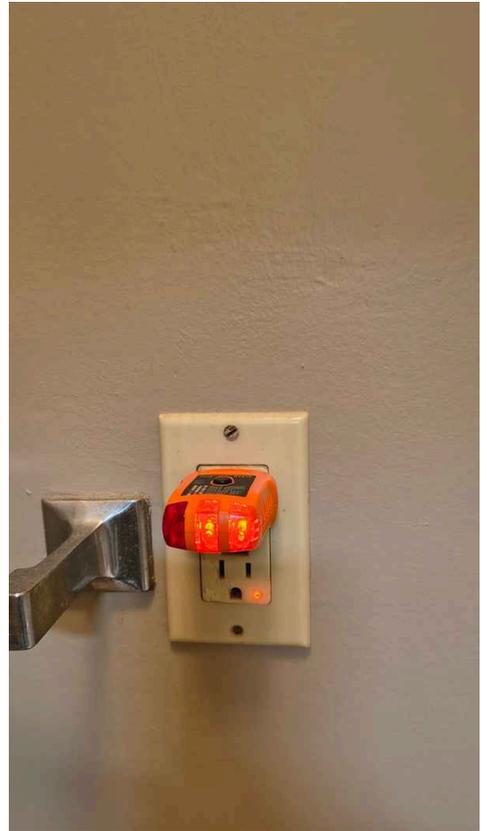
Lighting Fixtures, Switches & Receptacles: Electrical Receptacles - General Observations

Readily accessible electrical receptacles were tested using a standard plug-in tester to verify basic operation, grounding, and polarity. Most receptacles functioned as expected at the time of inspection. This evaluation is limited to visible and accessible devices and does not include load testing, circuit tracing, or evaluation of wiring concealed within walls or conduits. Specialty medical or dental equipment circuits are outside the scope unless otherwise noted. Any receptacles showing damage, improper operation, or missing cover plates in the accompanying photos should be further evaluated and corrected by a qualified electrical contractor.

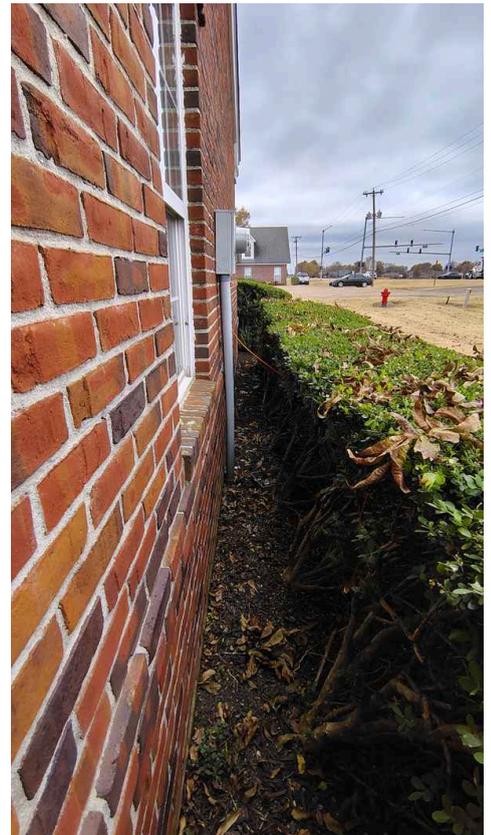
Dense bushes were observed obstructing access to the electrical meter and gas meter along the exterior wall. This vegetation makes access for inspection, meter reading, and maintenance difficult. Trimming the vegetation back to provide clear working space around the service equipment is recommended.

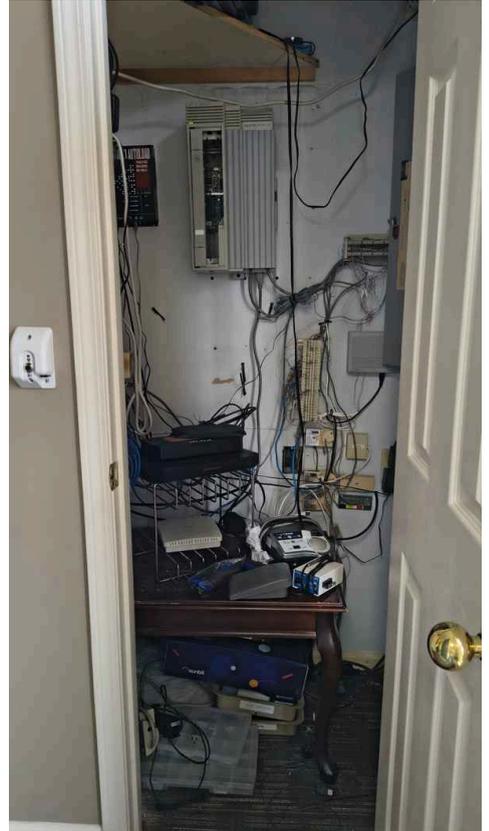
Items in front of panel make access difficult.

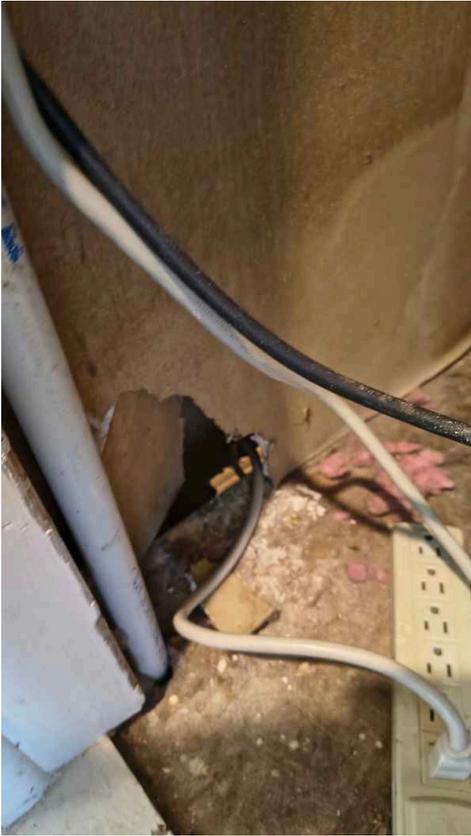
IMPROPER ELECTRICAL CORD ROUTING THROUGH WALL – SAFETY CONCERN

An electrical cord was observed passing through an opening in the wall. Flexible appliance cords, extension cords, and power strips are not permitted to be routed through walls, ceilings, floors, or other concealed spaces. This condition is considered improper wiring practice and does not meet commercial electrical safety standards. Cords routed this way are vulnerable to abrasion, heat damage, and potential fire hazards.

Have a qualified commercial electrician evaluate the condition and install a permanent, code-compliant electrical receptacle or conduit as needed. The opening in the wall should be properly sealed and repaired to maintain the building's fire-resistance and separation assemblies.

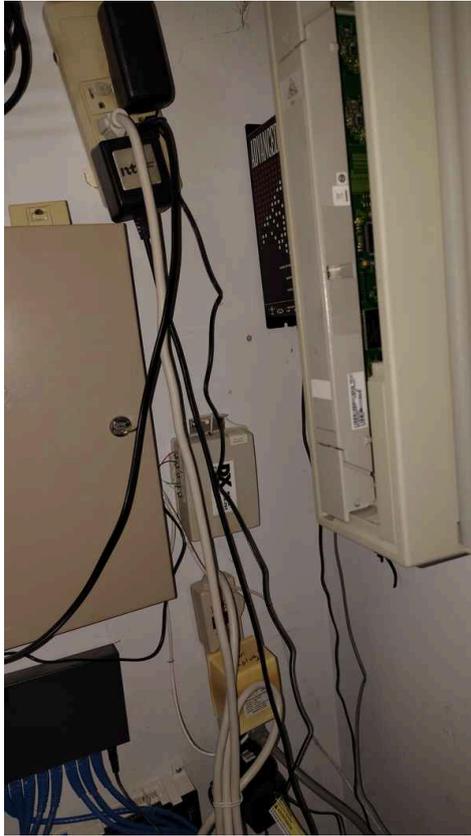
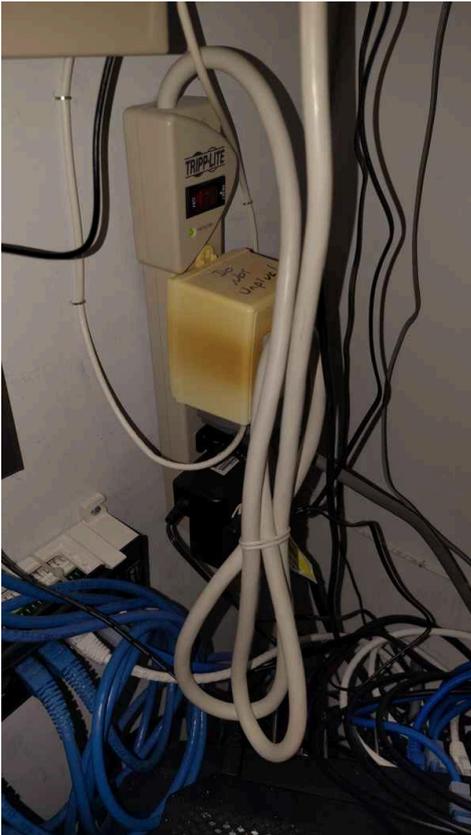
9.3.2 Branch Wiring Circuits, Breakers & Fuses

POWER STRIP USED AS PERMANENT WIRING

A power strip was observed being used as a substitute for permanent wiring (sometimes daisy-chained together). Power strips are designed for temporary use only and are not permitted to serve as long-term or structural wiring solutions. This practice can result in overheating, overloading, or fire hazards, and does not comply with accepted commercial electrical safety standards.

Have a qualified commercial electrician install additional permanent, code-compliant receptacles or circuits as needed to eliminate reliance on extension cords or power strips for permanent wiring.

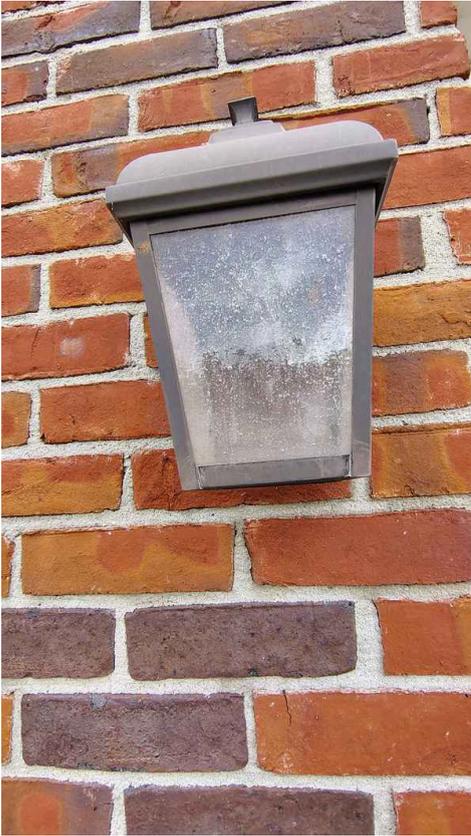
9.4.1 Lighting Fixtures, Switches & Receptacles

LIGHT INOPERABLE

Contact a qualified electrical contractor.

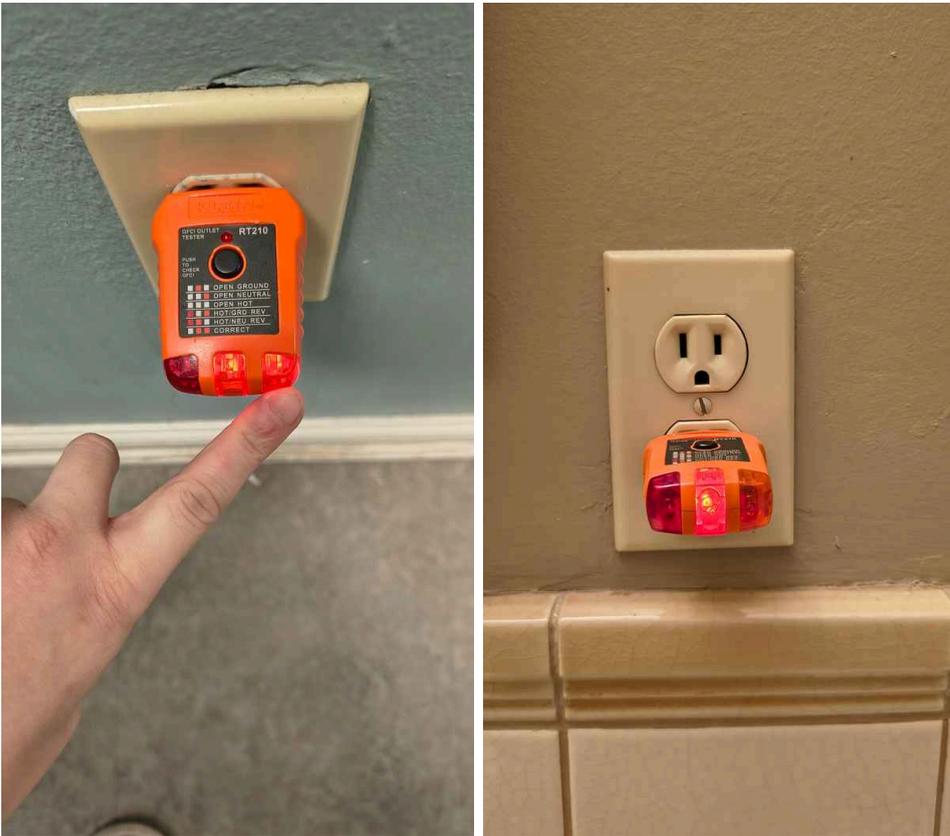
9.4.2 Lighting Fixtures, Switches & Receptacles

UNGROUND RECEPTACLE

One or more receptacles are ungrounded. To eliminate safety hazards, all receptacles in kitchen, bathrooms, garage & exterior should be grounded.

Contact a qualified electrical contractor.

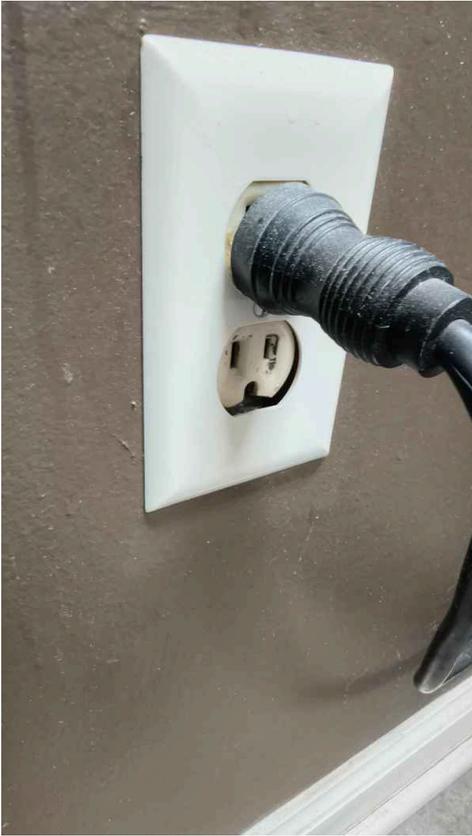
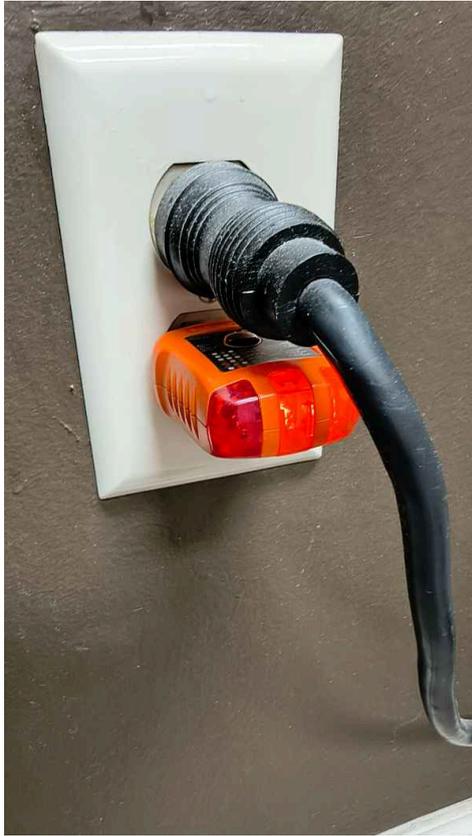
9.4.3 Lighting Fixtures, Switches & Receptacles

DAMAGED / UNSAFE ELECTRICAL RECEPTACLE

A damaged electrical receptacle was observed, including a cracked face and visible internal components. The connected plug does not seat securely, and the receptacle may no longer provide safe electrical contact. This condition presents a potential shock hazard, fire risk, and risk of equipment malfunction—especially important in a healthcare environment such as a dental office where reliable power is critical.

A licensed electrical contractor should replace the receptacle and verify that the associated wiring and circuit are in safe operating condition.
