UPCHURCH INSPECTION

INTERNACHI COMMERCIAL

1234 Main Street
Memphis, TN 38117

03/17/2026 9:00AM

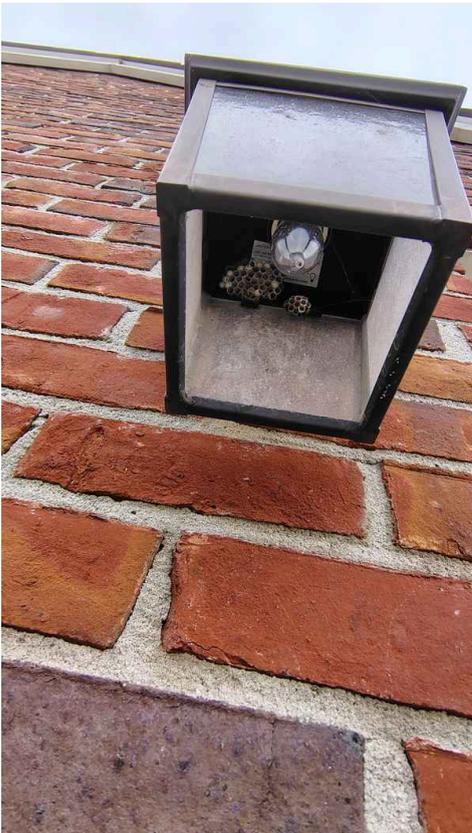
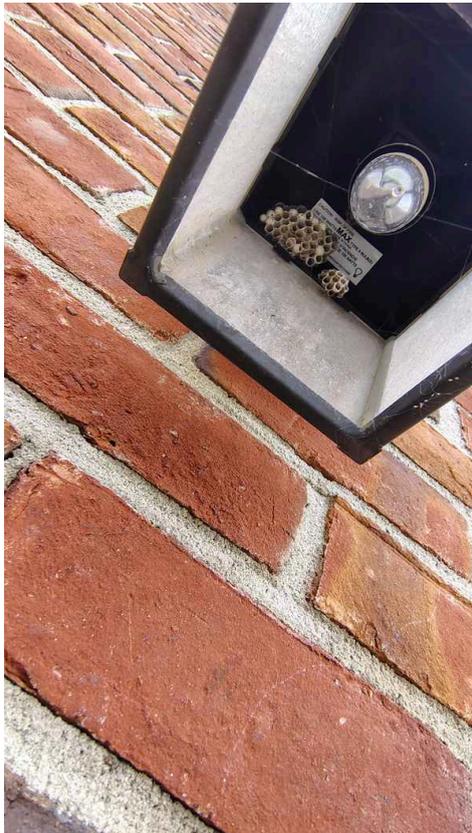
9.4.4 Lighting Fixtures, Switches & Receptacles

WASP NEST OBSERVED IN LIGHT FIXTURE

Non-active wasp-nest observed in exterior light fixture. Removal is recommended.

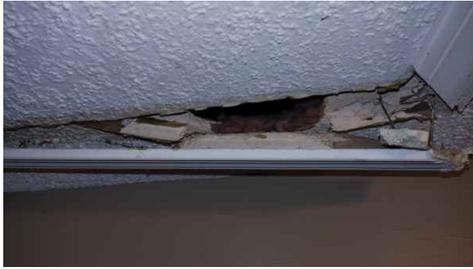
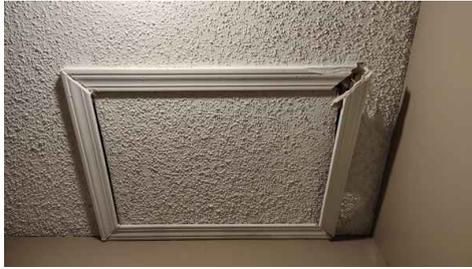
DAMAGED ATTIC ACCESS HATCH

The attic access hatch (scuttle hole) is damaged, with broken drywall, missing material around the opening, and exposed insulation. This condition can reduce the effectiveness of the thermal barrier, allow air leakage between conditioned and unconditioned spaces, and create a pathway for dust, insulation fibers, or pests to enter interior rooms. A properly fitted and intact attic access is also important for fire separation and energy efficiency.

Repairs by a qualified contractor are recommended to restore the opening, secure the trim, and ensure the hatch is properly sealed and finished.

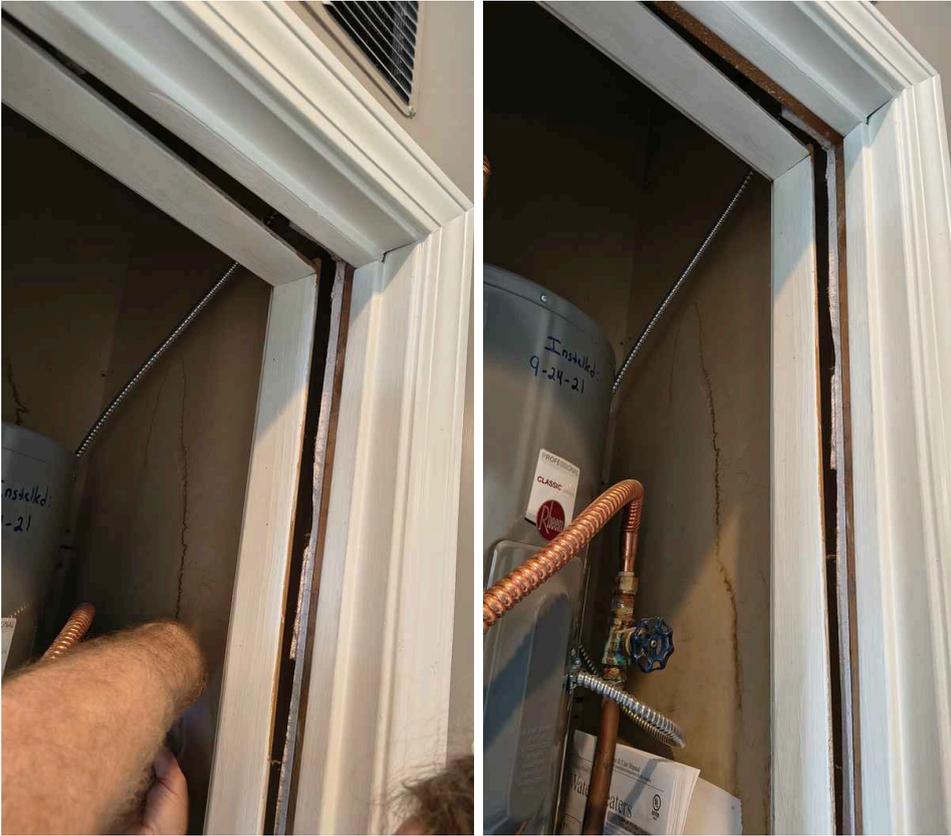
12.1.1 Doors

DOOR FRAMING CRACKED OR DAMAGED

Door frame cracked or damaged, have a qualified professional repair.

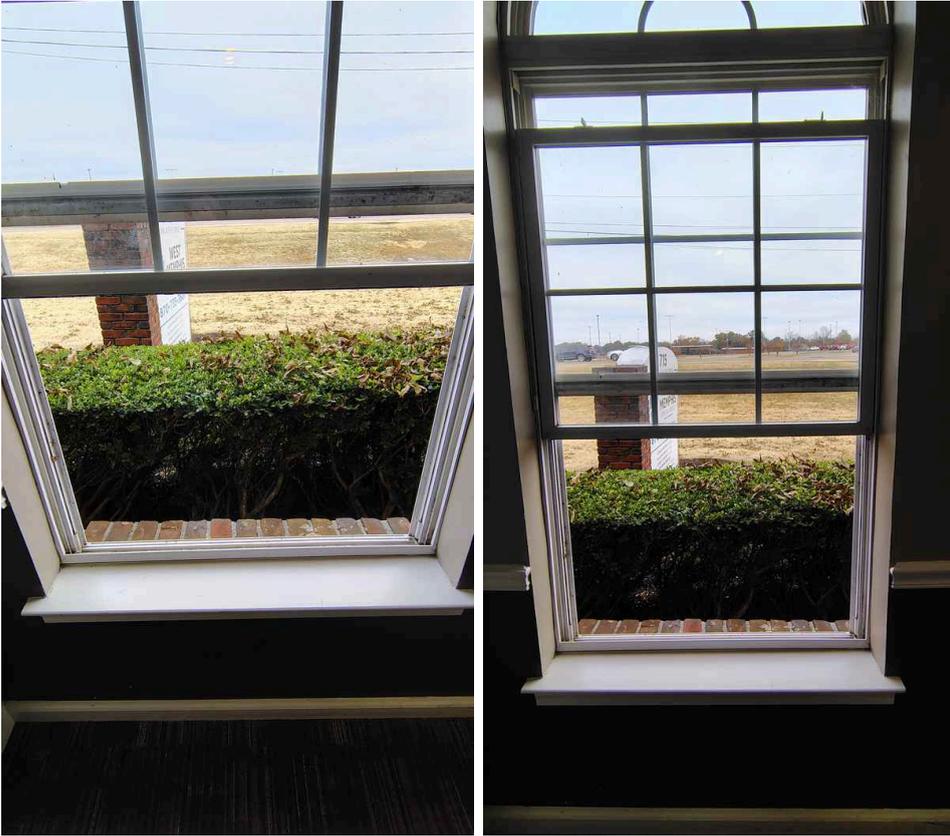
12.2.1 Windows

MISSING SCREEN

Window missing screen. Recommend replacement.

Recommendation

Contact a qualified window repair/installation contractor.

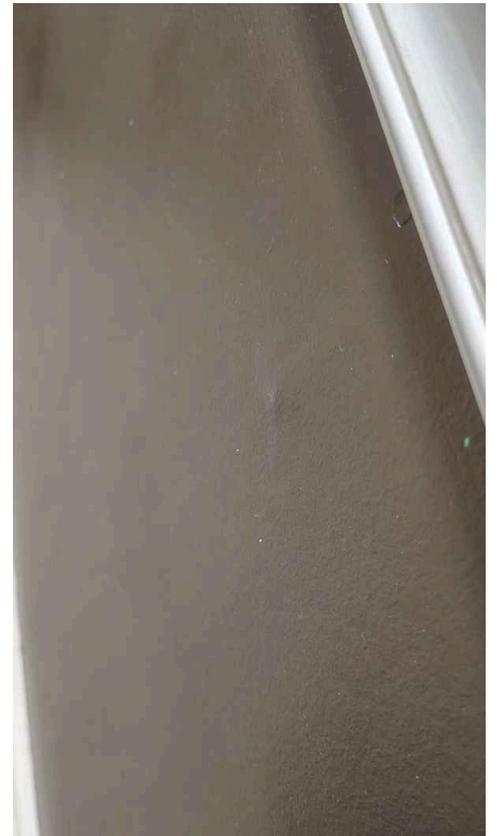
12.4.1 Walls

NAIL POPS

Protruding nail heads visible at the time of the inspection appeared to be the result of contact with moisture. After the source of moisture is located and corrected, protruding nails should be removed, drywall re-fastened and the drywall finished to match the existing wall surfaces. All work should be performed by a qualified drywall or painting contractor.

Recommendation

Contact a qualified drywall contractor.

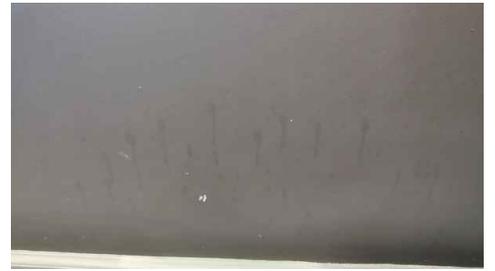
12.4.2 Walls

SURFACE STAINING

Surface staining was observed on the interior wall of patient room in the area shown. This appears to be cosmetic and does not indicate a structural or moisture-related issue at the time of inspection. Cleaning or repainting may be needed for aesthetic purposes. No further concerns noted in this area.

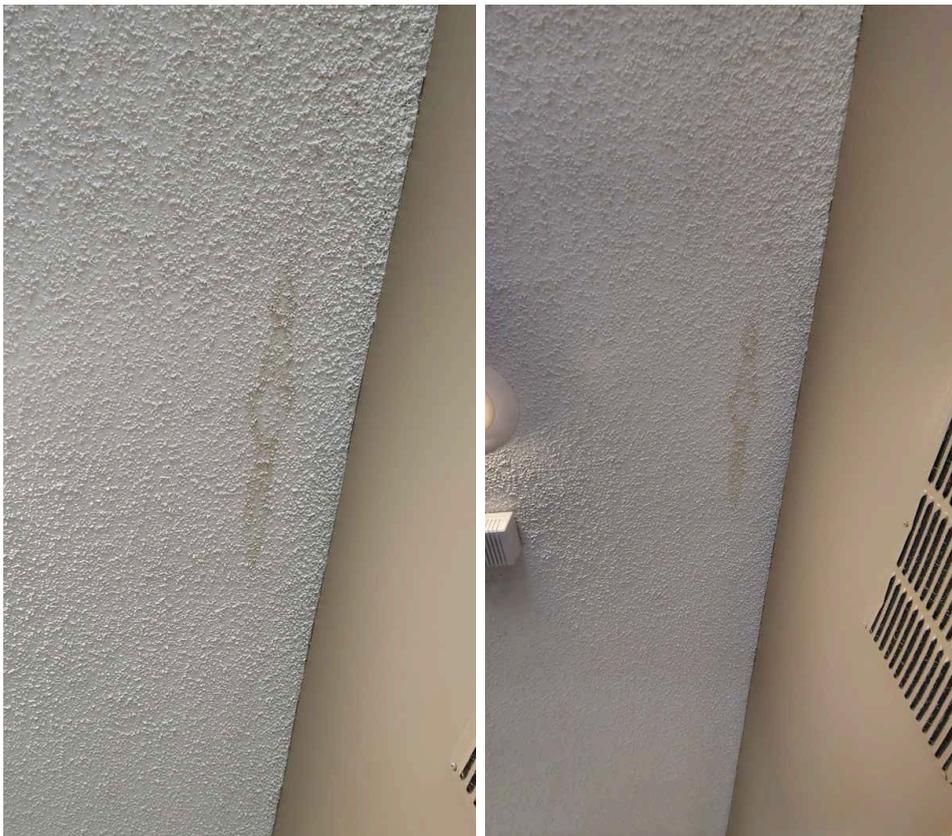
12.5.1 Ceilings

CEILING STAIN OBSERVED – POSSIBLE MOISTURE INTRUSION

A brownish discoloration was observed on the ceiling surface, indicative of a past or ongoing moisture condition. The stain's pattern suggests water may be entering from above, potentially from roof leakage, plumbing lines, or HVAC condensation. The area was dry at the time of inspection, but the source of the moisture could not be confirmed during a visual, non-invasive inspection.

Further investigation by a qualified contractor is recommended to identify and correct the source of the moisture and to repair the affected ceiling material as needed.

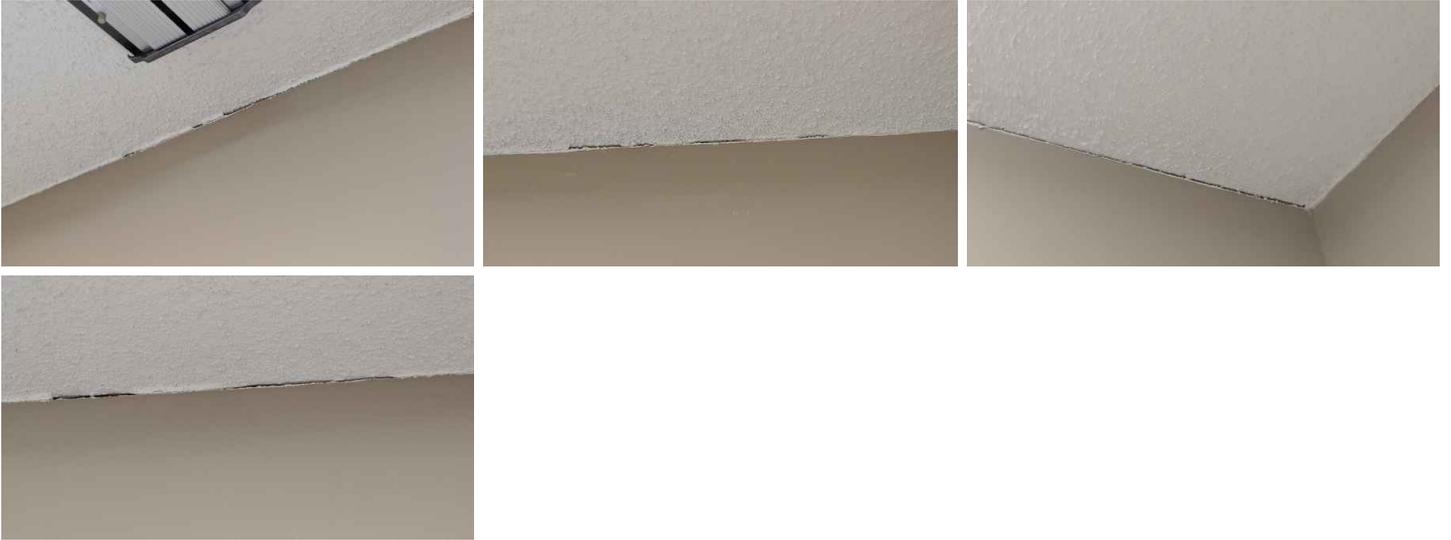
12.5.2 Ceilings

CEILING/WALL JOINT SEPARATION

Ceiling/wall joint separation was noted in multiple areas. There is visible cracking and separation along the drywall joint where the ceiling meets the wall. This indicates movement at the joint or deterioration of the joint compound/tape. Cosmetic in appearance but still a building defect that may worsen over time.

Repairs by a qualified drywall or general contractor are recommended to restore the joint, prevent further cracking, and improve interior finish quality.

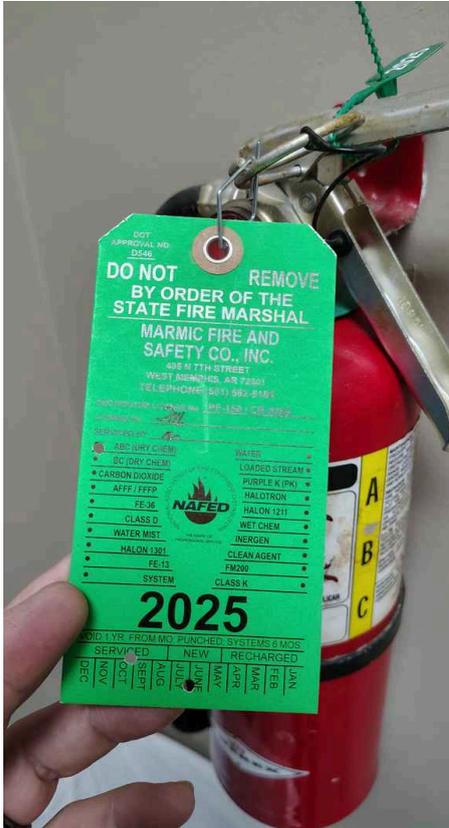
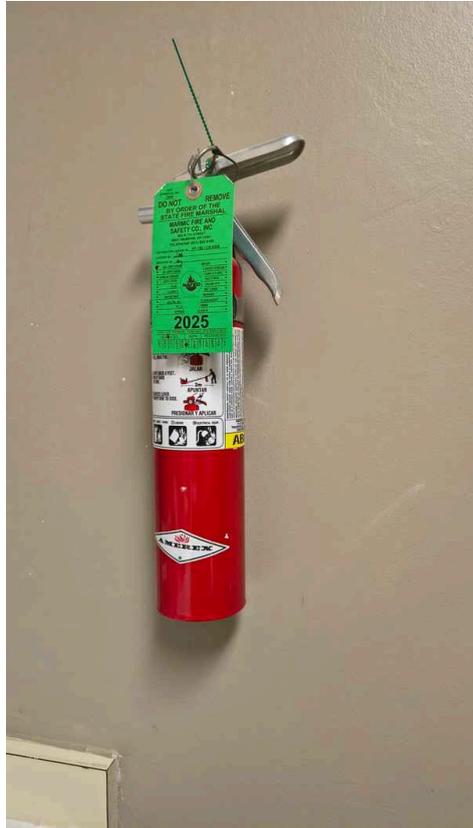
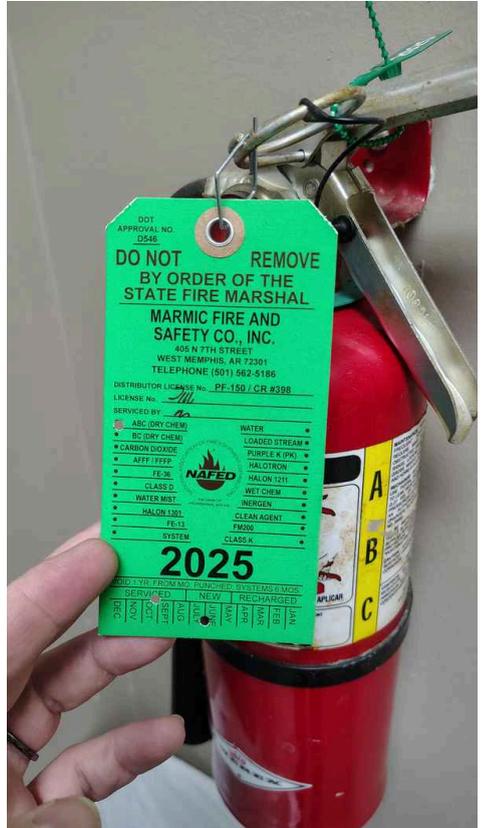
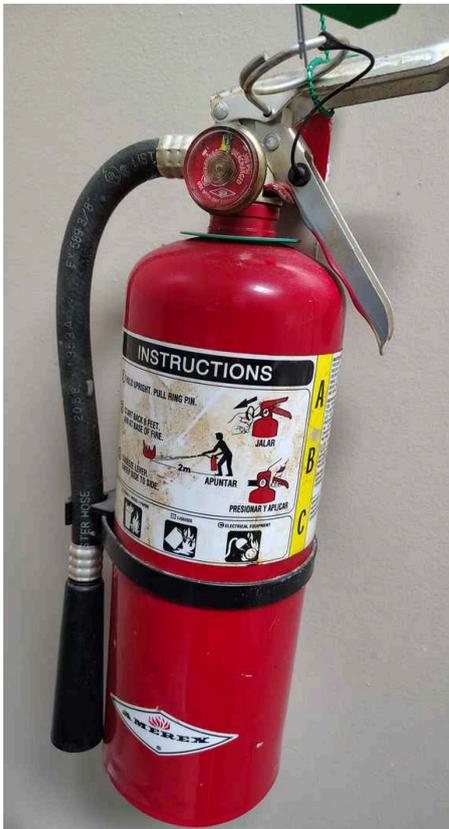
Portable Fire Extinguishers: Portable Fire Extinguisher - Overview

A portable fire extinguisher was observed on the premises. The unit was tagged as serviced in October 2025, and the pressure gauge indicated the extinguisher was in the charged/operable range at the time of inspection. The extinguisher was mounted in an accessible location and showed no visible damage or corrosion. This inspection is limited to a visual check of the gauge, condition, and service tag; it does not include internal testing or verification of compliance with NFPA 10 requirements for commercial fire-protection equipment.

Routine monthly visual inspections and annual professional servicing should continue as required for commercial facilities.

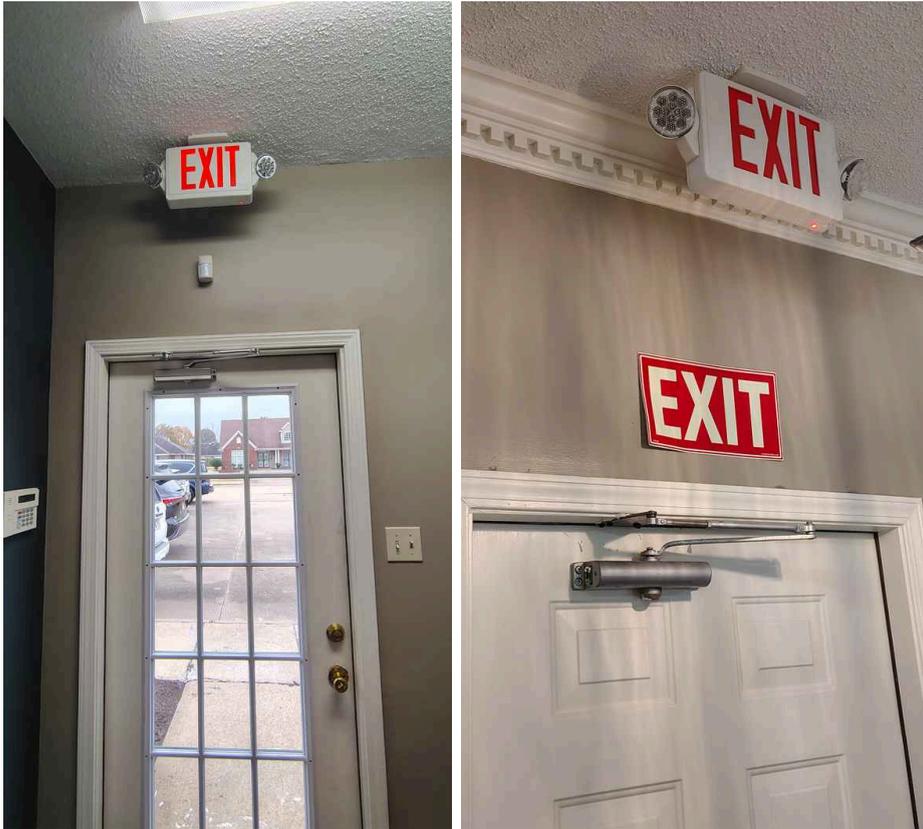
Emergency Lighting Systems: Emergency Lighting – Front Entrance and Hallway Exit

Emergency lighting was present and operational at the front entrance and at the hallway emergency exit. These fixtures help provide illumination during a power outage and support safe occupant egress. No deficiencies were observed at these locations.

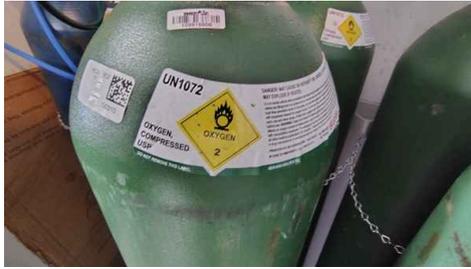
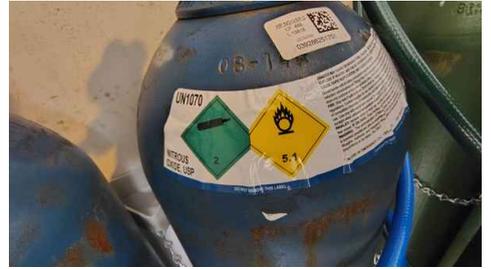
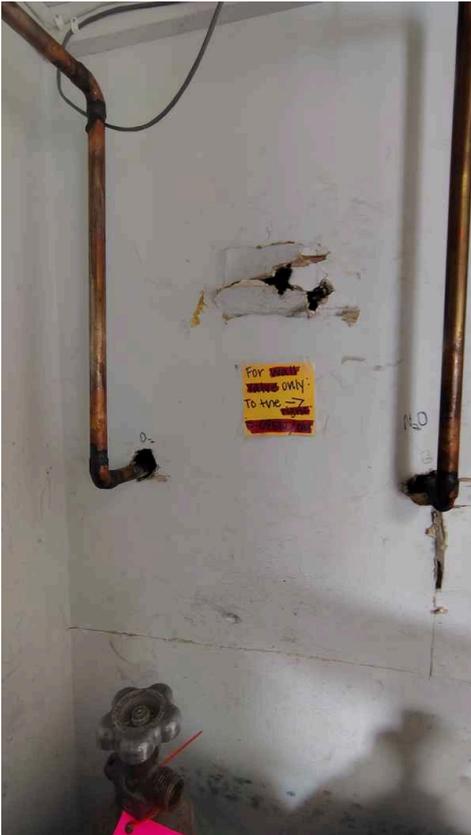
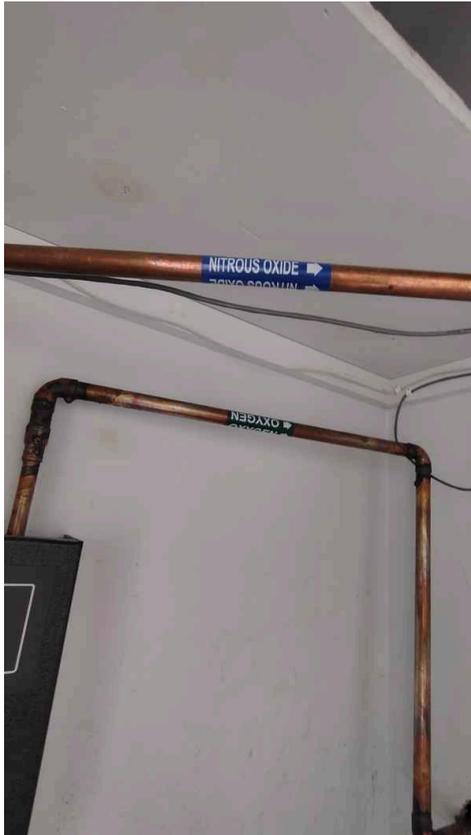
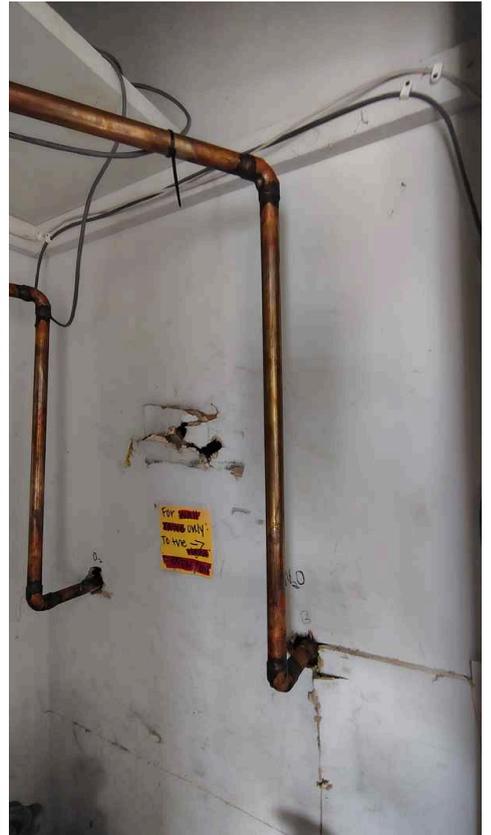
IMPROPER STORAGE OF DENTAL GAS CYLINDERS – FIRE AND SAFETY HAZARD

Dental gas cylinders (such as oxygen or nitrous oxide) were observed stored in a room (closet) that is not equipped with automatic fire sprinklers and does not appear to have 1-hour fire-rated walls or a fire-rated door assembly. Compressed gas storage in medical and dental facilities is typically required to meet specific fire-protection standards, including separation from ignition sources, securing of cylinders, ventilation, and enclosure within a rated room or protected area.

Storing compressed gases in a non-rated, non-sprinklered room increases the risk of fire spread, explosion hazard, and regulatory non-compliance. This condition represents a significant life-safety concern for staff, patients, and the facility.

A qualified fire-protection contractor or life-safety specialist should evaluate the storage location and conditions, verify applicable requirements (NFPA 99, NFPA 55, local fire code), and implement corrective measures such as:

- relocating cylinders to a compliant storage enclosure
- installing required fire-rated construction
- adding sprinklers if required
- ensuring proper cylinder securing and ventilation

Corrective action should be taken promptly.

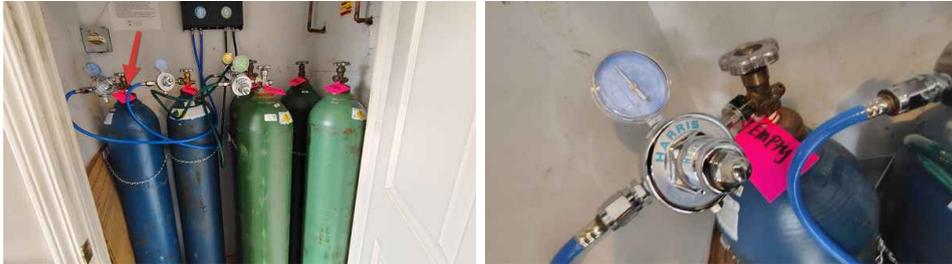
13.3.2 Storage of Flammable and Combustible Materials
IMPROPERLY LABELED MEDICAL GAS CYLINDER

Safety Hazard

A medical gas cylinder was observed with an “empty” tag attached, although the cylinder still appeared to contain pressure based on the valve indicator. Incorrect or outdated labeling of compressed gas cylinders is a safety concern and may indicate improper handling practices. Accurate identification is essential for safe storage, rotation, and use of medical gases in a clinical setting.

A qualified medical gas supplier or facility manager should review the cylinder inventory process, update labeling, and ensure all gas cylinders are correctly marked to reflect their actual status.

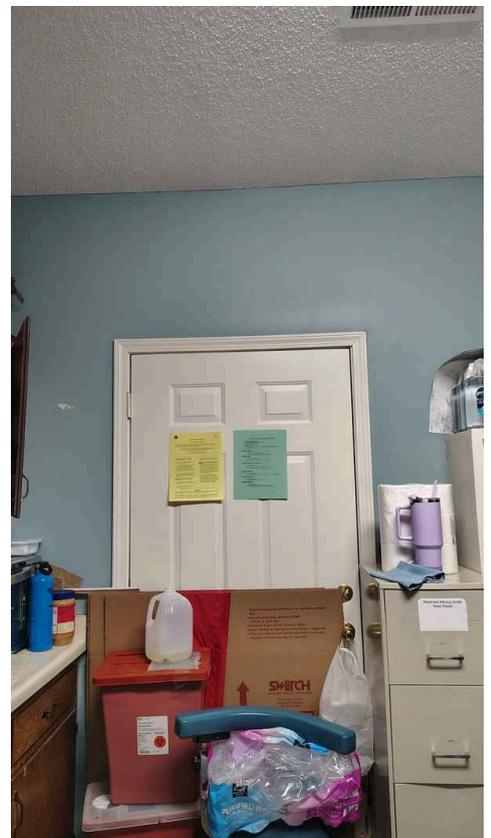
13.9.1 Emergency Lighting Systems

Safety Hazard

MISSING EXIT LIGHTING AT EXTERIOR EXIT DOOR

The exterior exit door located in the break room does not have an exit light or illuminated exit signage installed above or adjacent to the door. Commercial facilities, including medical and dental offices, are typically required to maintain clearly marked and illuminated exit paths to facilitate safe egress during normal and emergency conditions. The lack of exit lighting may reduce visibility during a power outage or emergency evacuation and may not meet common life-safety or local code expectations.

A qualified electrical or life-safety contractor should evaluate the exit path and install appropriate illuminated exit signage in accordance with applicable commercial building and fire-safety standards.

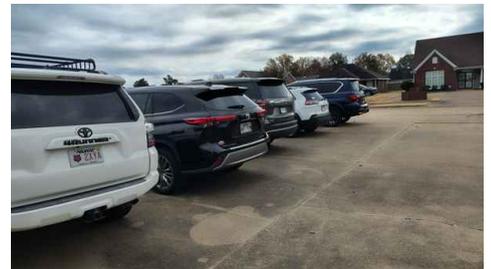
NO DESIGNATED ACCESSIBLE (HANDICAP) PARKING SPACES OBSERVED

No marked accessible (handicap) parking spaces were observed in the parking lot. Commercial properties open to the public are typically required to provide clearly marked accessible parking spaces that meet ADA standards, including proper striping, signage, and access aisles.

- Potential non-compliance with ADA accessibility requirements.
- Increased liability exposure for the property owner.
- Lack of accessible accommodations for customers or occupants with mobility impairments.

Have a qualified paving/stripping contractor and/or accessibility specialist evaluate the site and install the required number of accessible parking spaces, including proper striping, signage, and access aisles, per current ADA and local code requirements.

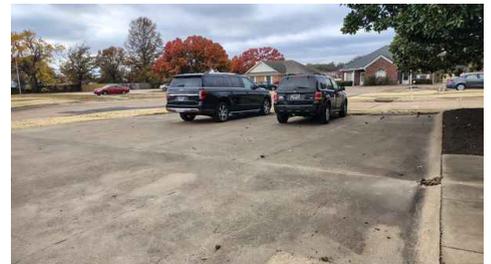
15.1.2 Parking

PARKING LOT LINES AND MARKINGS (FADED)

The parking lot striping is significantly faded. Pavement markings, including parking stall lines and directional indicators, are no longer clearly visible. Faded striping can lead to disorganized parking, reduced traffic control, and potential safety concerns for both drivers and pedestrians.

Have a qualified paving or striping contractor re-stripe the parking lot to restore proper visibility and compliance with site safety and traffic-flow standards.

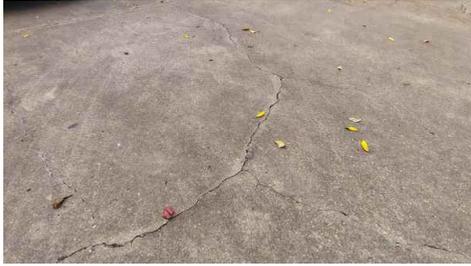
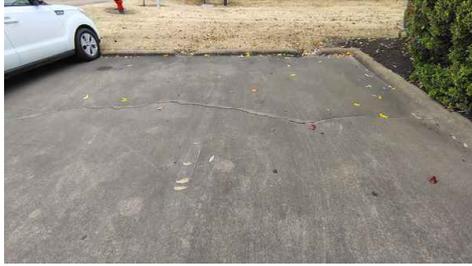
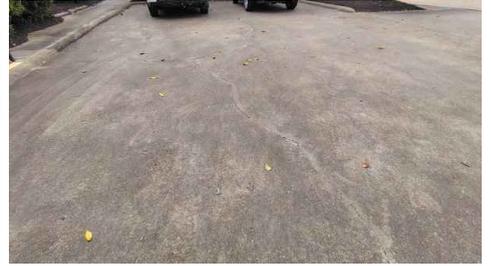
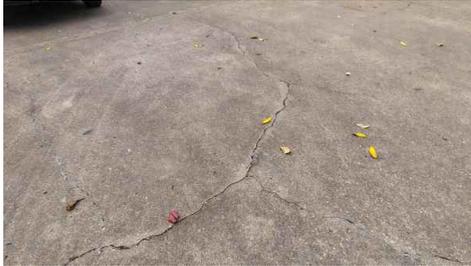
CRACKS IN CONCRETE OF PARKING AREA

Minor cracking in concrete parking area. Recommend sealing and routine maintenance.

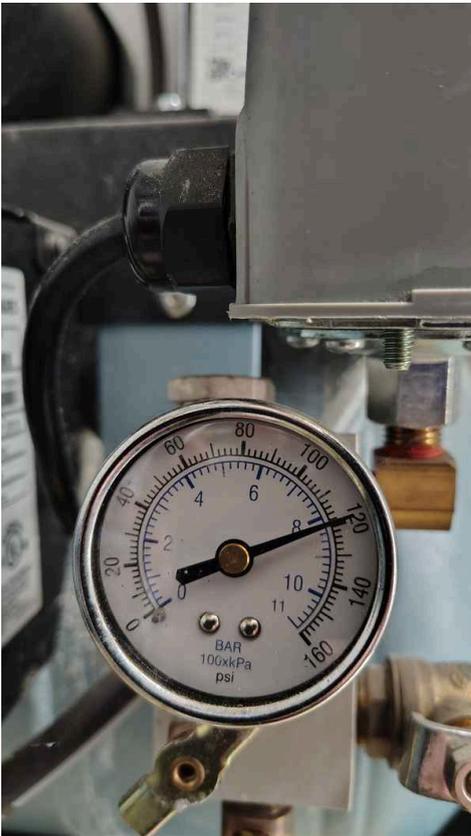
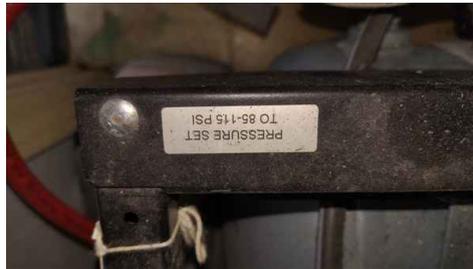
16.1.1 Speciality Dental Equipment

The AirStar dental air compressor displayed a pressure reading of approximately 120 PSI, while the manufacturer's equipment label indicated a recommended operating pressure range of 85–115 PSI. A gauge reading above the labeled range may indicate a regulator or pressure-control issue and may affect the safe operation of connected dental equipment.

Because dental air systems are specialized medical equipment outside the scope of a commercial property inspection, this observation is provided for informational purposes only. A qualified dental equipment technician or the system's maintenance provider should evaluate the compressor and confirm proper calibration, pressure regulation, and safe operating conditions.

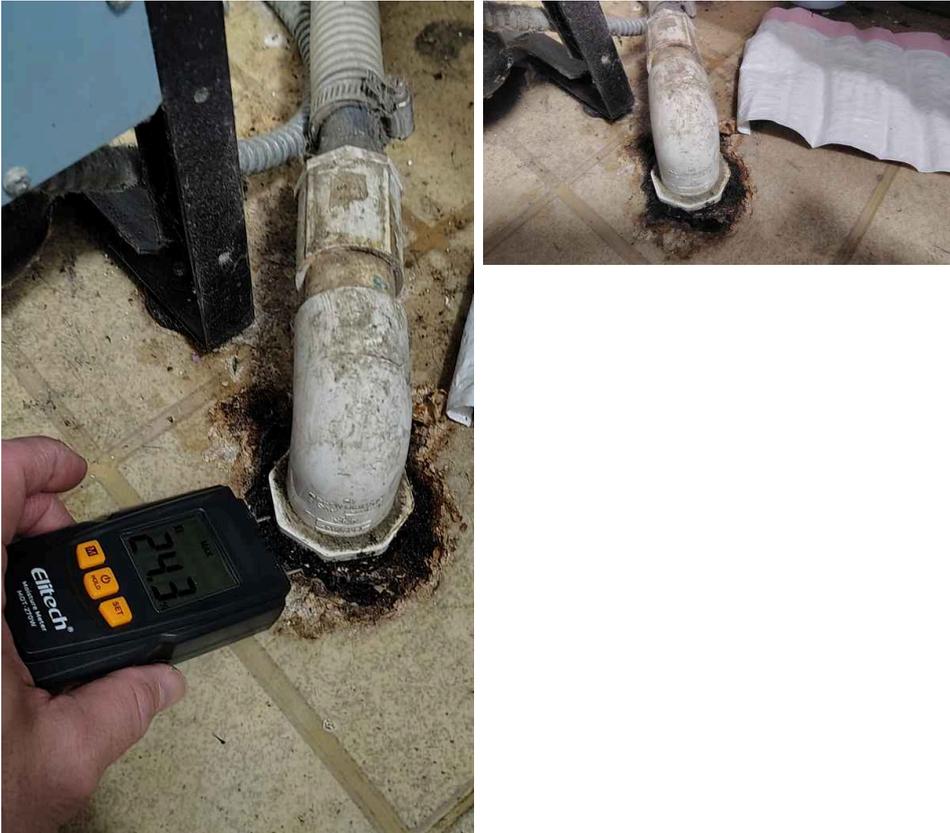
A drain/evacuation line serving dental equipment was found detached at the floor penetration. Moisture staining, damp flooring, and elevated moisture readings were present around the pipe entry point. This condition appears related to leakage from the disconnected equipment line rather than the building's plumbing system. Moisture at this location can contribute to material deterioration or microbial growth if not corrected. A qualified dental equipment service technician should reconnect and secure the line and verify proper operation of the associated equipment. Repairs to any affected flooring or materials may also be needed.

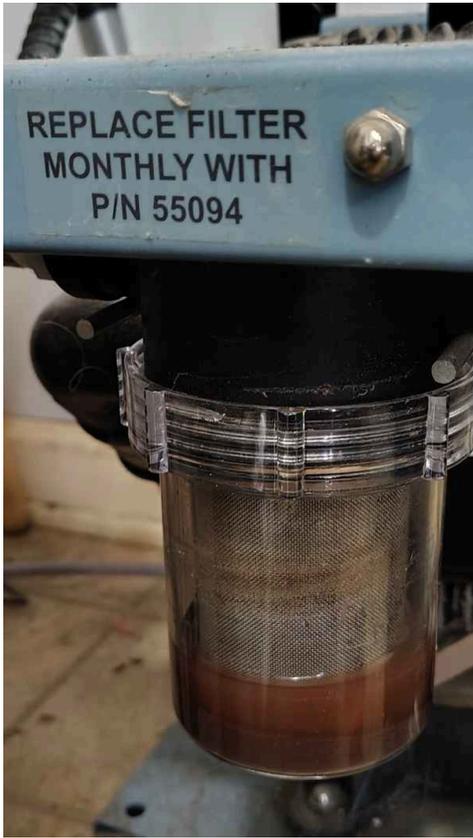
16.1.4 Speciality Dental Equipment

The vacuum system's inline filter canister contained a substantial amount of dark brown liquid and the filter media appeared heavily soiled. The label on the unit indicates the filter should be replaced monthly, but the condition observed suggests the filter has not been replaced or serviced in an extended period. This may indicate inadequate system maintenance, accumulated biofilm/debris within the dental evacuation lines, or improper drainage. Cleaning and servicing of the vacuum system, including replacement of the filter, is recommended by a qualified dental equipment technician.

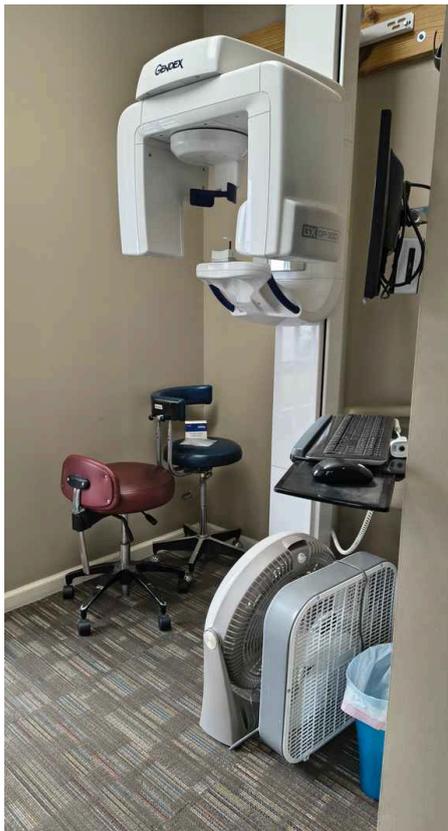
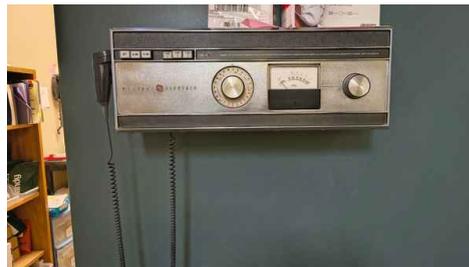
These systems are regulated medical devices that require evaluation by a licensed radiology technician, manufacturer-authorized service provider, or other qualified specialist. This inspection did not include testing, measuring, activation, calibration, radiation output assessment, alignment verification, shielding adequacy, dosimetry, or compliance with state or federal radiographic regulations.

Only the general room conditions and readily visible building components surrounding these systems were inspected. No determination is made regarding the safety, functionality, regulatory compliance, maintenance status, or performance of any dental X-ray or radiology equipment.

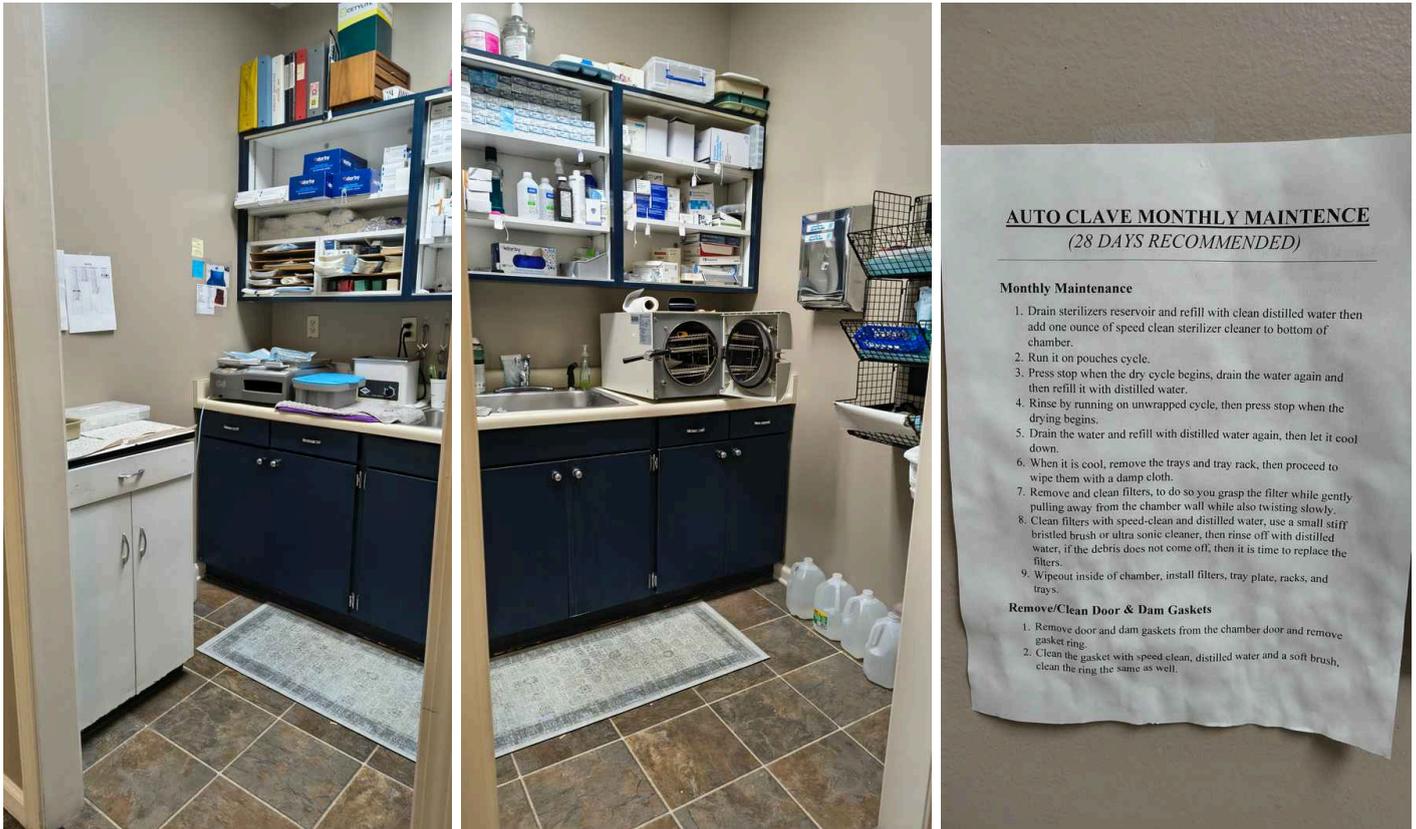
AUTO CLAVE MONTHLY MAINTENANCE (28 DAYS RECOMMENDED)

Monthly Maintenance

7. Remove and clean filters, to do so you grasp the filter while gently pulling away from the chamber wall while also twisting slowly.
8. Clean filters with speed-clean and distilled water, use a small stiff bristled brush or ultra sonic cleaner, then rinse off with distilled water, if the debris does not come off, then it is time to replace the filters.
