UPCHURCH INSPECTION
+19013508885
wes@upchurchinspection.com
<https://upchurchinspection.com>

RESIDENTIAL REPORT

1234 Main Street
Memphis, TN 38117

Buyer Name
01/10/2026 9:00AM

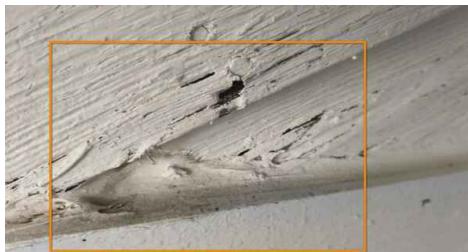
Indications of wood minor wood on Facia, in several areas.

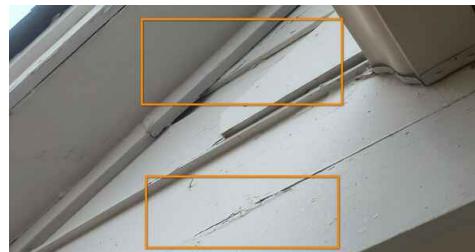
Peeling Paint Indicates Moisture in underlying wood.

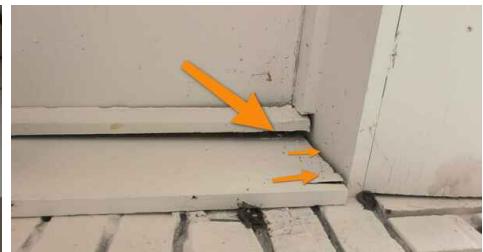
Separation of trim near attic in carport

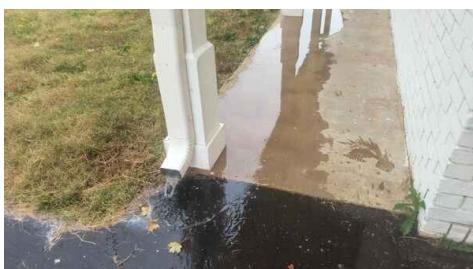
3.2.2 Roof Drainage Systems

DOWNSPOUT POOLING WATER IN BACKYARD

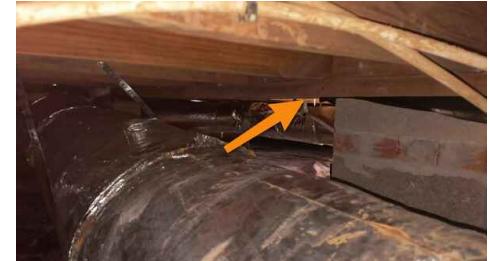
A support beam in the crawl space running along the hallway above shows visible signs of sagging. This condition may be due to factors such as age, settling of the foundation, or insufficient support beneath the beam. The sagging could lead to uneven floors, as observed in the living room and hallway of the home. It could compromise the structural integrity of the home over time if left unaddressed.

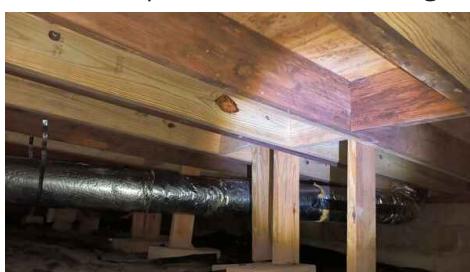
4.3.4 Floor Structure

FASTENING LOAD SUPPORT AT SIDES OF INDIVIDUAL FLOOR JOISTS

Contact a qualified structural engineer.

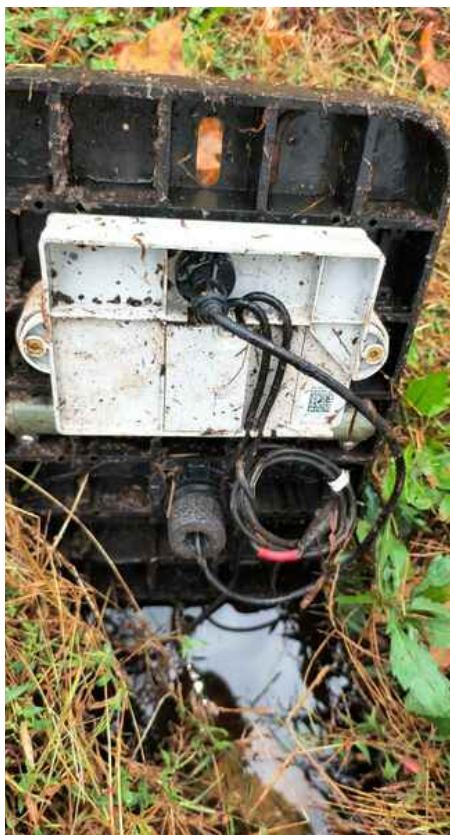
While the presence of water may not indicate a malfunction, it is advisable to monitor the area for drainage issues to prevent potential water pooling or saturation around the valve. Ensuring proper drainage will help maintain the accessibility and functionality of the shut-off valve.

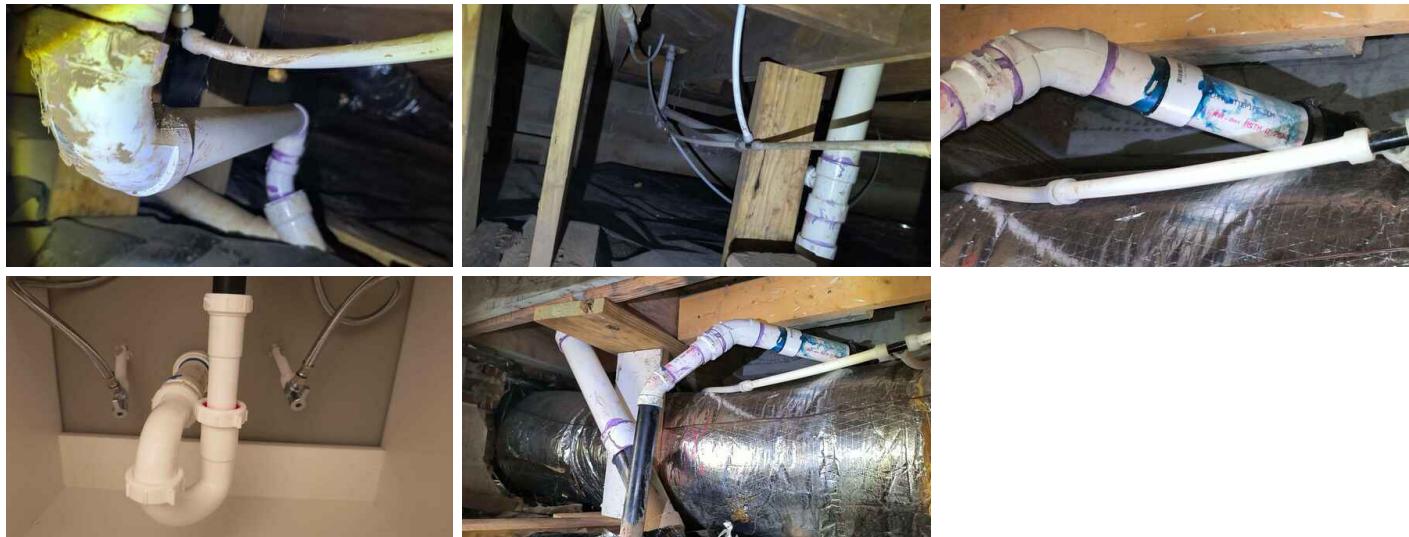
**Drain, Waste, & Vent Systems:****Drain Size**

The DWV system utilizes a combination of PVC piping for the waste lines and vent stacks. The drain lines were inspected at visible locations, including under sinks, in the crawlspace, and near fixtures. No signs of leakage, corrosion, or improper connections were observed at these locations. The venting system appears to allow proper airflow, supporting adequate drainage and preventing sewer gas odors from entering the home.

Overall, the DWV system appears to be functioning as intended, with proper venting and drainage observed. Regular monitoring and maintenance are recommended to ensure continued performance and to address any potential issues proactively.

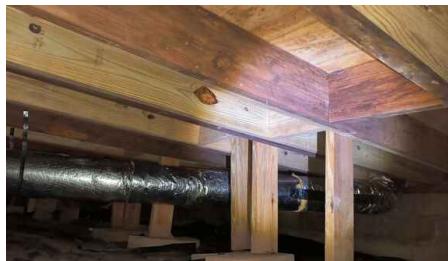
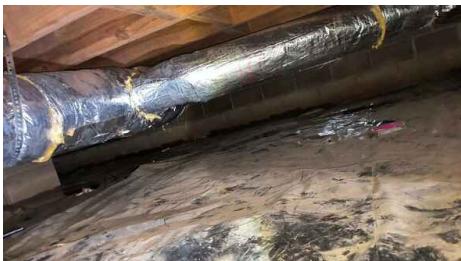
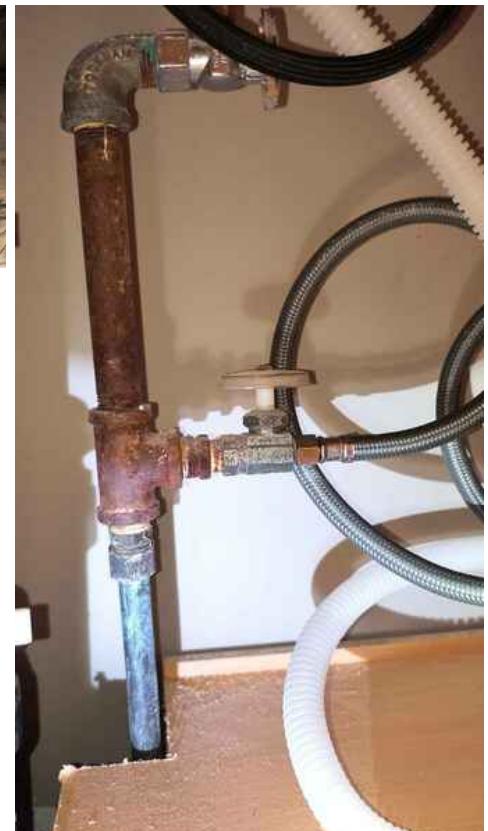
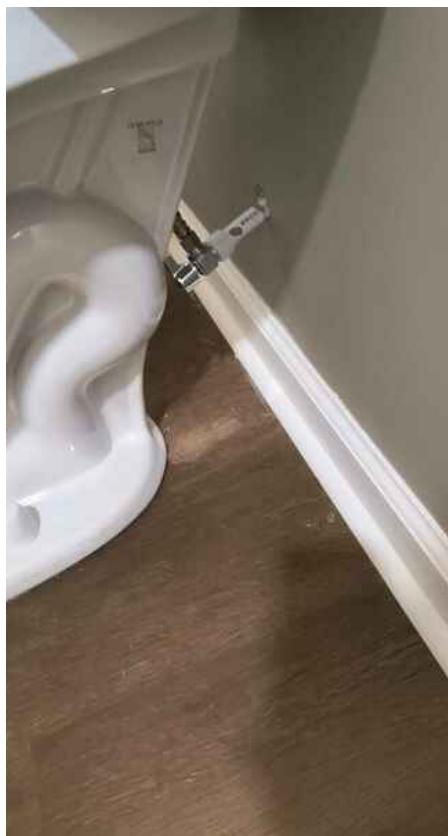
Water Supply, Distribution Systems & Fixtures: Distribution Material

Each fixture, including sinks, showers, and tubs, was turned on to verify that both hot and cold water were available. Multiple fixtures were operated simultaneously, resulting in only a minimal drop in water pressure, which is generally expected in typical household water systems. No significant loss of pressure was noted, and water flow remained consistent across the fixtures tested. Checked attachment of toilets and faucets. All were secure.

The water supply system appears to be in good working order, delivering adequate pressure and temperature at each fixture. Regular maintenance is recommended to ensure continued performance and pressure stability.

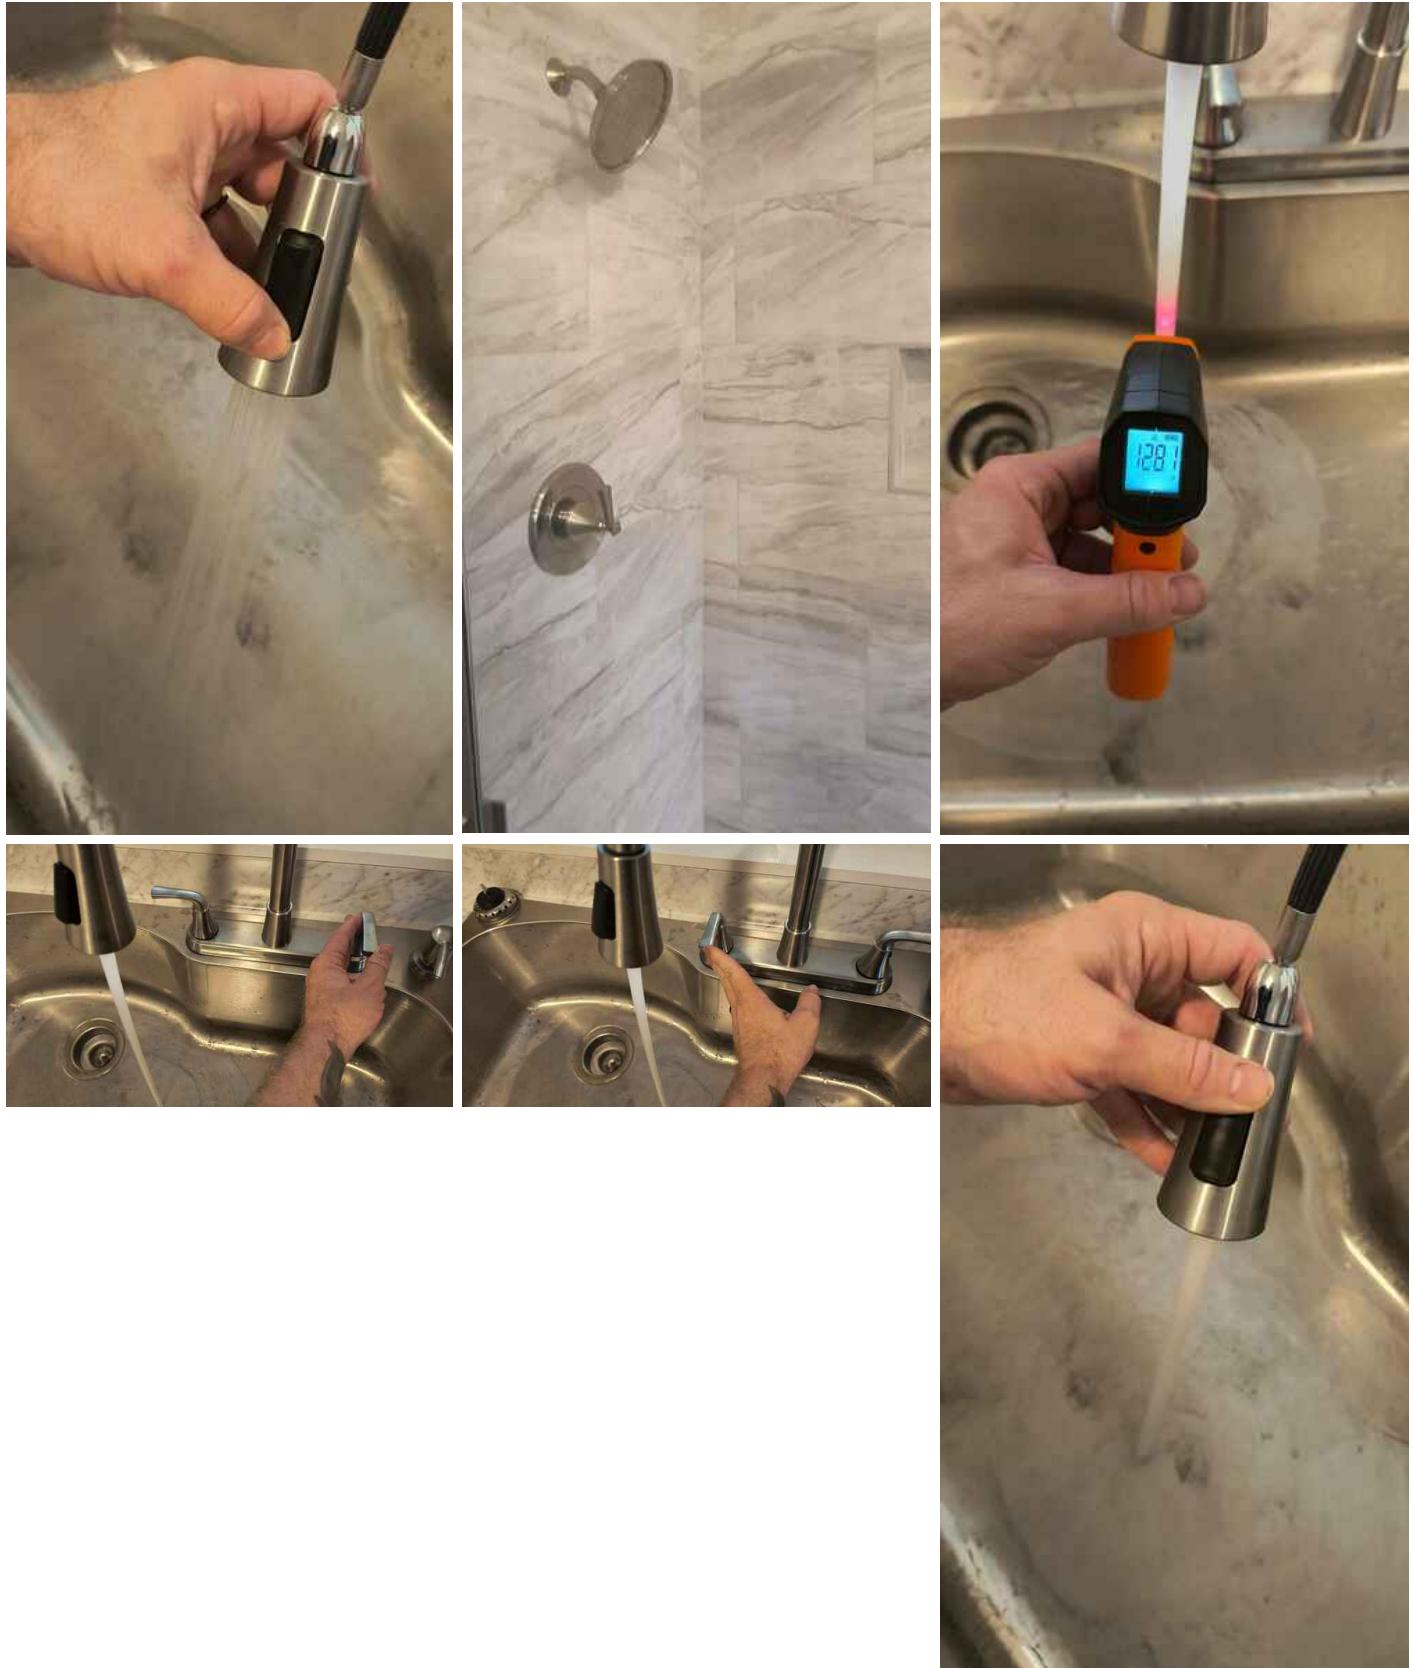
Water Supply, Distribution Systems & Fixtures: Functionality & Installation

During inspection, water was run through all observed bathtubs, sinks, and toilets, and each fixture demonstrated adequate drainage without noticeable delays or backups. No gurgling sounds or other signs of potential venting issues were noted, and all fixtures cleared water at an appropriate rate. All fixtures were securely attached.

The bathtubs, sinks, and toilets are functioning as intended with efficient drainage observed. Regular maintenance is recommended to help prevent future clogs or slow drainage.

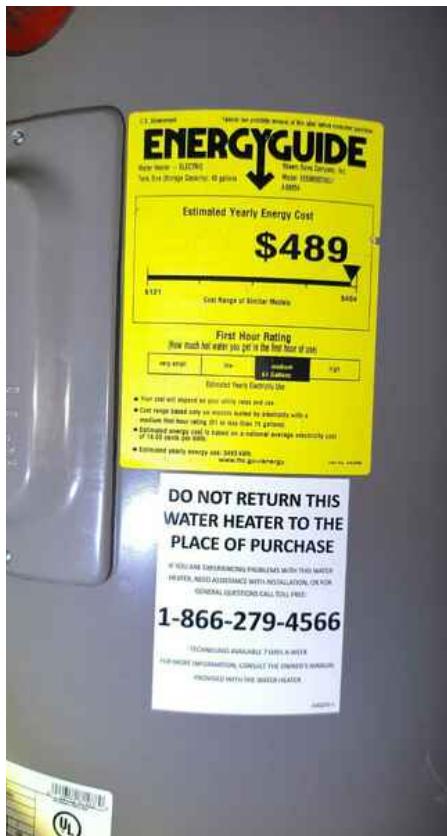
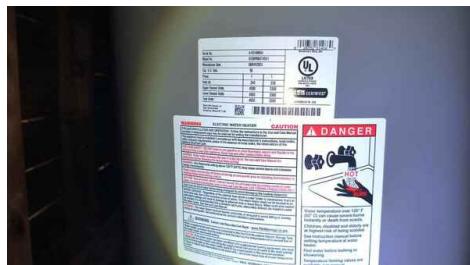
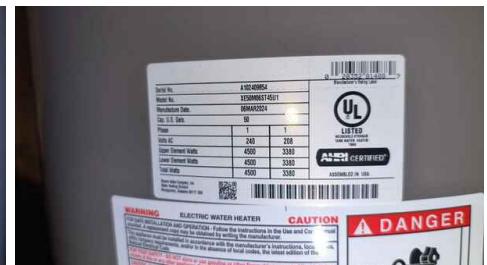
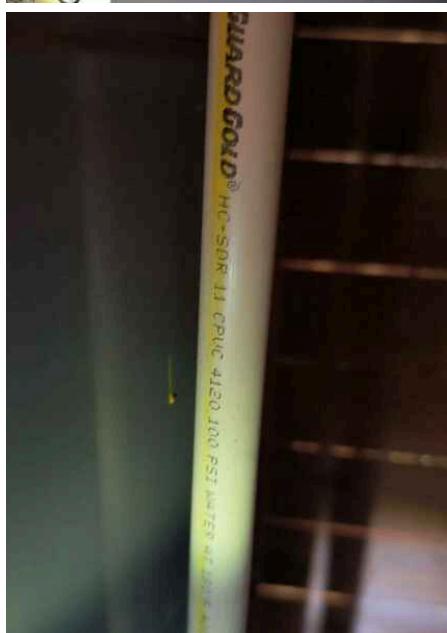
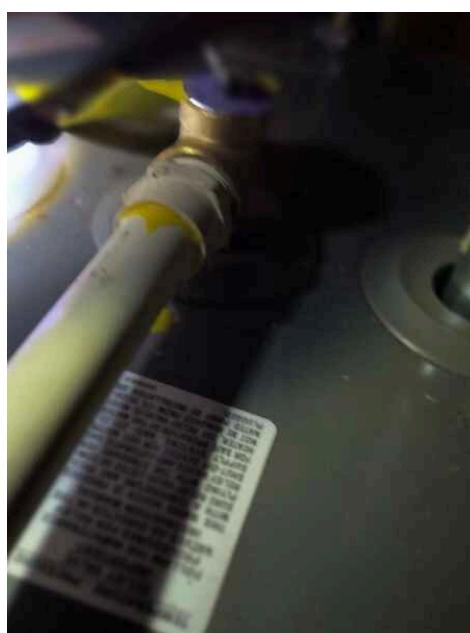
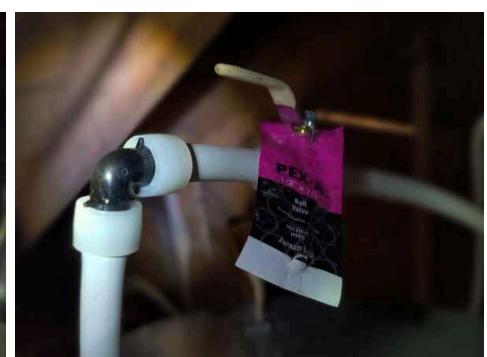
**Hot Water Systems, Controls,
Flues & Vents: Capacity**

A 50-gallon Rheem electric water heater was observed installed in the attic. This unit is a standard electric model with a capacity of 50 gallons, sufficient for typical household needs. The water heater is located in the attic, which may require monitoring to ensure it operates efficiently in this elevated position and prevent any potential leaks. The installation appears to include a drain pan and discharge pipe, though regular inspection is recommended to ensure they remain clear and functional.

Verify that the water heater is regularly maintained and inspected, particularly because attic installations can present additional risks for potential water damage if a leak occurs.

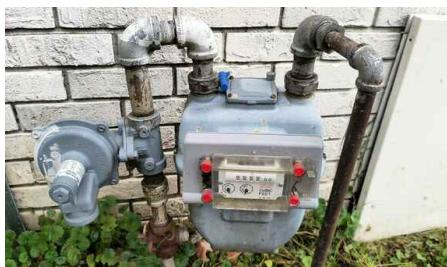
Fuel Storage & Distribution

The gas meter and main shutoff valve are located behind the house near the HVAC unit. The gas meter and shutoff valve appear to be in good working condition, with no visible signs of damage or leaks. The shutoff valve is easily accessible, allowing for convenient access if needed for maintenance or emergencies.

No action required at this time; the gas meter and shutoff valve are functioning properly. Regular inspection is recommended to ensure ongoing safety and functionality.

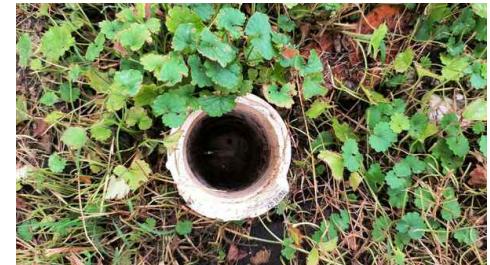
6.2.1 Drain, Waste, & Vent Systems

The septic system cleanout was observed without a cap in place. An uncapped septic cleanout can allow debris, water, and other contaminants to enter the system, potentially leading to blockages or other issues within the septic system.

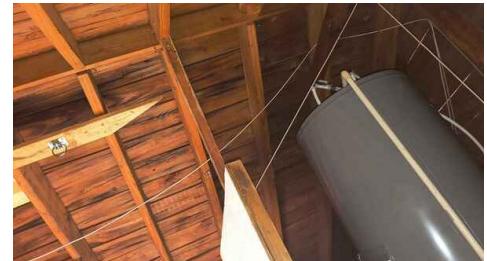
6.4.1 Hot Water Systems, Controls, Flues & Vents

**NO PERMANENT LIGHT FIXTURE
INSTALLED NEAR WATER HEATER****Observation:**

During the inspection of the attic space, it was noted that there are no permanent light fixtures located near the water heater. This lack of lighting can create visibility challenges when performing routine maintenance or inspections, particularly in low-light conditions.

A permanent lighting fixture and a 120 V receptacle outlet should be installed near a water heater in an attic. Recommend contacting electrician to add these features for future maintenance.

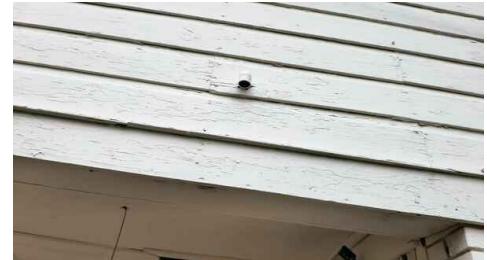
**DRAINPAN DISCHARGE PIPE SHOULD
TERMINATE NO MORE THAN 24 INCHES ABOVE THE
GROUND.**

The drain pan discharge pipe from the hot water heater was observed to terminate at the exterior of the building at an overhead height. However, it has been noted that the termination height exceeds the recommended standards.

To promote effective drainage and reduce the risk of water damage or foundation issues, it is recommended that the discharge pipe be modified to terminate no more than 24 inches above the ground. This adjustment will help facilitate proper water flow and mitigate potential drainage-related problems in the future.

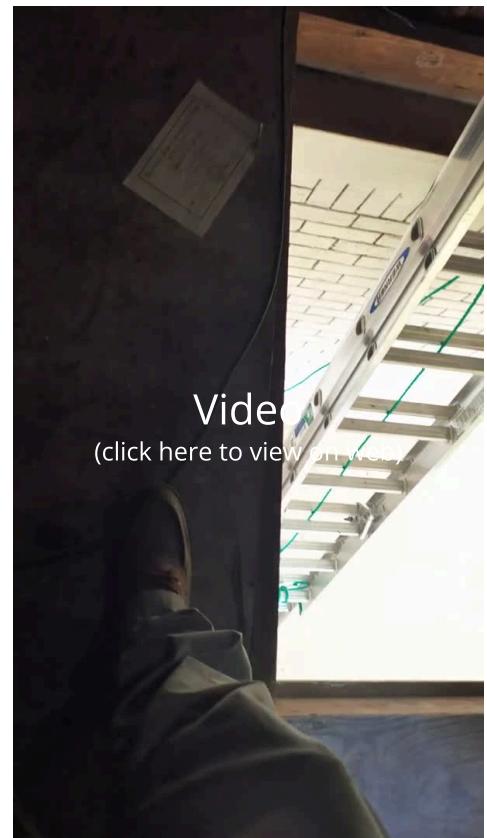
The walkway flooring surrounding the water heater is not securely fastened. The flooring around the water heater in the attic appears loose and not properly anchored, which could pose a tripping hazard during maintenance or inspections. Securely fastened flooring is essential to ensure safe access, especially when navigating tight attic spaces.

Recommend fastening or reinforcing the walkway flooring around the water heater to improve safety and prevent any accidental slipping or tripping hazards during future access.

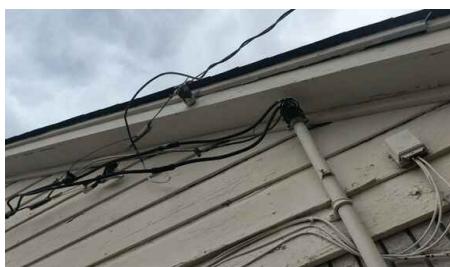
The service entrance conductors entering the property from the back right corner, near the laundry room, were inspected. The service entrance conductors are routed through the back right corner of the property and transition into the structure adjacent to the laundry room. Upon examination, these conductors appear to have adequate clearance from the ground and surrounding structures. This clearance helps ensure safe operation and reduces the risk of damage or interference from vegetation or debris.

The insulation on the conductors appears intact, with no visible signs of wear or degradation. Proper installation and clearance are crucial for preventing electrical hazards and ensuring the longevity of the electrical system. It is worth noting that fascia has peeling paint near the service industry conductors, which should be addressed to prevent moisture problems and provide protection from the elements.

Overall, the service entrance conductors are well-installed, maintaining sufficient clearance and integrity, which is essential for safe and reliable electrical service to the home.

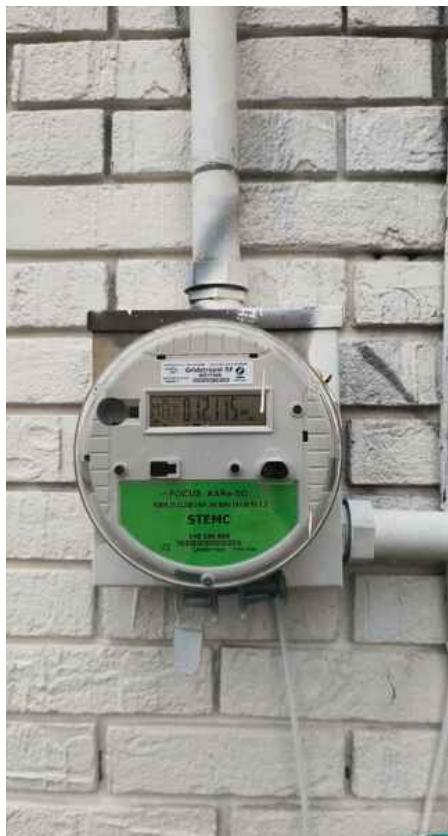
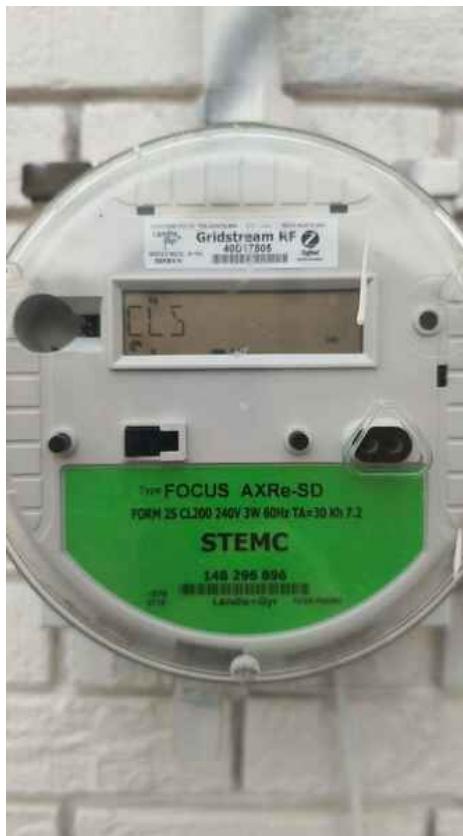
Service Entrance Conductors: Electrical Meter

The electric meter located on the exterior of the property was inspected for condition and functionality. The electric meter is mounted securely on the exterior wall, positioned at a height that allows for easy reading and access. Upon examination, the meter appears to be in good condition, with no visible signs of damage or wear. The glass face is clear, allowing for easy visibility of the dials and digital display.

Overall, the electric meter is in satisfactory condition, functioning properly, and compliant with local regulations. Regular monitoring of the meter readings is recommended to ensure efficient energy use and identify any potential issues with electrical consumption.

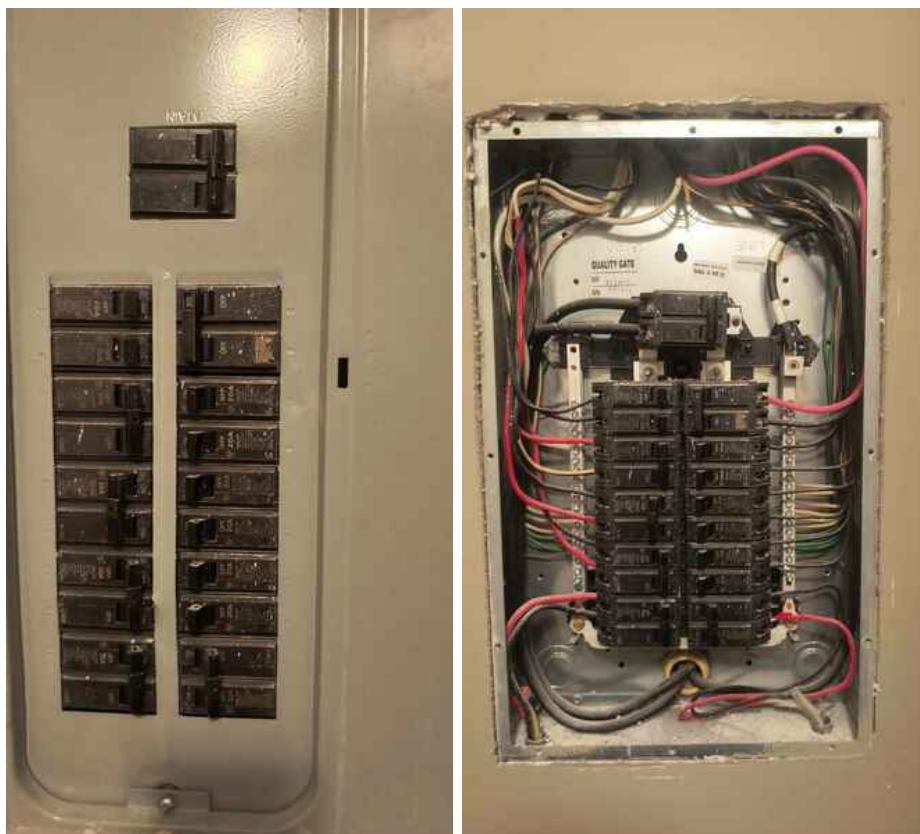
**Main & Subpanels, Service & Grounding, Main Overcurrent****Device: Main Panel Location**

Main panel is of circuit breaker type. No missing switches were observed, indicating that all circuits are accounted for and operational. The size of the circuit breaker panel appears adequate for the electrical load demands of the home, ensuring it can handle the current usage without overloading. This includes assessing both the amperage rating of the panel and the individual breakers, which were found to be appropriate for the home's electrical system. Defects noted.

Overall, the circuit breaker panel is functioning as intended, providing a safe and reliable means of managing the electrical distribution throughout the property. Regular monitoring and maintenance are recommended to ensure continued safety and performance.

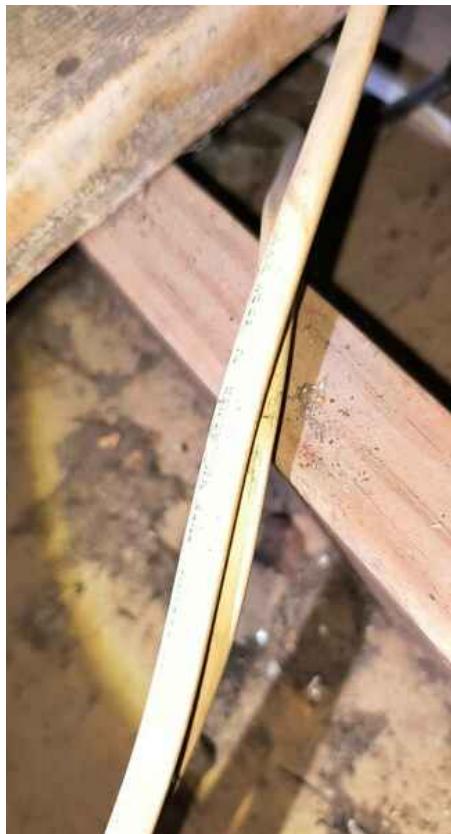
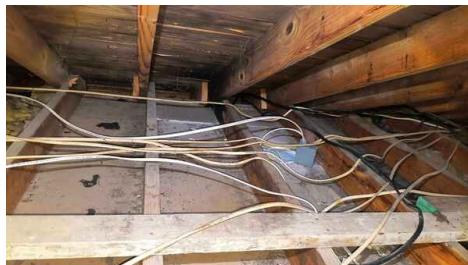
Branch Wiring Circuits, Breakers & Fuses: Branch Wire 15 and 20

All observed branch circuits appear to use Type NM (Non-Metallic) Romex wire. During the inspection, it was noted that the branch circuits throughout the home are wired with Type NM Romex cable. This type of wiring is commonly used for residential electrical systems and is suitable for dry interior locations. The insulation and construction of Romex wire provide a level of safety and efficiency in electrical installations.

The use of Type NM Romex wire in the observed branch circuits indicates compliance with standard wiring practices. However, it is essential to ensure that all installations meet local electrical codes and safety standards.

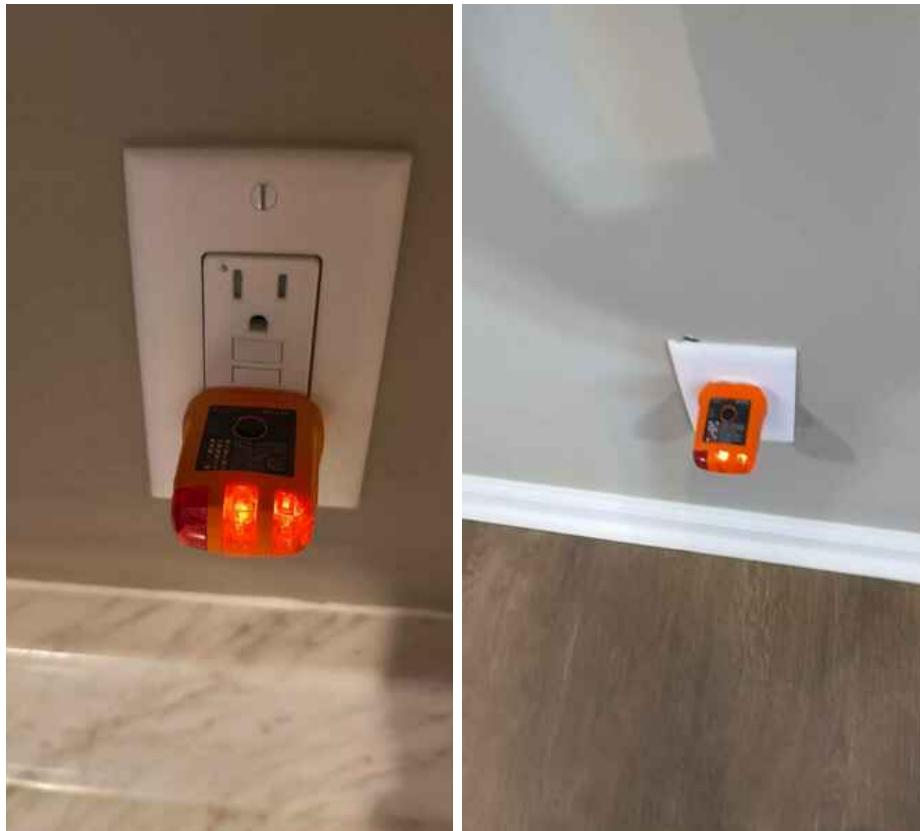
Lighting Fixtures, Switches & Receptacles: Outlets Tested

A representative number of electrical outlets were inspected throughout the home. Lights were tested as well. Each outlet or fixture tested was functional, providing power as expected. Additionally, the outlets displayed proper polarity, ensuring that the wiring is correctly configured for safe usage. This includes verifying that the hot and neutral wires are connected to their appropriate terminals, which is crucial for preventing electrical hazards. Several light bulbs were out, however swapping the bulbs with known good bulbs indicated that the fixtures themselves worked.

The outlets and fixtures throughout the home are in good working order and adhere to safety standards, contributing to a safe electrical system in the residence.

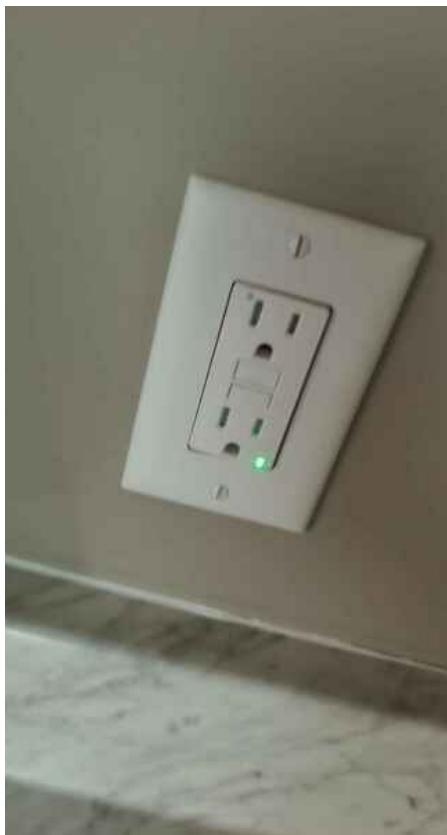
GFCI & AFCI: GFCI Present in Bathroom and Kitchen

The GFCI outlets in the kitchen and bathroom are operational and compliant with safety standards, effectively protecting against ground faults and enhancing overall electrical safety in these critical areas.

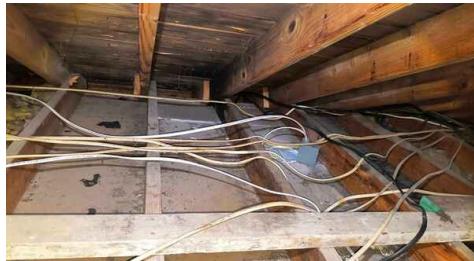
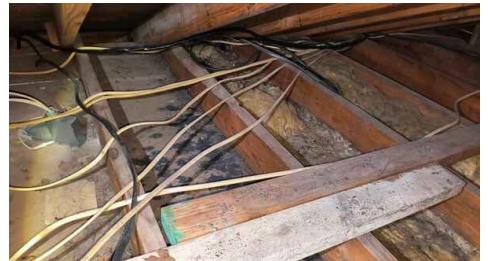
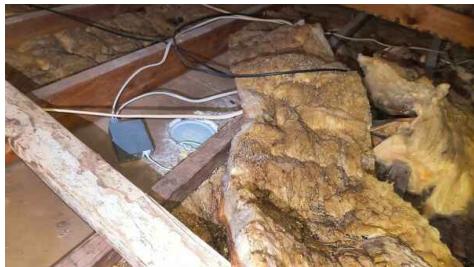
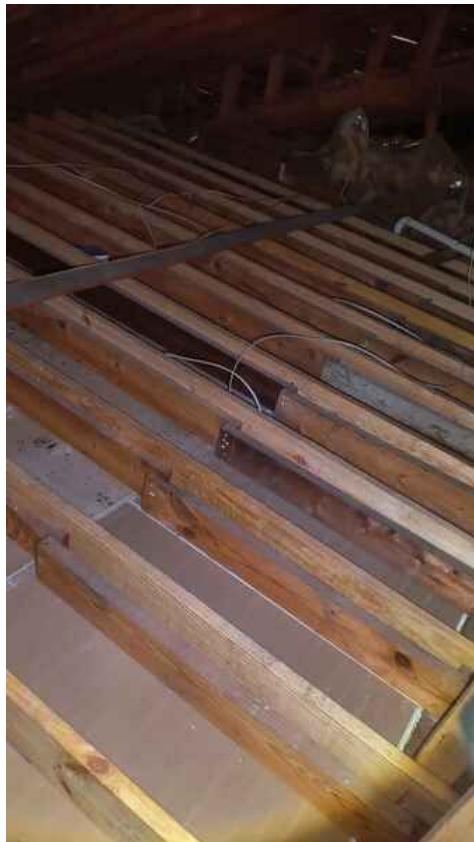
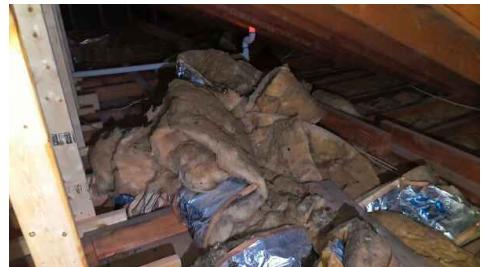
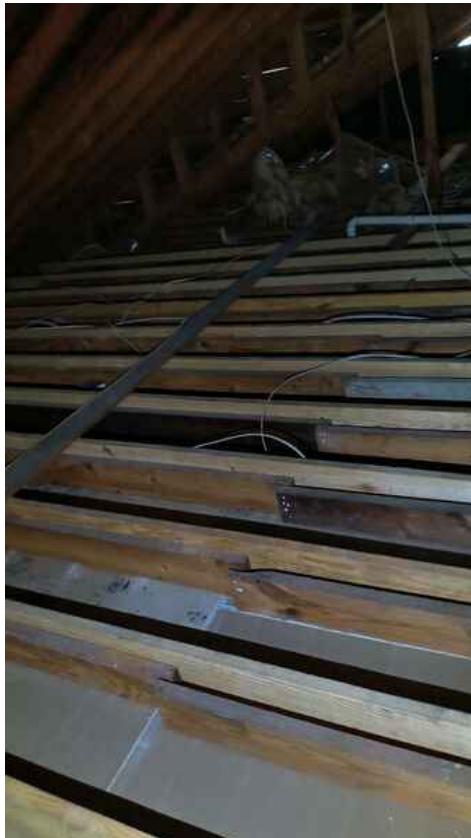
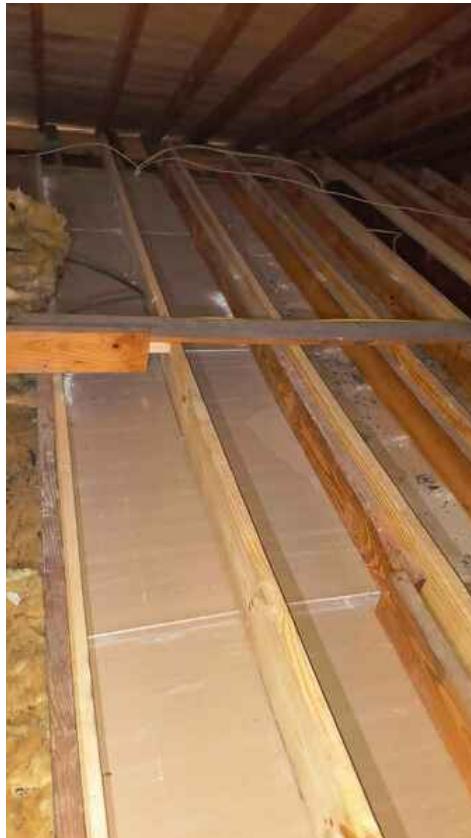
8.1.2 Attic Insulation

INSUFFICIENT INSULATION

Insulation inadequate. Recommend a qualified attic insulation contractor install additional insulation.

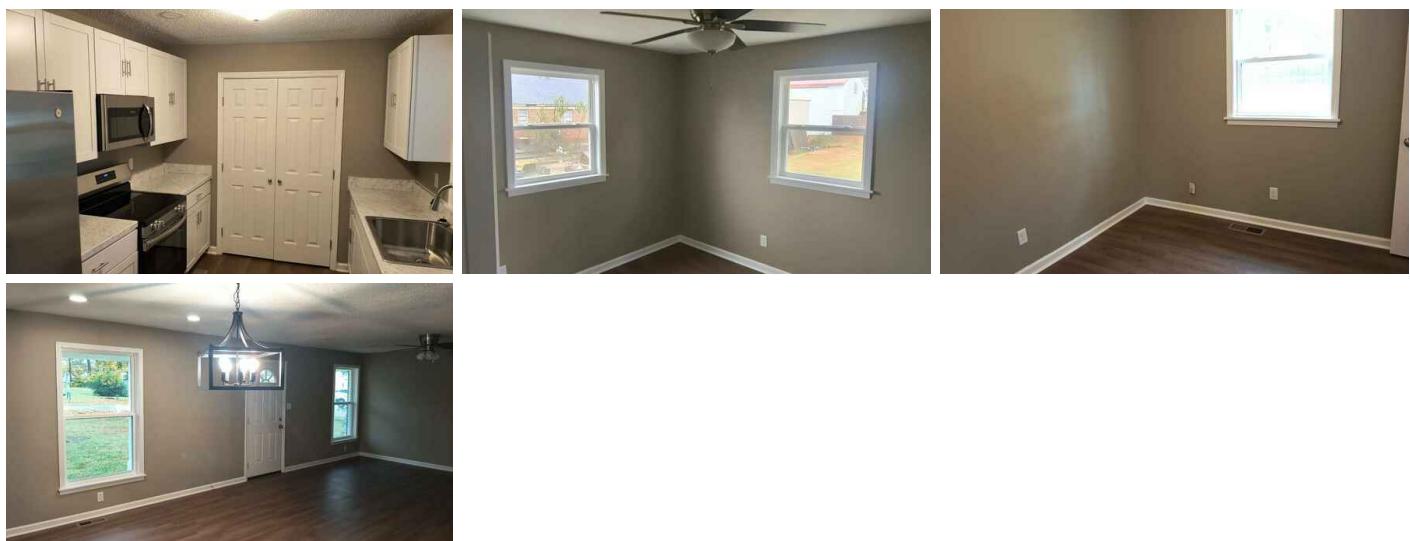
Doors: Door Installation Correct and Doors Functional

All interior and exterior doors were observed to be functioning as intended. Each door opens and closes smoothly, with proper alignment and secure latching. No signs of sticking, misalignment, or damage were noted.

No action is necessary at this time. Regular checks and maintenance, such as lubricating hinges, are recommended to ensure continued smooth operation.

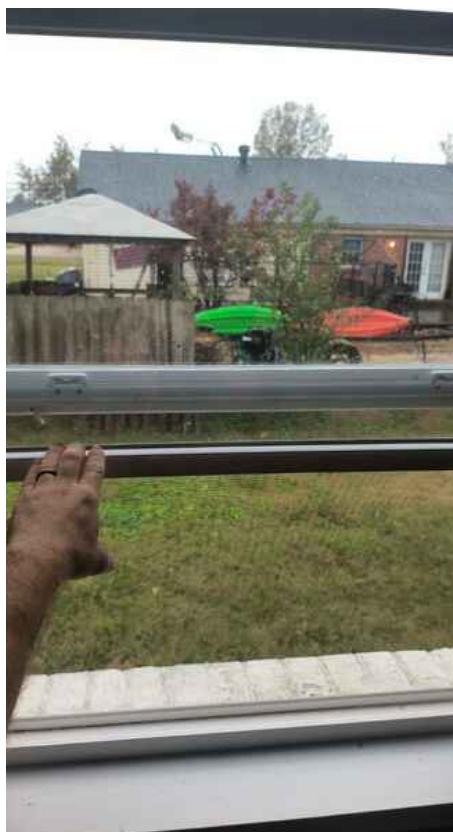
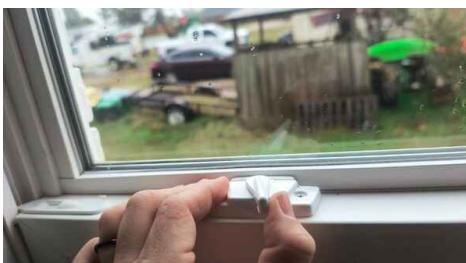
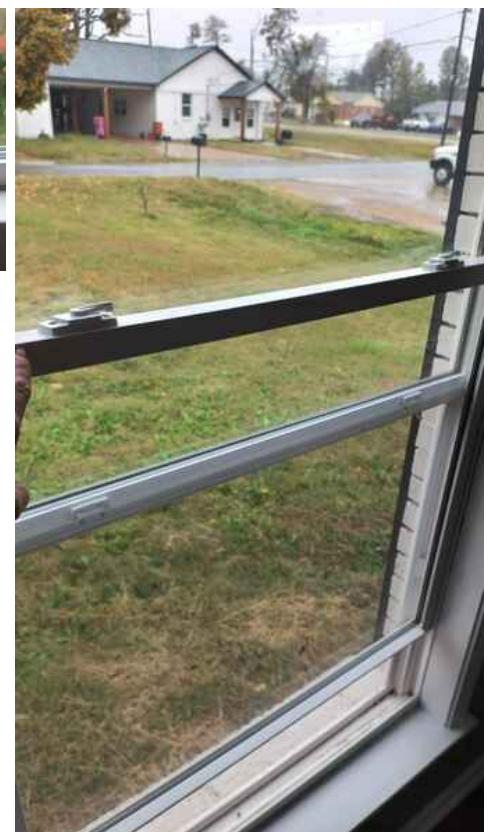
Windows: Double Hung Windows

The property is equipped with double-hung windows that appear to be a new installation. Inspected double-hung windows operate smoothly, opening and closing without any issues. The sashes lock securely in place, ensuring proper security and insulation. The window frames and panes are free of any visible defects, and the seals appear intact. Additionally, appropriate screens are installed, providing added protection against pests.

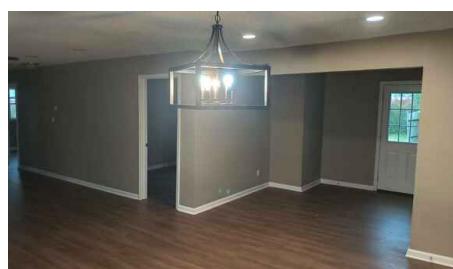
Walls: Drywall

The home's walls are made of drywall, which appears in overall good condition (except where noted below in this report).

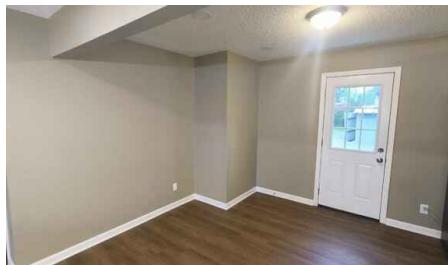
Ceilings: Ceiling Appears To Be In Good Condition

The popcorn ceiling appeared to be in good condition, with no visible signs of water intrusion, staining, or damage. The texture is consistent throughout, and there were no indications of cracking or peeling.

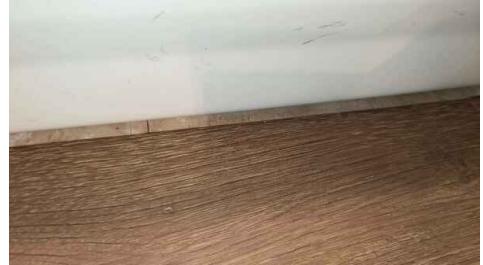
9.3.2 Floors

FLOOR OF HALLWAY BATHROOM NOT SEALED AT BATHTUB

The flooring in the hallway bathroom is not sealed along the edge of the bathtub. A gap was noted between the floor and the base of the bathtub, where no caulking or sealant was present. This unsealed area may allow moisture to penetrate, potentially leading to water damage, mold growth, or deterioration of the floor materials over time.

To prevent potential moisture issues, it is advised to apply a suitable waterproof sealant along the edge of the bathtub where it meets the floor. Sealing this area will help protect the flooring and improve the longevity of bathroom materials.
